Hi-Speed Industrial Service
7030 Ryburn Dr
Millington, Tn 38053
901-873-5300

AC Recondition Repair Report

Molex, Inc. (10511)
801 Murphy Dr.
Maumelle, AR 72113

1. Job Number	98135
2. Report Date	04/22/2021
3. Customer	MOLEX

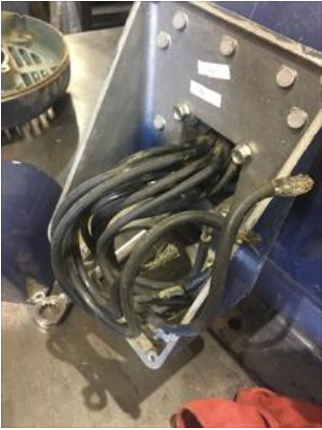
18.	Number of Leads	9	P13

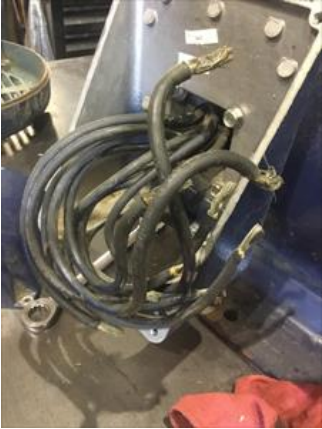
21. Lead Condition	(P) Pass	P42

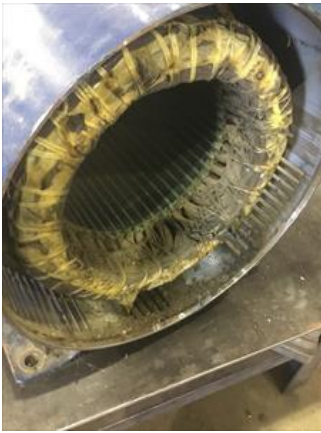
30. Bearing Rtd's Condition	(NA) Not Applicable	
31.	Contamination		P104
	<i>Dirty</i>

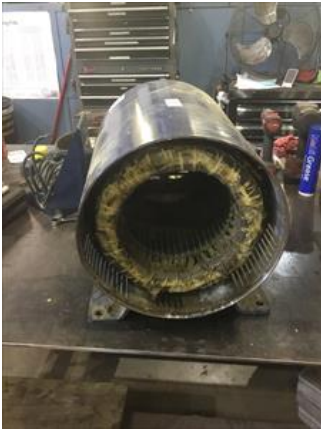
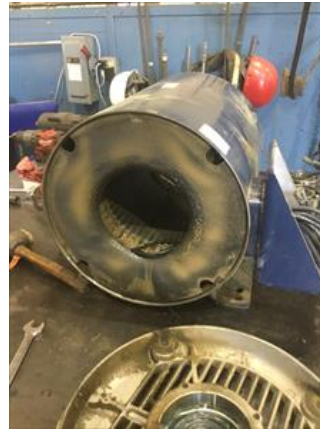
P106

32. Frame Condition

(P) Pass

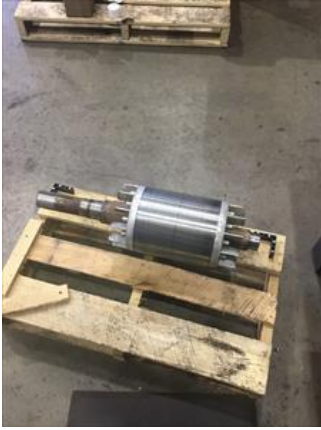
P4

44. Rotor Type

laminate press squirrel cage

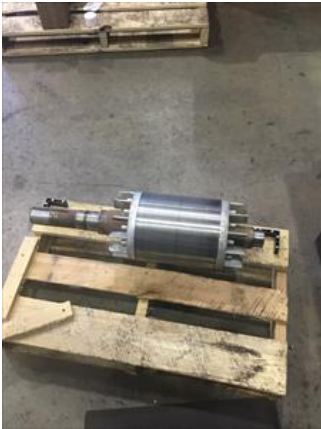
P50

● 49. Rotor Condition

(P) Pass

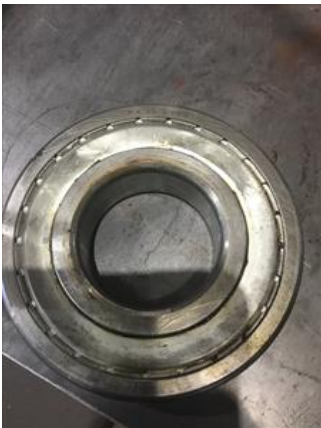
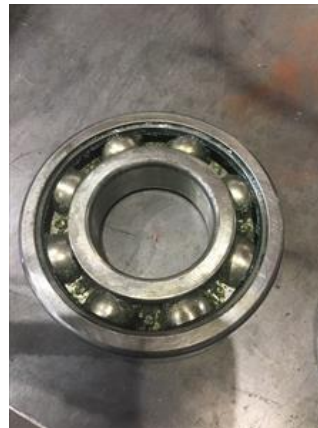
P15

51. Bearing DE Size

6313 Z C3

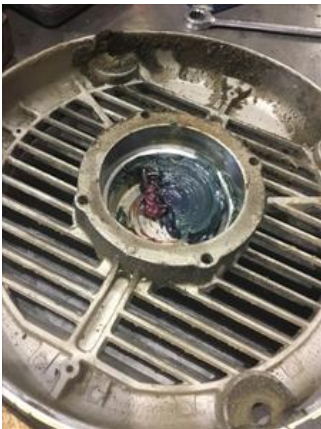
P74

59. Grease Condition

(F) Fail

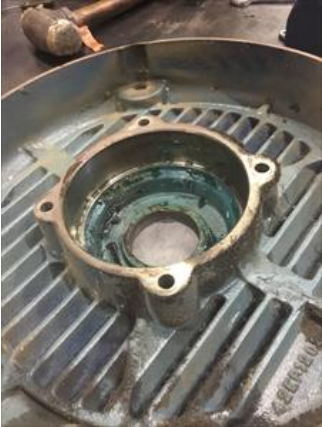
89.	DE Final Air Seal Shaft Size	
90.	ODE Air Seal Shaft Fit	
91.	ODE Initial Air Seal Shaft Size	
92.	ODE Final Air Seal Shaft Size	
93.	DE Endbell Fit	P129

94.	DE Initial Endbell Fit Size 1	5.5129 "
95.	DE Initial Endbell Fit Size 2	5.5124 "
96.	DE Initial Endbell Fit Size 3	5.5122 "
97.	DE Final Endbell Fit Size 1
