AC Recondition Repair Report

Molex, Inc. (10511)
801 Murphy Dr.
Maumelle, AR 72113

1. Job Number	98135
2. Report Date	04/22/2021
3. Customer	MOLEX

BALDOR

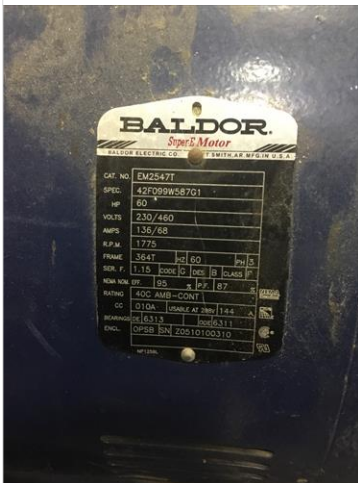
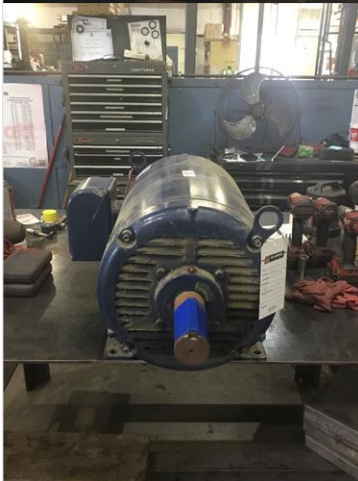
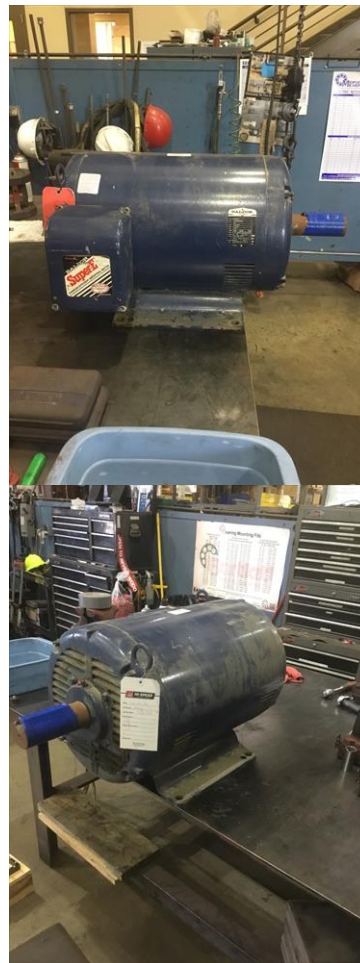
P5

Name Plate Information

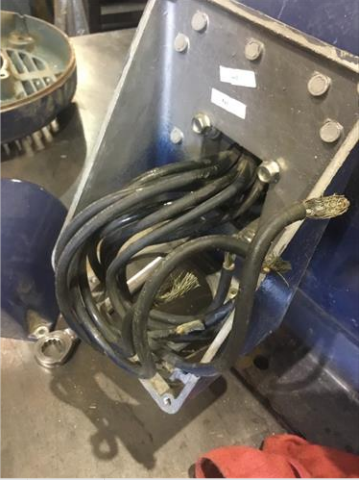
18. Number of Leads	9	P13

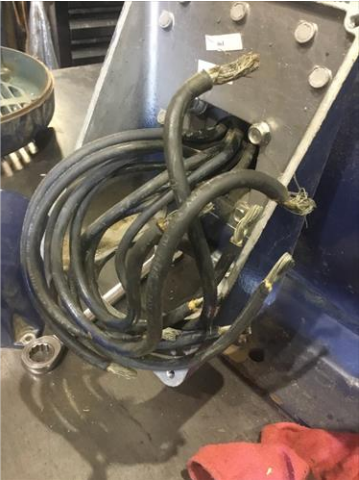
19. Lead Length	12 Inches	
20. Lead Size		
● 21. Lead Condition	(P) Pass	P42

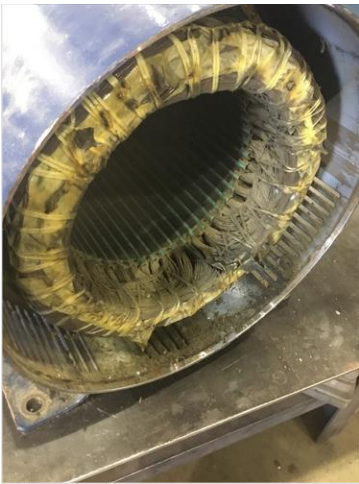
22. Lead Markings	1-9	
23. Lug Size, Condition, and Type		
24. Winding RTD's		
25. Winding Rtd's Condition		
26. Shaft Run Out	0.001	
27. Does Shaft Turn Freely	yes	
28. Does Shaft Have Visible Damage	no	
29. Bearing Rtd's	(NA) Not Applicable	
● 30. Bearing Rtd's Condition	(NA) Not Applicable	
31. Contamination		P104
<i>Dirty</i>

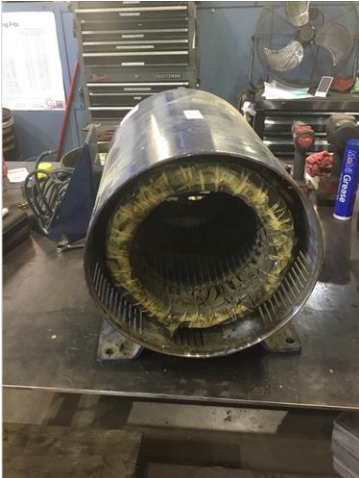
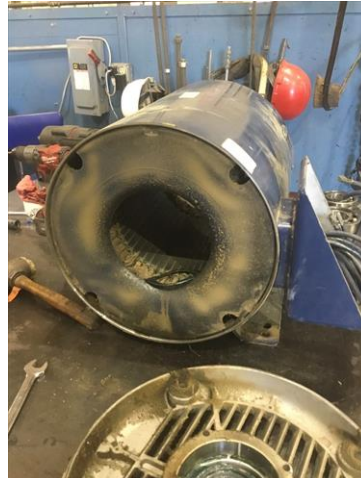
P106

32. Frame Condition

(P) Pass

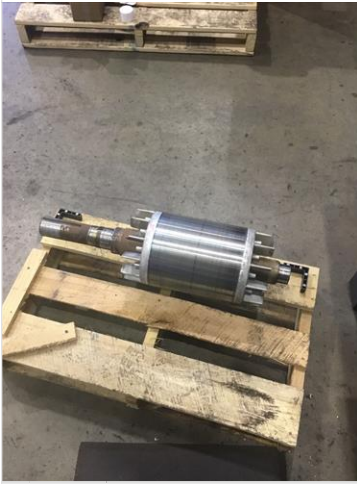
P4

44. Rotor Type

laminate press squirrel cage

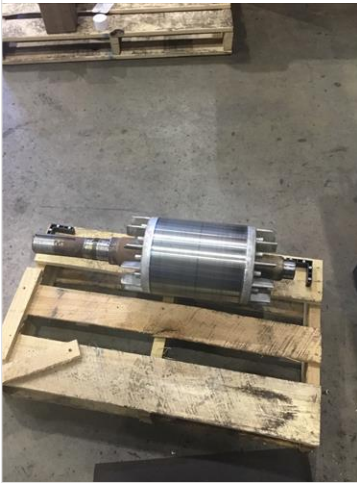
P50

● 49. Rotor Condition

(P) Pass

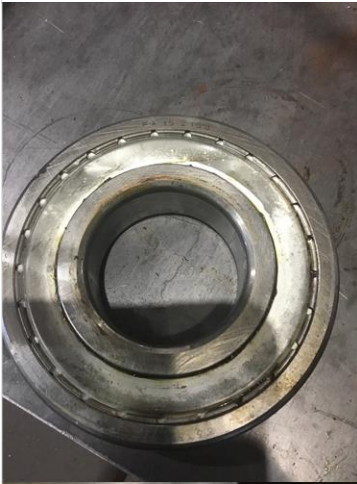
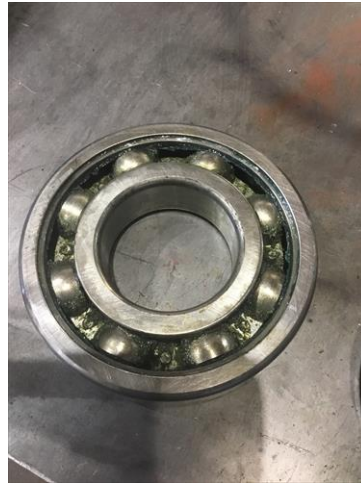
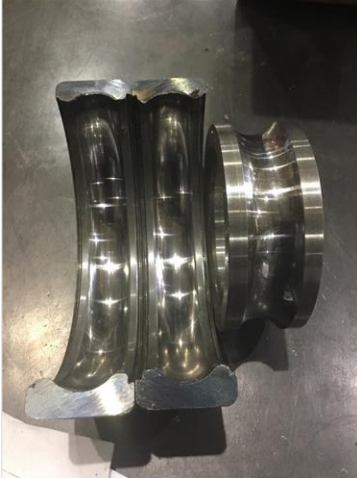
P15

50. Bearing Manufacture

SKF

51. Bearing DE Size

6313 Z C3

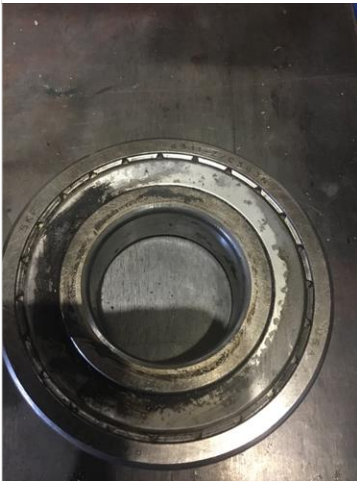
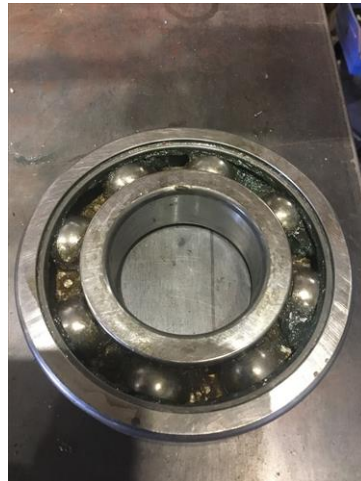
P43

54. Bearing ODE Size

6311 Z C3

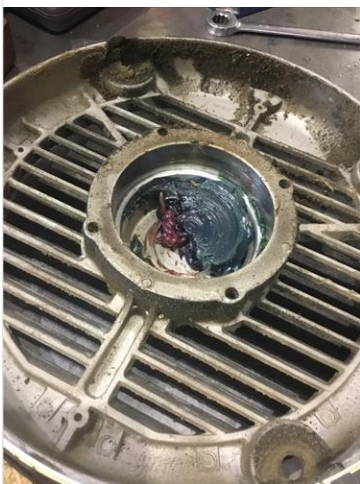
55. Bearing ODE Type	deep groove ball bearing	
56. ODE Bearing Qty.	1	
57. Insulated Bearing		
58. Lubrication Type	grease	
59. Grease Condition	(F) Fail	P74

66. Component Failure	bearings worn	
67. Cause of Failure	Contaminated grease	
68. Comments	Stator windings tested bad with new tester. Retested windings with old machine, windings tested good.	
69. Service Technician	Terrence. Holland

**Rewind stator.**

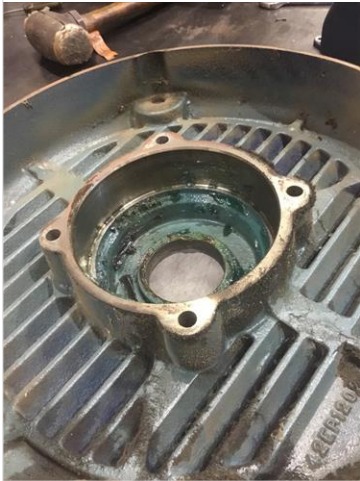
89.	DE Final Air Seal Shaft Size	
90.	ODE Air Seal Shaft Fit	
91.	ODE Initial Air Seal Shaft Size	
92.	ODE Final Air Seal Shaft Size	
93.	DE Endbell Fit	P129

94.	DE Initial Endbell Fit Size 1	5.5129 "
95.	DE Initial Endbell Fit Size 2	5.5124 "
96.	DE Initial Endbell Fit Size 3	5.5122 "
97.	DE Final Endbell Fit Size 1

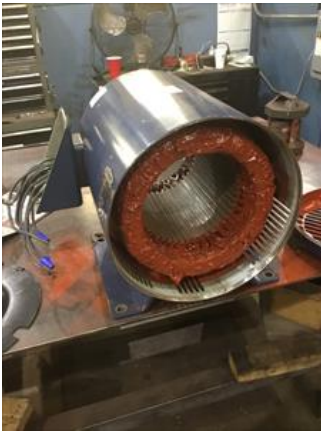
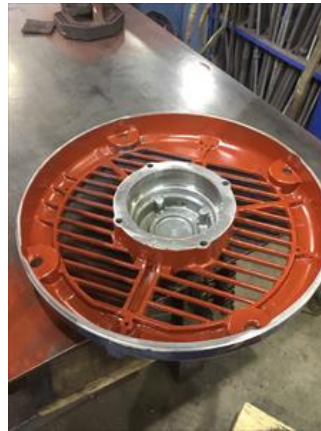
132.	Winding Resistance 1-3	
133.	Test Run Voltage Phase A	
134.	Test Run Amps A	
135.	Test Run Voltage Phase B	
136.	Test Run Amps B	
137.	Test Run Voltage Phase C	
138.	Test Run Amps C	
139.	DE Horizontal Vibration Reading	0.05 In/Sec
140.	DE Vertical Vibration Reading	0.03 In/Sec
141.	DE Axial Vibration Reading	0.03 In/Sec
142.	ODE Horizontal Vibration Reading	0.04 In/Sec
143.	ODE Vertical Vibration Reading	0.05 In/Sec
144.	ODE Axial Vibration Reading	0.02 In/Sec
145.	Ambient Temp at start of Test Run	
146.	Temp at 5 minutes	
147.	Temp at 10 minutes	
148.	Temp at 15 minutes	
149.	Temp at 20 minutes	
150.	Temp at 25 minutes	
151.	Temp at 30 minutes	
152.	Temp at 35 minutes	
153.	Temp at 40 minutes	
154.	Temp at 45 minutes	
155.	Temp at 50 minutes	
156.	Temp at 55 minutes	
157.	Temp at 60 minutes	
● 158.	Motor Paint	(P) Pass P136
