AC Recondition Repair Report

Riceland Foods (11100-RLF)

1. Job Number	98164
2. Report Date	05/03/2021
3. Customer	RICELAND FOODS STUTTGART

4. Manufacturer	WEG
5. Model	30018XT30449T
6. Serial Number	17NOV20151030405430
7. Horsepower	300
8. KW	
9. Volts	460
10. Amps	334
11. RPM	1785
12. Frame	449T
13. Enclosure	TEFC-XP
14. Cycles	60
15. Phase	3
16. Service Factor	1.15
17. Motor Mount Position

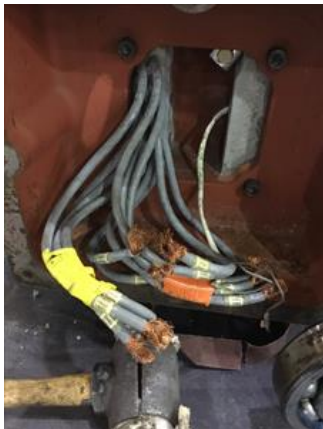
P42

18. Number of Leads	12
19. Lead Length	16 Inches
20. Lead Size	2
● 21. Lead Condition	(P) Pass

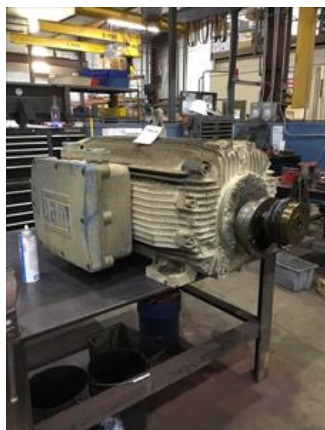
● 32. Frame Condition	(P) Pass	P106
-----------------------	----------	------

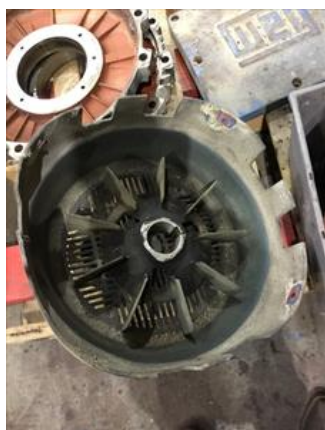
● 33. Fan Condition	(P) Pass	P109
---------------------	----------	------

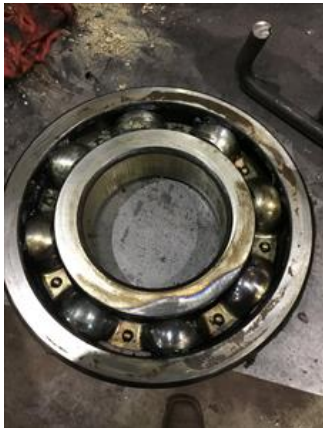
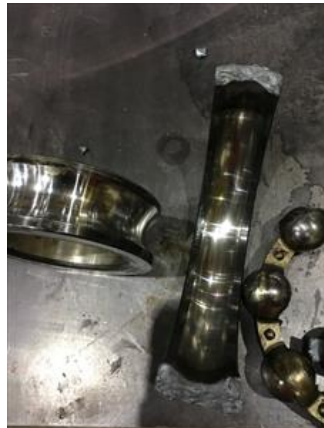
44.	Rotor Type	cast aluminum	
45.	Air Gap <10% Variation		
46.	Number of Rotor Bars	40	
47.	Number of Broken Rotor Bars	0	
<div><div></div></div> 48.	Growler Test	(P) Pass	
<div><div></div></div> 49.	Rotor Condition	(P) Pass	
Mechanical Inspection		<div><div></div></div>	
50.	Bearing Manufacture	ntn	
51.	Bearing DE Size	6322 c3	P15
<div><div>

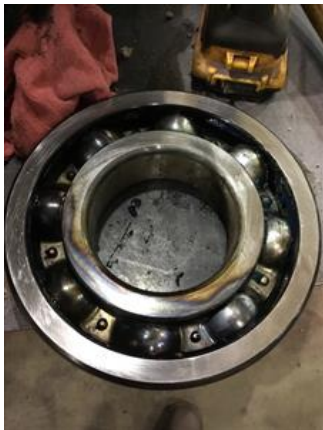
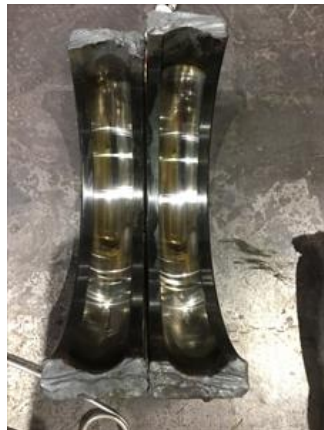
</div></div>			
52.	Bearing DE Type	ball	
53.	DE Bearing Qty.	1	
54.	Bearing ODE Size	6319 c3	P43
<div><div>

</div></div>			
55.	Bearing ODE Type	ball	
56.	ODE Bearing Qty.	1	
57.	Insulated Bearing	no	
58.	Lubrication Type	grease	
<div><div></div></div> 59.	Grease Condition	(F) Fail

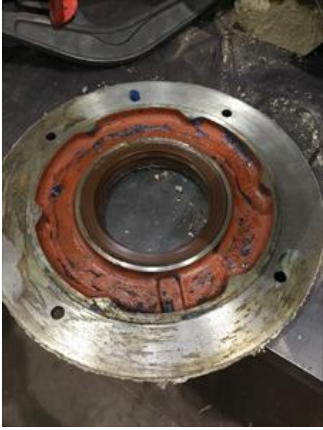
P80

60. Bearing Retainers

(Y) Yes

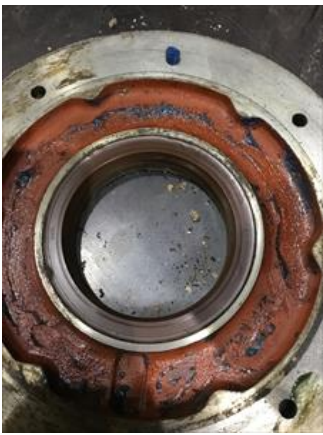
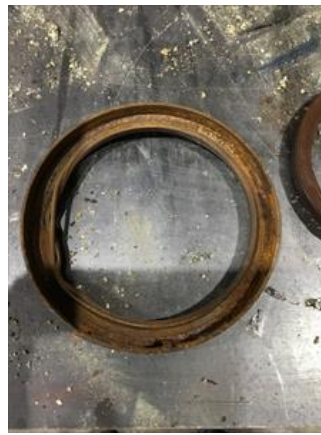
P86

62. DE Seal

(Y) Yes

6336 viton
5.5125x4.8750x0.5250

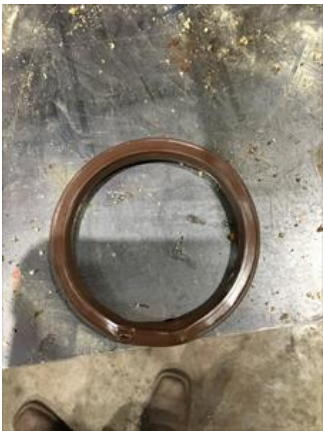
P95

64. ODE Seal

(Y) Yes

viton 4.1730x4.5250x0.5250
