AC Recondition Repair Report

Arauco-Malvern MDF (10298)
1275 Willamette Rd
Malvern, AR 72104

1. Job Number	98173
2. Report Date	05/01/2021
3. Customer	ARAUCO

5. Model	1LA04454SD42
6. Serial Number	7K516623210836
7. Horsepower	150
8. KW	
9. Volts	460
10. Amps	170
11. RPM	1780
12. Frame	445TS
13. Enclosure	TEFC
14. Cycles	60
15. Phase	3

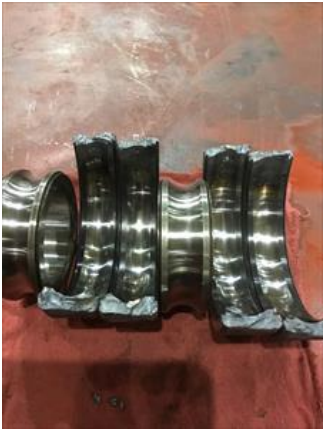
46.	Number of Rotor Bars	36
47.	Number of Broken Rotor Bars	0
● 48.	Growler Test	(P) Pass
● 49.	Rotor Condition	(P) Pass
Mechanical Inspection		
50.	Bearing Manufacture	P1

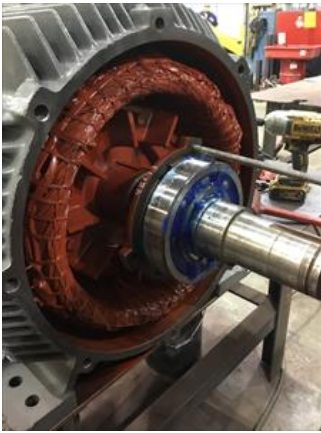
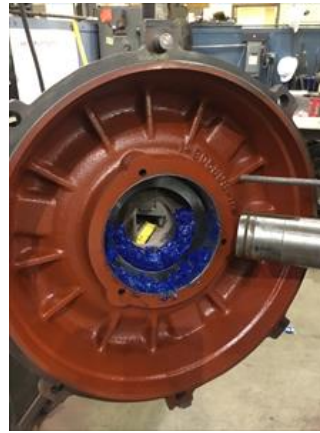
158. Motor Paint	(P) Pass	P136
