Hi-Speed Industrial Service  
7030 Ryburn Dr  
Millington, Tn 38053  
901-873-5300

## AC Recondition Repair Report

FolderID: 98193  
FormID: 10600465

TRIANGLE ENGINEERING OF  
ARKANSAS  
1101 NORTH REDMOND ROAD  
JACKSONVILLE, AR 72076

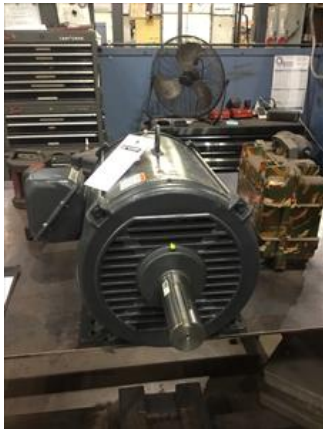
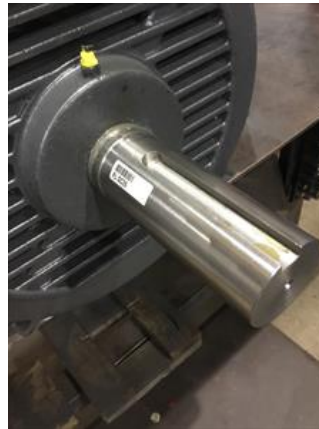
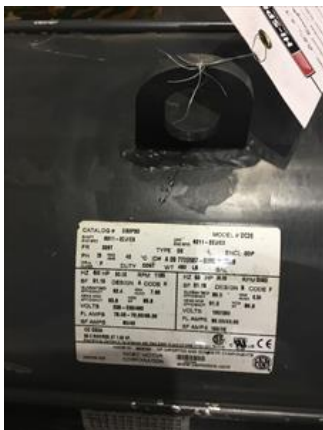
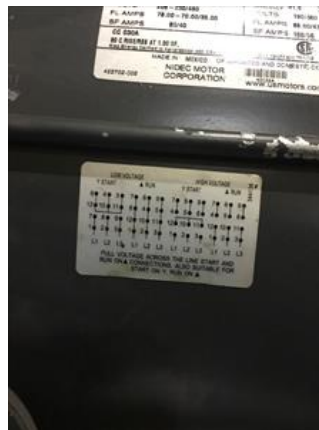
P5

| 4. Manufacturer | U.S. MOTORS |

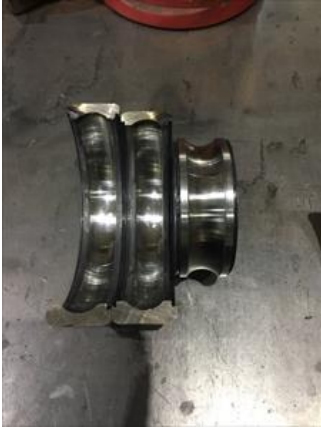
P15

51. Bearing DE Size

6311 Z

52. Bearing DE Type

regular ball bearing

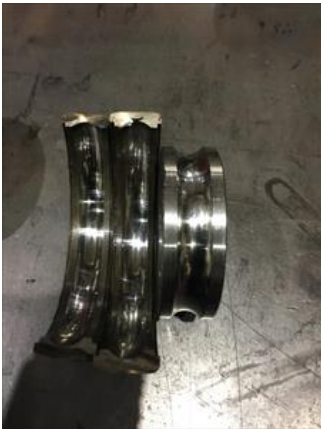
P43

54. Bearing ODE Size

6211 2Z

55. Bearing ODE Type

regular ball bearing
