AC Recondition Repair Report

Riviana Foods
28 W. White Oak st
Brinkley, AR 72021

1. Job Number	98243
2. Report Date	05/19/2021
3. Customer	RIVIANA FOODS

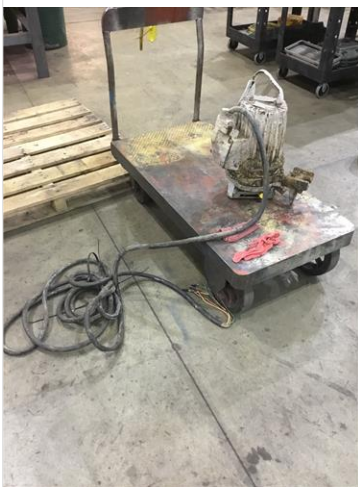
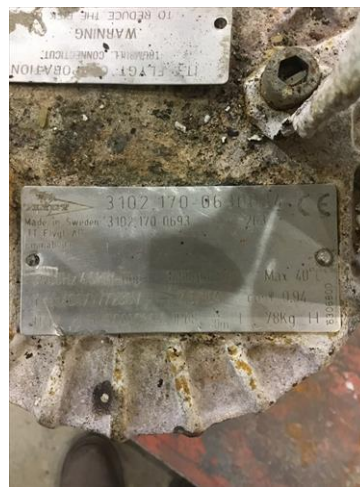
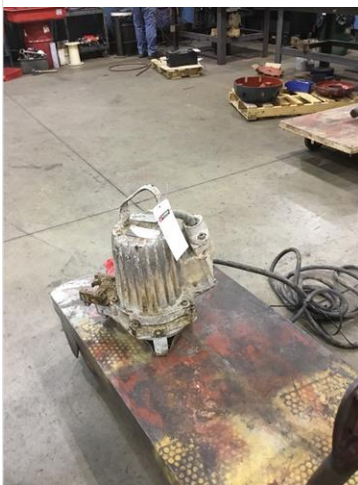
P5

FLYGT

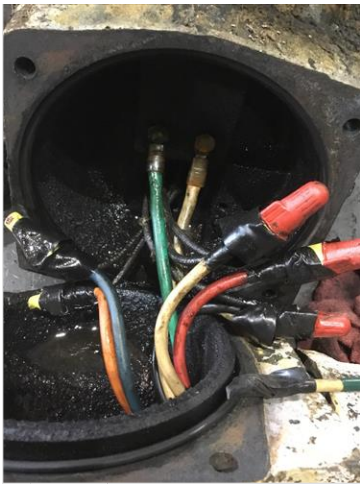
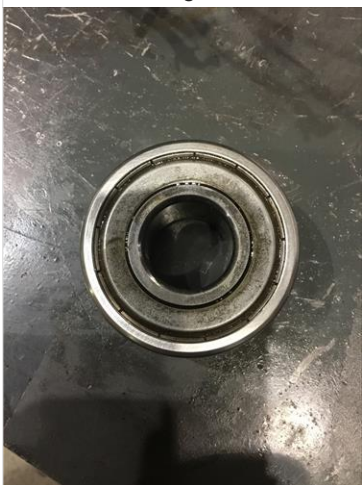
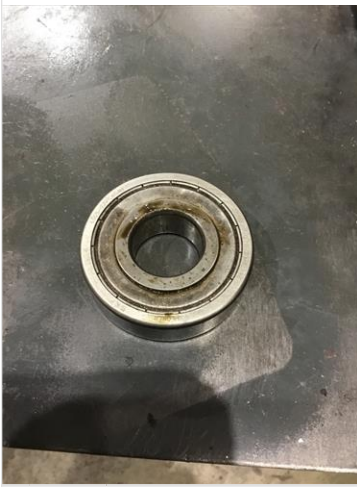
15.	Phase	3
16.	Service Factor	
17.	Motor Mount Position	
Initial Inspection		
18.	Number of Leads	7
19.	Lead Length	Inches
20.	Lead Size	
●	21. Lead Condition	(F) Fail
■	<i>Water</i>

22. Lead Markings	Red lead #2, Black lead #3, and White #1 power.
■	<i>Orange and blue are sensor leads. Green and white with black stripe are ground.</i>

29. Bearing Rtd's	(NA) Not Applicable
●	30. Bearing Rtd's Condition	(NA) Not Applicable
	31. Contamination	
	<i>Water and debris.</i>	
●	32. Frame Condition	(P) Pass
●	33. Fan Condition	(NA) Not Applicable

34. Broken or missing components	
	<i>Cutter ring missing</i>

66. Component Failure	seals failed
67. Cause of Failure	<i>Debris became lodged in between the cutter and the impeller causing motor to lock up. Also both seals failed on D.E. shaft in conjunction the power cord grommet seals, which allowed water to enter inside the stator windings resulting in an electrical short.</i>
68. Comments	<i>Rewind stator, and replace power cord. 28'- 7C / 12 AWG. Replace all o rings and seals. Replace worn impeller.</i>
69. Service Technician	Terrence. Hollnd

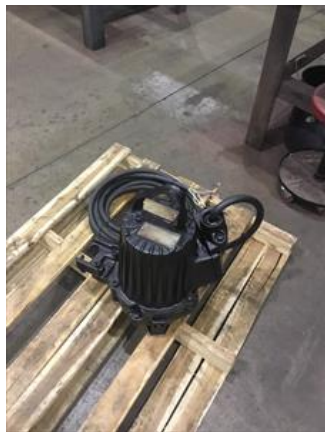
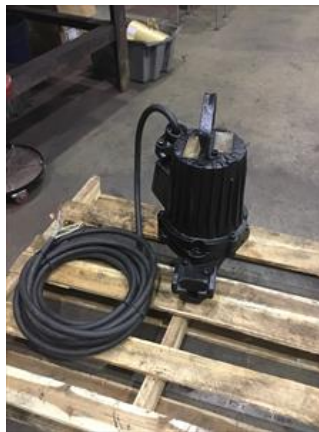
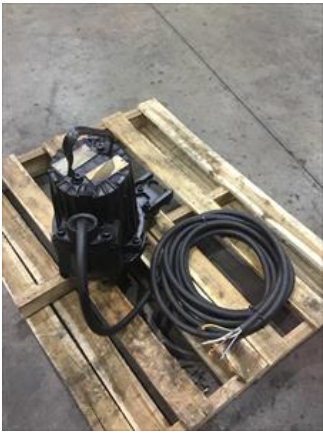
P136

158. Motor Paint	(P) Pass
