Hi-Speed Industrial Service  
7030 Ryburn Dr  
Millington, Tn 38053  
901-873-5300

## AC Recondition Repair Report

FolderID: 98288  
FormID: 10770292

**SAGE**  
5901 SLOAN DRIVE  
LITTLE ROCK, AR 72206

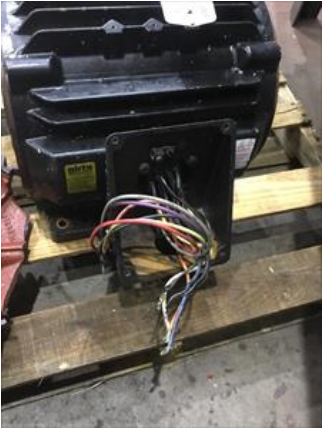
| 18. | Number of Leads | 9 | P13 |

| | 21. Lead Condition | (P) Pass | |
| 22. | Lead Markings | 1-9 | |

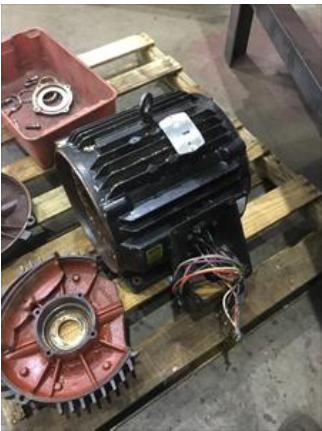
| | 32. Frame Condition | (P) Pass | P106 |

| | <i>Rust from excessive water</i> | | |

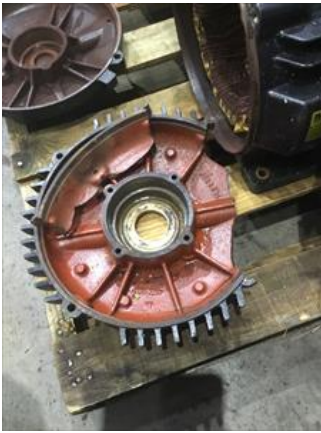
| 34. | Broken or missing components | | P113 |

| | <i>D.E. End bell housing broken.</i> | | |

Drive end housing severely cracked.

Rotor impacted and dragged on stator iron because the drive end housing was cracked in multiple places.

*Re-sleeve ode end bell housing fit: Lip worn in sleeve. Rewind stator. Replace D.E. housing and end pro seal. Rewind stator with minor core repair.*

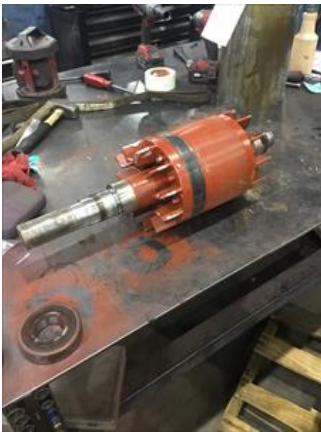
| 44. Rotor Type | squirrel cage laminate | P4 |

| ● 49. | Rotor Condition | (P) Pass |

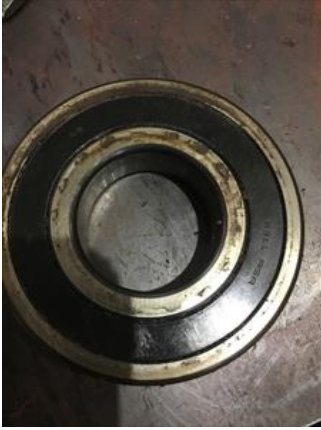
P15

51. Bearing DE Size

6311

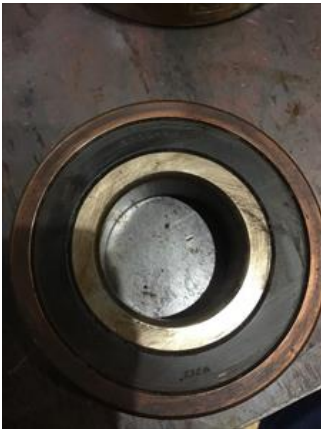
P43

54. Bearing ODE Size

6309
