Hi-Speed Industrial Service
7030 Ryburn Dr
Millington, Tn 38053
901-873-5300

AC Recondition Repair Report

ARKANSAS INDUSTRIAL
MACHINERY
3804 N. NONA ST
NORTH LITTLE ROCK, AR 72118

1. Job Number	98307
2. Report Date	06/08/2021
3. Customer	ARKANSAS INDUSTRIAL MACHINE

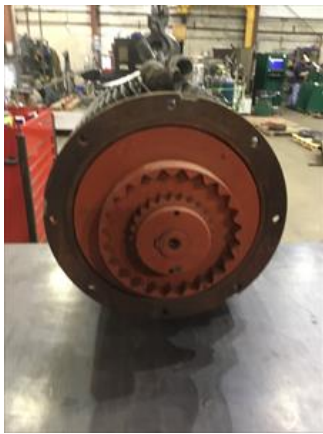
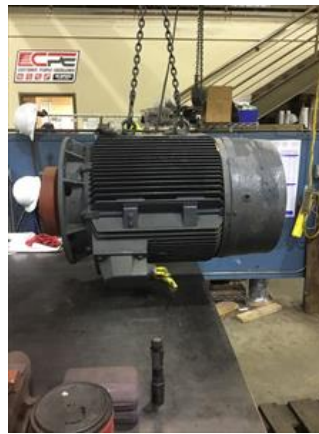
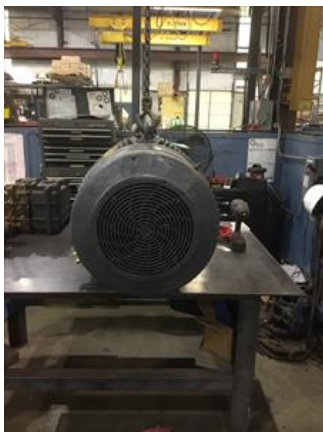
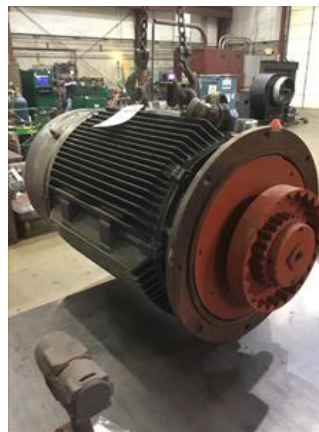
P5

4. Manufacturer SIEMENS

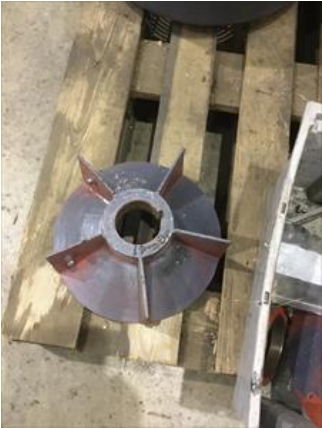
26.	Shaft Run Out		
27.	Does Shaft Turn Freely		
28.	Does Shaft Have Visible Damage		
29.	Bearing Rtd's		
30.	Bearing Rtd's Condition		
31.	Contamination <i>Water</i>		
32.	Frame Condition	(P) Pass	
33.	Fan Condition	(P) Pass	P109

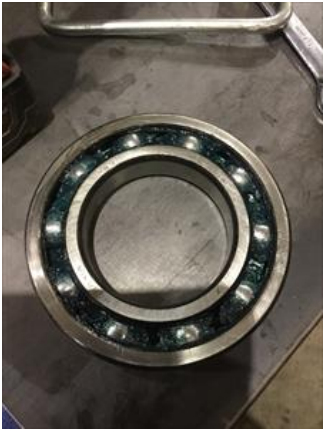
50.	Bearing Manufacture	URB1	P1

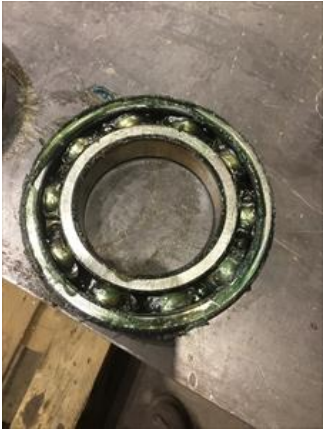
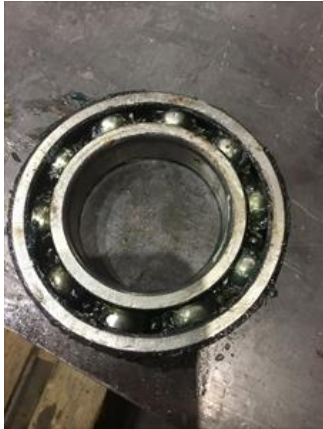
51.	Bearing DE Size	6216	
52.	Bearing DE Type	regular ball bearing	
53.	DE Bearing Qty.	1	
54.	Bearing ODE Size	6216	P43

55.	Bearing ODE Type	regular ball bearing	
56.	ODE Bearing Qty.	1	
57.	Insulated Bearing	no	
58.	Lubrication Type	grease	
●	59. Grease Condition	(F) Fail

<i>Water contaminated.</i>		
●	60. Bearing Retainers	(Y) Yes	
61.	Shaft Grounding Device		
62.	DE Seal		
63.	DE Seal Type/Size		
64.	ODE Seal		
65.	ODE Seal Type/Size		
Root Cause of Failure
