AC Recondition Repair Report

Bryce Corporation (10053-BRC)
450 S. Benton
Searcy, AR 72143

1. Job Number	98327
2. Report Date	06/11/2021
3. Customer	BRYCE

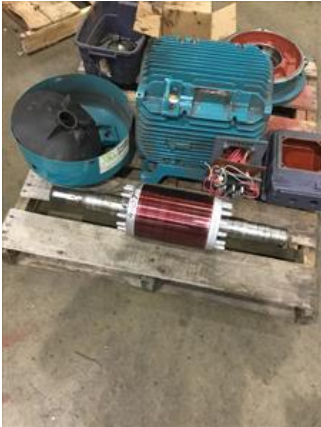
P4

44. Rotor Type squirrel cage laminate

45. Air Gap <10% Variation	
46. Number of Rotor Bars	
47. Number of Broken Rotor Bars	
48. Growler Test	(P) Pass
49. Rotor Condition	(P) Pass

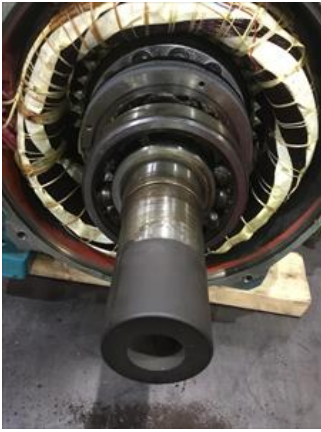
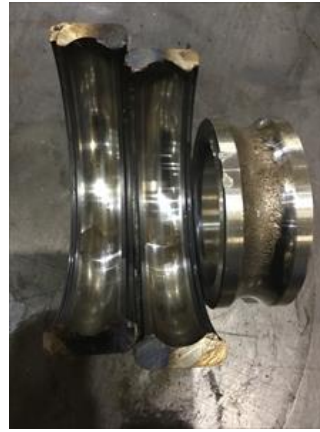
P15

51. Bearing DE Size

6312

66.	Component Failure	D.E. bearing
67.	Cause of Failure	<i>D.E. Bearing cage failure from metal fatigue.</i>
68.	Comments	<i>Windings show bad on both testers.</i>

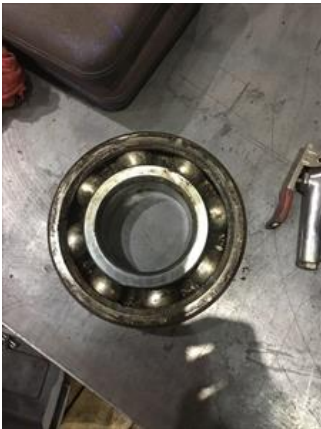
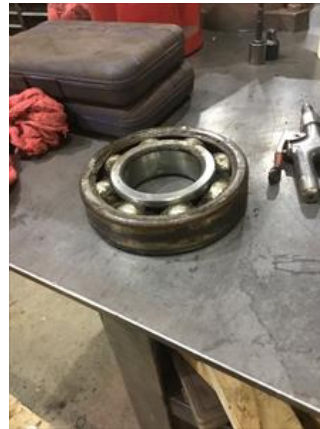
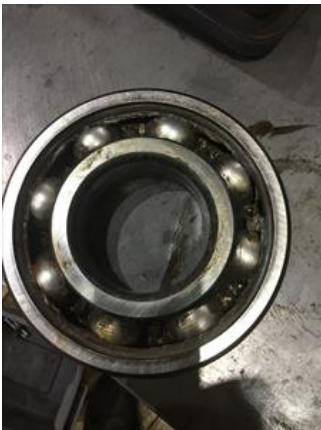
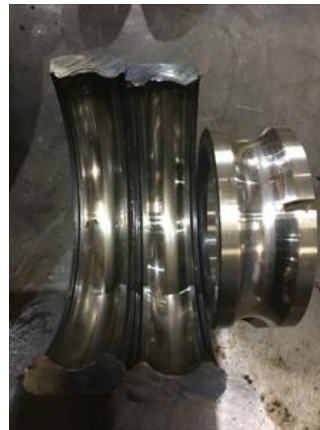
P43

54. Bearing ODE Size

6312

☒ 59. Grease Condition

(F) Fail
