AC Recondition Repair Report

Bryce Corporation (10053-BRC)
450 S. Benton
Searcy, AR 72143

1. Job Number	98347
2. Report Date	06/17/2021
3. Customer	BRYCE

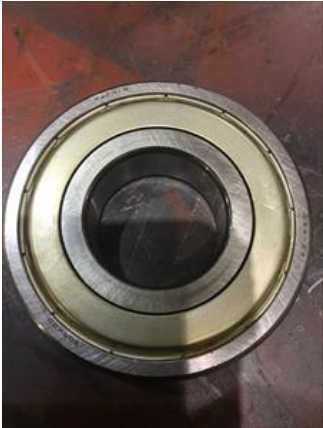
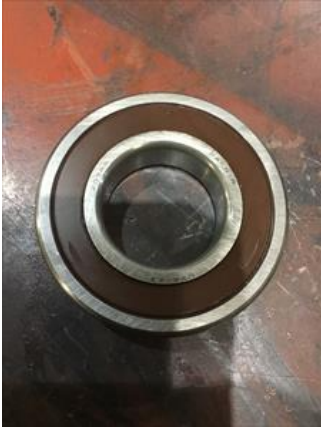
50.	Bearing Manufacture	fafnir

51.	Bearing DE Size	6309
52.	Bearing DE Type	regular ball bearing
53.	DE Bearing Qty.	1
54.	Bearing ODE Size	6207
55.	Bearing ODE Type	regular ball bearing
