AC Recondition Repair Report

FUTURE FUEL CHEMICAL
2800 GAP RD HWY 394 SO
BATESVILLE, AR 72501

1. Job Number	98358
2. Report Date	06/22/2021
3. Customer	FUTURE FUEL

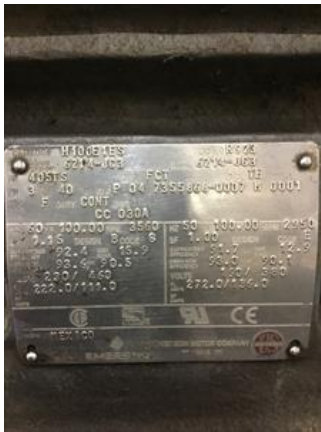
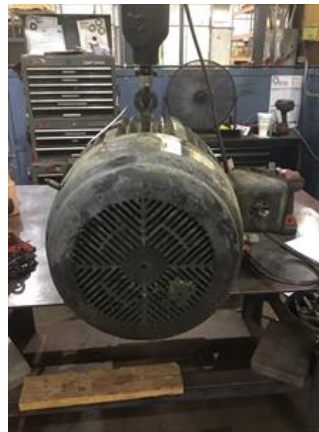
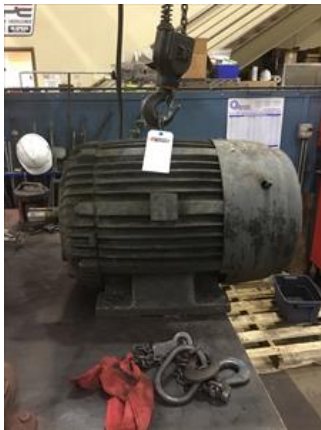
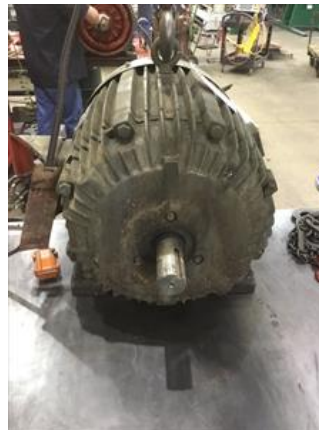
P5

4. Manufacturer	U.S. MOTORS
-----------------	-------------

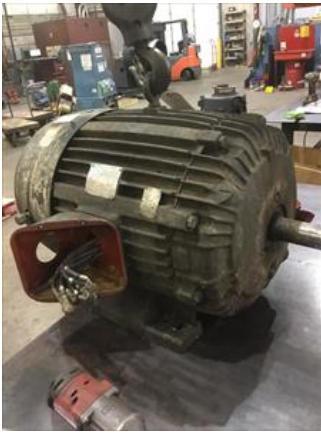
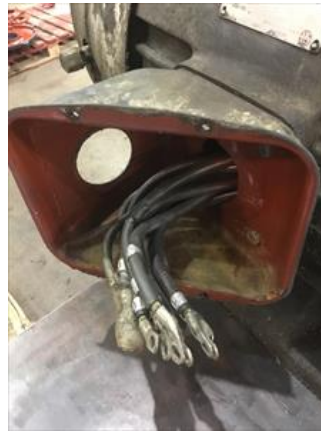
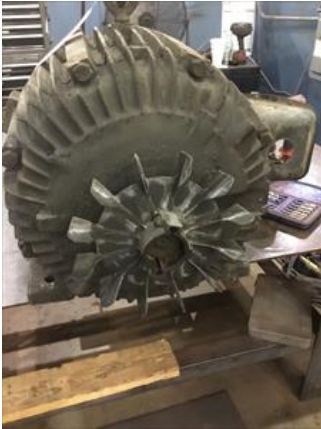
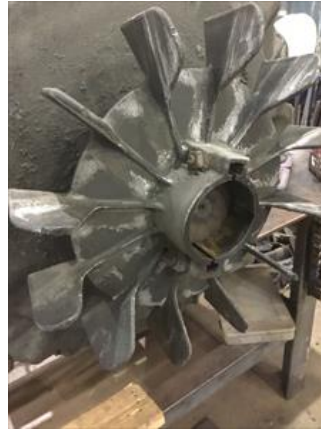
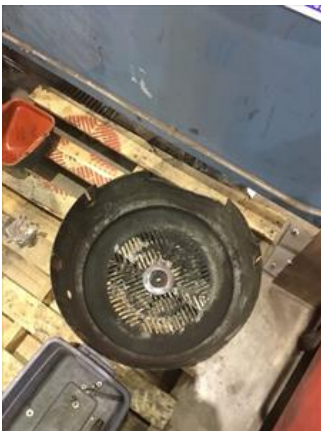
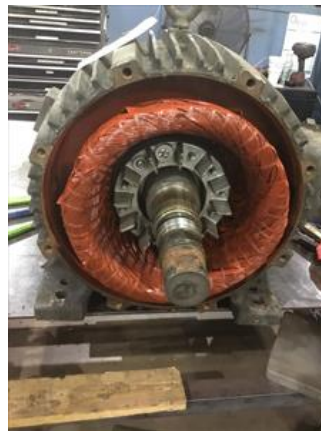
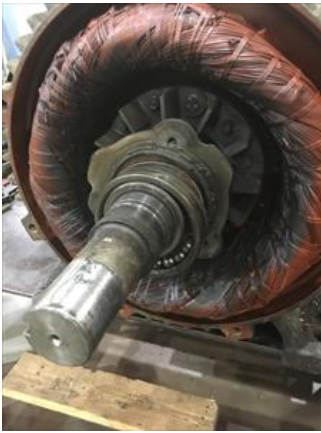
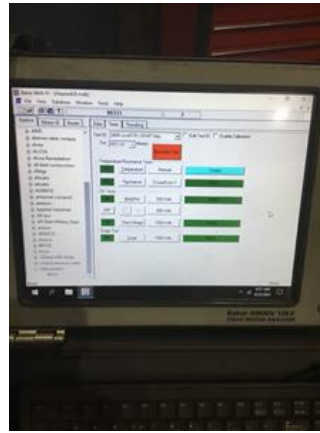
D.E. bearing suffered catastrophic failure and came apart. As a result the drive end shaft was bent 10 thousands out of tolerance. Primary cause of bearing failure appears to be lack of lubrication. Also the drive end housing fit requires machine work as well.

89.	DE Final Air Seal Shaft Size	
90.	ODE Air Seal Shaft Fit	
91.	ODE Initial Air Seal Shaft Size	
92.	ODE Final Air Seal Shaft Size	
93.	DE Endbell Fit	(F) Fail
	<i>Machine work needed.</i>

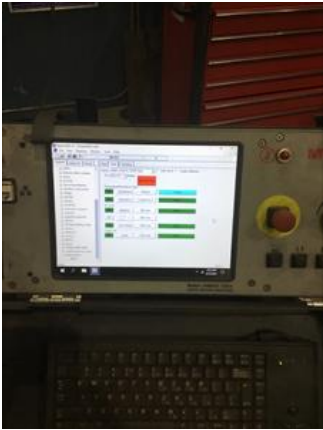
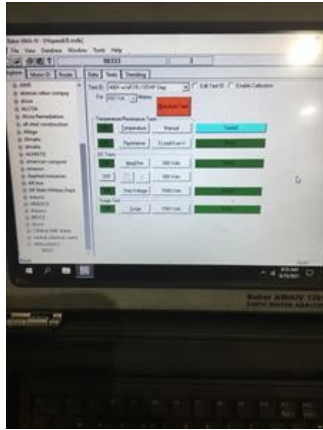
35.	Resistance to Ground		
36.	Winding Resistance 1-2		
37.	Winding Resistance 2-3		
38.	Winding Resistance 1-3		
39.	Resistive Imbalance		
40.	Hi-Pot		
41.	Surge Test	(P) Pass	P58

42.	Stator Condition	pass	
43.	Failure Location		
Initial Rotor Inspection			
44.	Rotor Type	squirrel cage laminate	
45.	Air Gap <10% Variation		
46.	Number of Rotor Bars		
47.	Number of Broken Rotor Bars		
48.	Growler Test		
49.	Rotor Condition		
Mechanical Inspection

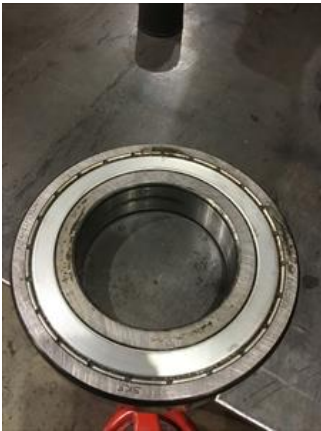
P53

59. Grease Condition

(F) Fail

D.E. bearing came apart
