AC Recondition Repair Report

Arauco-Malvern MDF (10298)
1275 Willamette Rd
Malvern, AR 72104

1. Job Number	98359
2. Report Date	06/23/2021
3. Customer	ARAUCO

4. Manufacturer	RELIANCE	P5
-----------------	----------	----

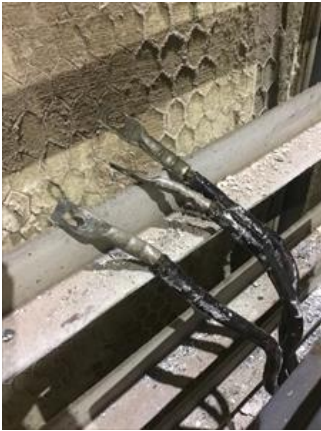
21. Lead Condition	(P) Pass
22. Lead Markings	
23. Lug Size, Condition, and Type	P67

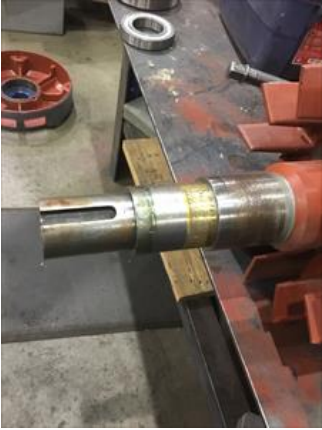
27.	Does Shaft Turn Freely		
28.	Does Shaft Have Visible Damage	no	P94

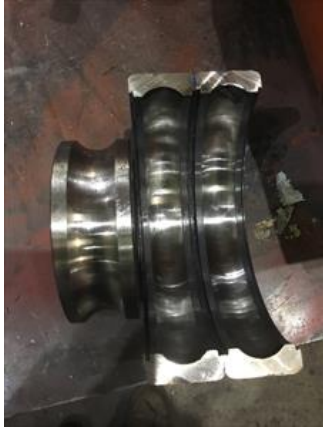
52. Bearing DE Type	regular ball bearing	P23

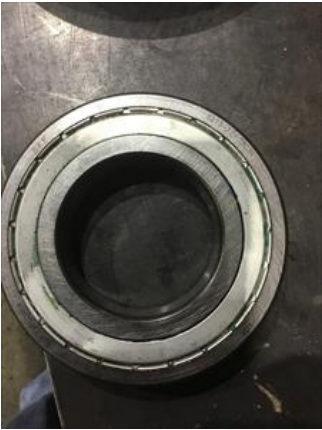
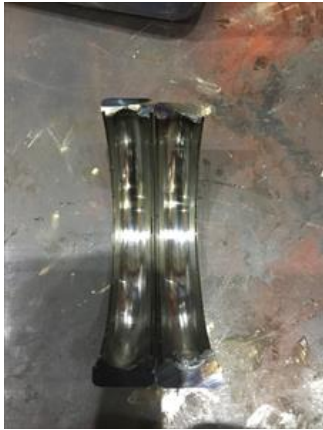
53. DE Bearing Qty.	1	
54. Bearing ODE Size	6213	
55. Bearing ODE Type	regular ball bearing	P53

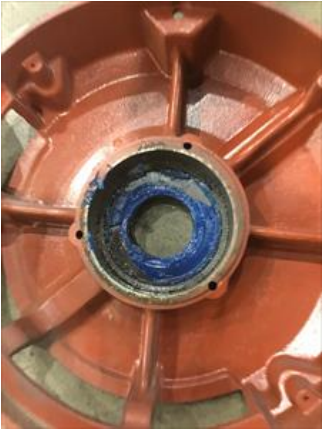
56. ODE Bearing Qty.	1	
57. Insulated Bearing	no	
58. Lubrication Type	grease	
<input checked="" type="radio"/> 59. Grease Condition	(F) Fail	P74
