Hi-Speed Industrial Service
7030 Ryburn Dr
Millington, Tn 38053
901-873-5300

AC Recondition Repair Report

1. Job Number	98376
2. Report Date	06/30/2021
3. Customer	INDUSTRIAL SUPPLY

4. Manufacturer	BALDOR	P5
-----------------	--------	----

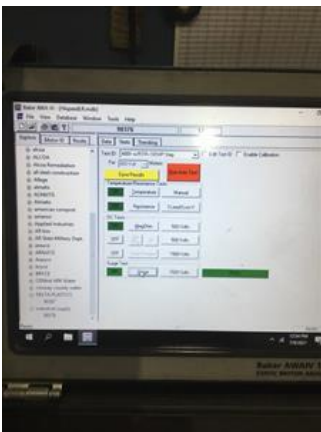
42.	Stator Condition	pass but windings are dirty	
43.	Failure Location	bearings and both housing fits	
Initial Rotor Inspection

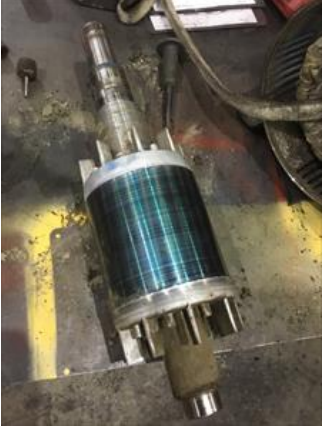
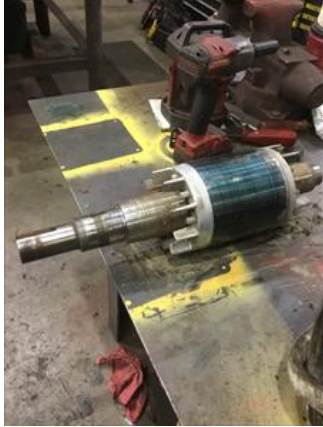
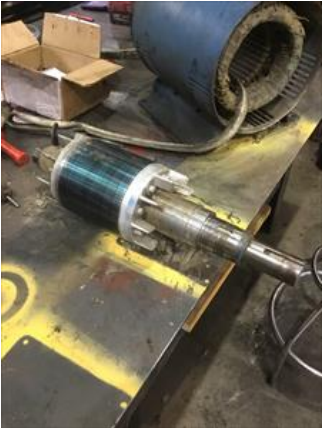
49.	Rotor Condition	(P) Pass
			P50

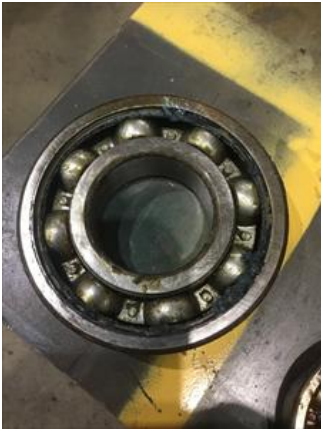
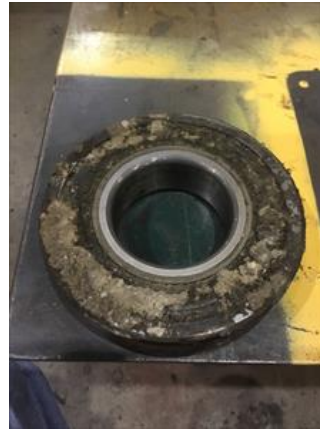
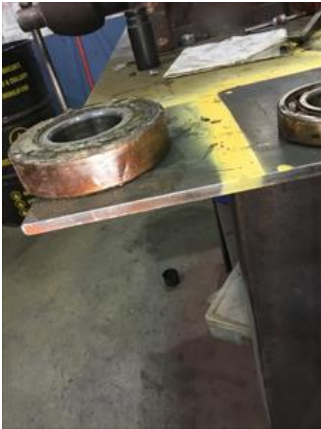
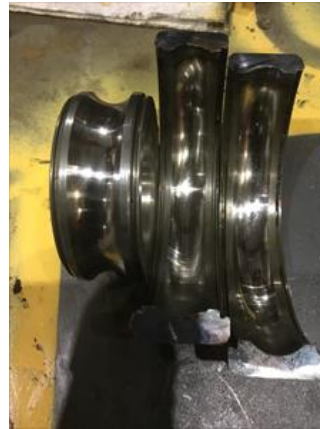
50.	Bearing Manufacture	NSK	
51.	Bearing DE Size	6311 2Z/ C3

regular ball bearing

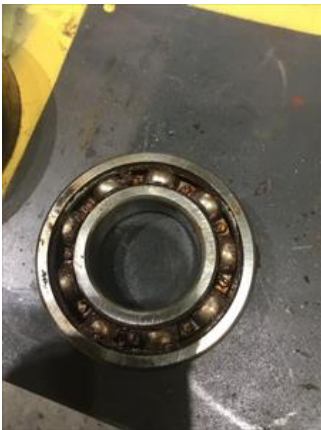
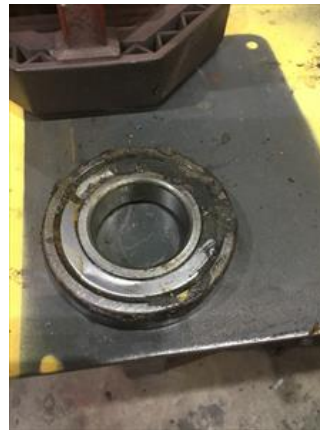
54. Bearing ODE Size

6208 2Z/C3

55. Bearing ODE Type

regular ball bearing

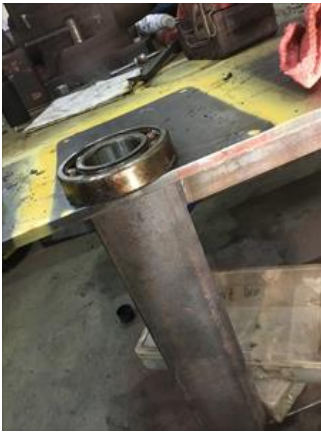
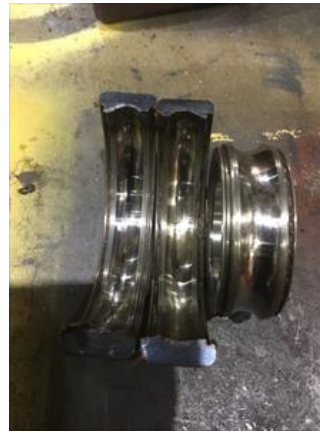
56.	ODE Bearing Qty.	1	
57.	Insulated Bearing	no	
58.	Lubrication Type	grease	
59.	Grease Condition	(F) Fail	P74

66.	Component Failure	bearings	
67.	Cause of Failure	<i>Contaminated grease and housing fits out of tolerance.</i>	
68.	Comments	<i>Both bearings contained contaminated grease and both housing fits show pitting and excessive wear. Also stator windings coated with excessive amounts of dirt.</i>

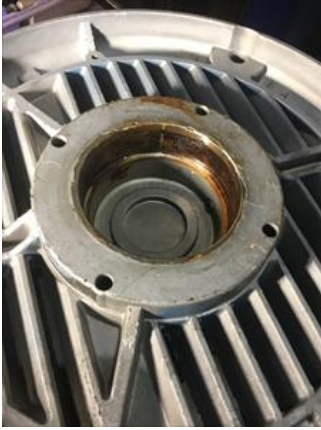
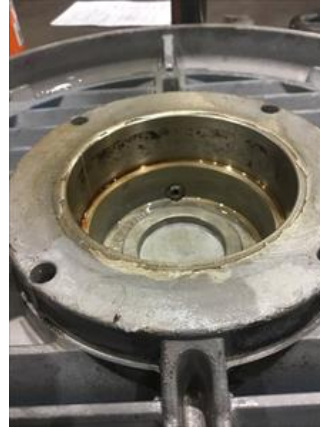
94.	DE Initial Endbell Fit Size 1	4.7255 "	
95.	DE Initial Endbell Fit Size 2	4.7256 "	
96.	DE Initial Endbell Fit Size 3	4.7256 "	
	Housing fit pitted and measures too large.		
97.	DE Final Endbell Fit Size 1		
98.	DE Finial Endbell Fit Size 2		
99.	DE Final Endbell Fit Size 3		
100.	DE Endbell Fit Insulated		
101.	DE Endbell Air Seal Fit		
102.	Initial Endbell Air Seal Fit Size		
103.	Finial Endbell Air Seal Fit Size

105. ODE Initial Endbell Fit Size 1	3.1505 "
106. ODE Initial Endbell Fit Size 2	3.1506 "
107. ODE Initial Endbell Fit Size 3	3.1505 "
Housing fit pitted and measures too large

108. ODE Final Endbell Fit Size 1	3.1498 "
-----------------------------------	----------
