AC Recondition Repair Report

Union Pacific-Vine St 10945
1020 N. Vine Street
North Little Rock, AR

1. Job Number	98406
2. Report Date	07/08/2021
3. Customer	10945

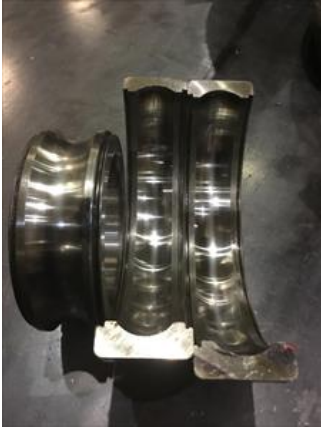
P1

50. Bearing Manufacture

NSK

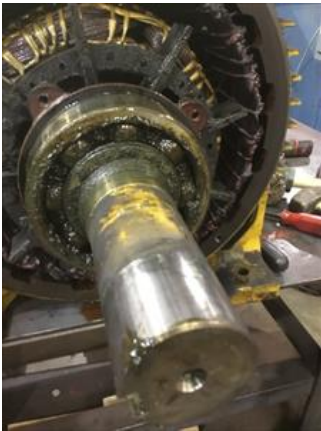
P15

51. Bearing DE Size

6316 C3

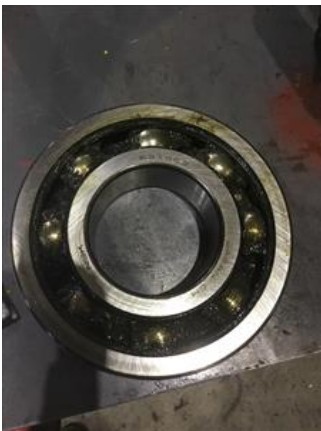
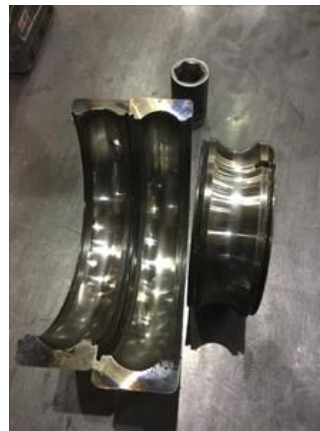
P43

54. Bearing ODE Size

6314/C3

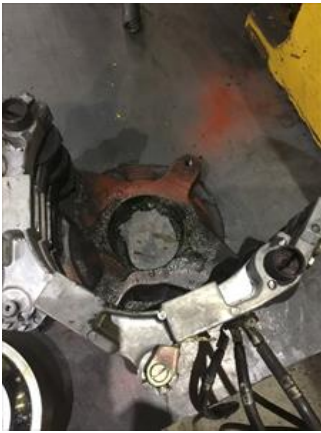
P80

☒ 59. Grease Condition

(F) Fail

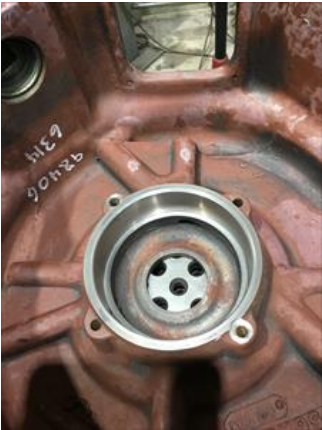
101. DE Endbell Air Seal Fit		
	102. Initial Endbell Air Seal Fit Size		
	103. Final Endbell Air Seal Fit Size		
●	104. ODE Endbell Fit	(F) Fail	
	105. ODE Initial Endbell Fit Size 1	5.907 "

106. ODE Initial Endbell Fit Size 2	5.907 "	
	107. ODE Initial Endbell Fit Size 3	5.907 "	
	108. ODE Final Endbell Fit Size 1	5.9057 "	P149

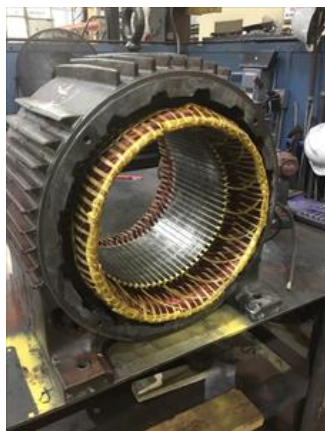
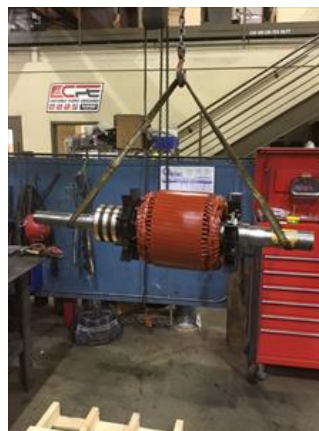
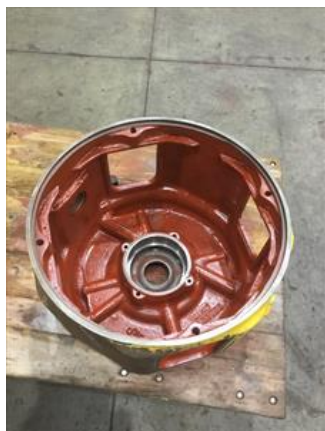
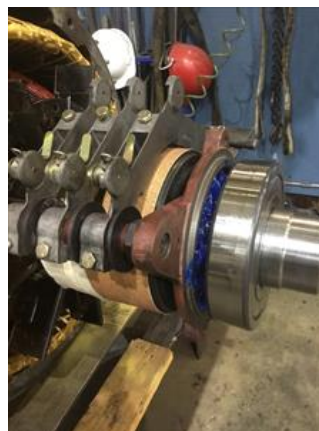
142. ODE Horizontal Vibration Reading	
143. ODE Vertical Vibration Reading	
144. ODE Axial Vibration Reading	
145. Ambient Temp at start of Test Run	
146. Temp at 5 minutes	
147. Temp at 10 minutes	
148. Temp at 15 minutes	
149. Temp at 20 minutes	
150. Temp at 25 minutes	
151. Temp at 30 minutes	
152. Temp at 35 minutes	
153. Temp at 40 minutes	
154. Temp at 45 minutes	Degrees F.
155. Temp at 50 minutes	
156. Temp at 55 minutes	
157. Temp at 60 minutes	
● 158. Motor Paint	(P) Pass P136
