Hi-Speed Industrial Service
7030 Ryburn Dr
Millington, Tn 38053
901-873-5300

AC Recondition Repair Report

Remington (10243)
2592 AR Hwy 15 N
Lonoke, AR 72086

1. Job Number	98453
2. Report Date	07/15/2021
3. Customer	10243

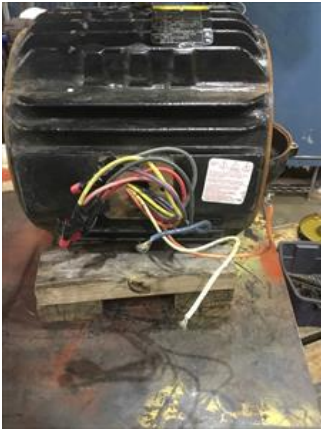
P42

☒ 21. Lead Condition

(P) Pass

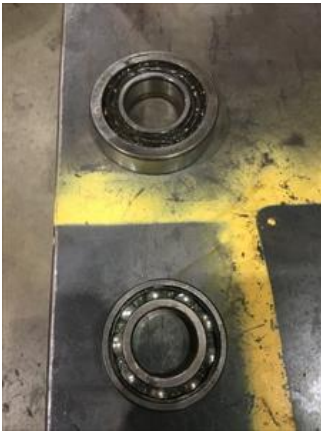
P104

31. Contamination

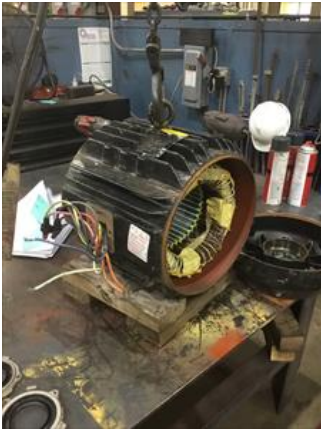
P106

32. Frame Condition

(P) Pass

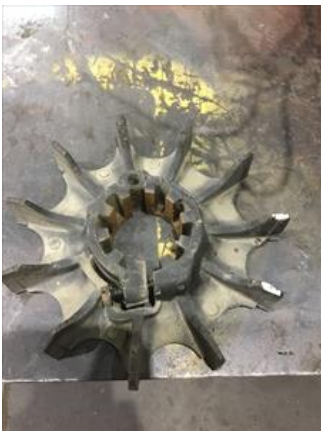
P109

33. Fan Condition

(P) Pass

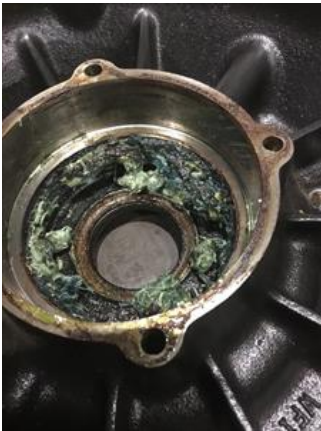
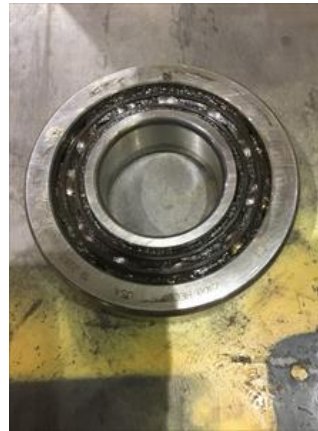
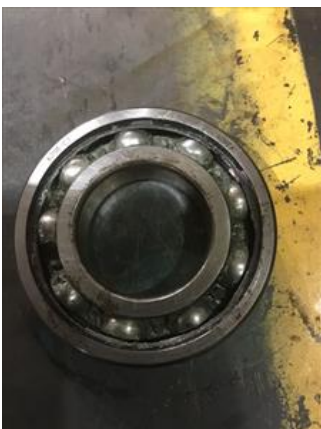
P74

59. Grease Condition

(F) Fail

Contaminated

| 66. Component Failure | O.d.e. housing fit pitted. |
| 67. Cause of Failure | <i>Contaminated grease and bad housing fit.</i> |

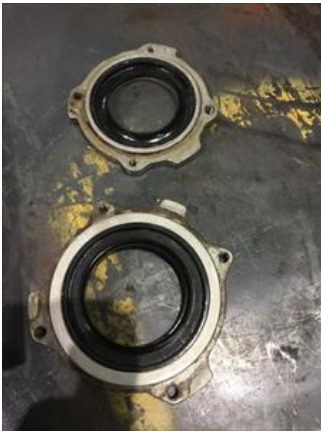
P80

60. Bearing Retainers

(Y) Yes
