## AC Recondition Repair Report

Remington (10243)  
2592 AR Hwy 15 N  
Lonoke, AR 72086

1. Job Number	98454
2. Report Date	07/15/2021
3. Customer	10243

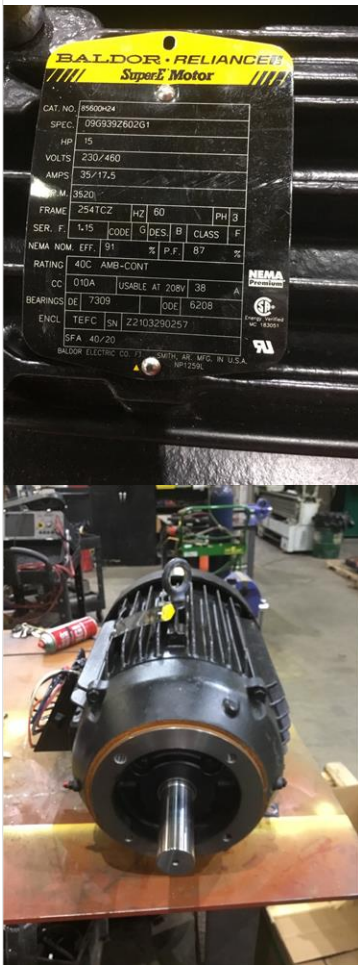
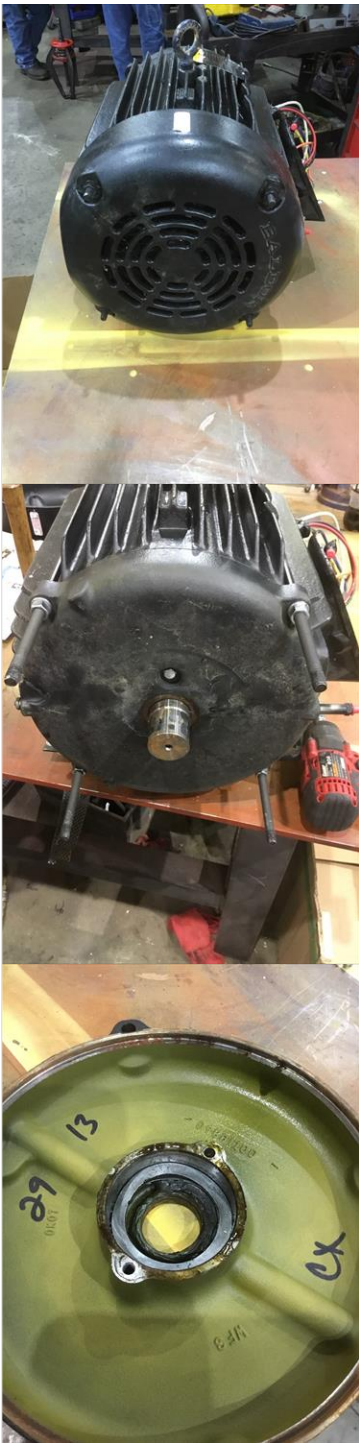
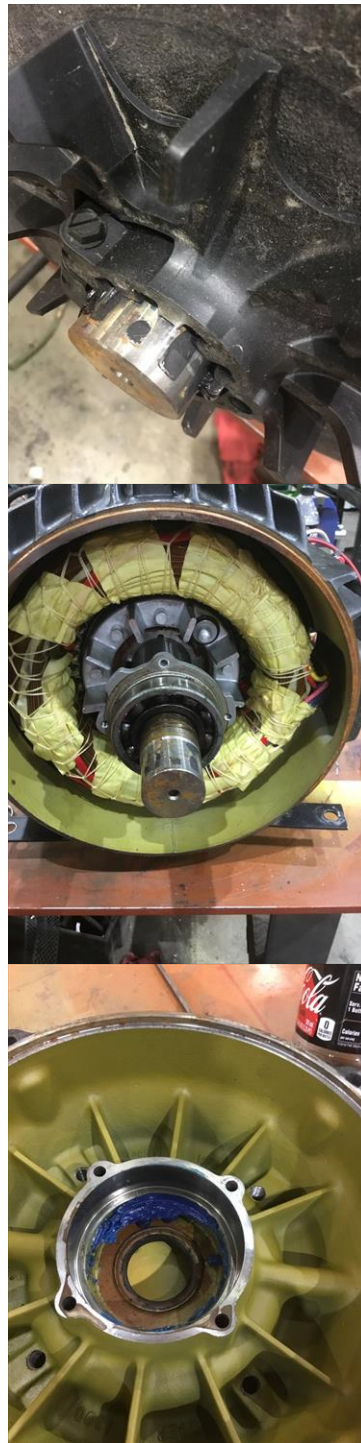
P5

5. Model	85600H24
6. Serial Number	Z2103290257
7. Horsepower	15
8. KW	
9. Volts	
10. Amps	35
11. RPM	3520
12. Frame	254TCZ
13. Enclosure	TEFC
14. Cycles	
15. Phase	3
16. Service Factor	1.15
17. Motor Mount Position	
<b>Initial Inspection</b>	
18. Number of Leads	9
19. Lead Length	12 Inches
20. Lead Size	10
21. Lead Condition	(P) Pass
22. Lead Markings	printed 1-9
23. Lug Size, Condition, and Type	None
24. Winding RTD's	(NA) Not Applicable
25. Winding Rtd's Condition	(NA) Not Applicable

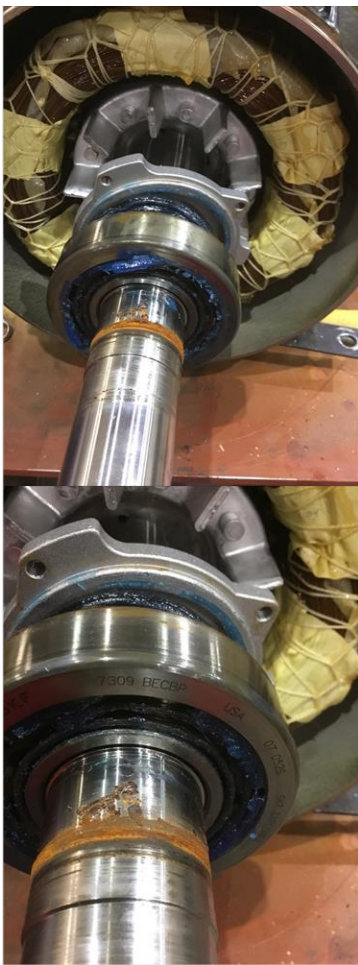
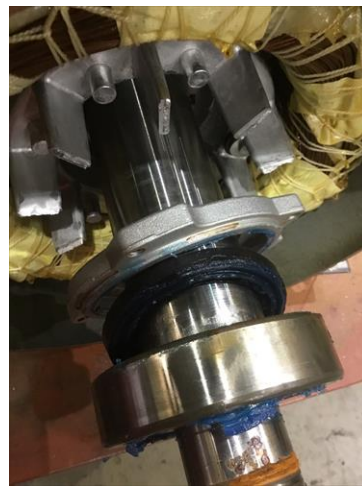
31.	Contamination	
32.	Frame Condition	(P) Pass
33.	Fan Condition	(F) Fail
34.	Broken or missing components	
	<i>Fan melted</i>	
<b>Initial Electric Test</b>

63.	DE Seal Type/Size	
64.	ODE Seal	(NA) Not Applicable
65.	ODE Seal Type/Size	
<b>Root Cause of Failure</b>		
66.	Component Failure	ODE bearing
67.	Cause of Failure <i>Metal fatigue</i>

68.	Comments <i>Replace Fan, 6208, 7309</i>	
69.	Service Technician	David Maclin

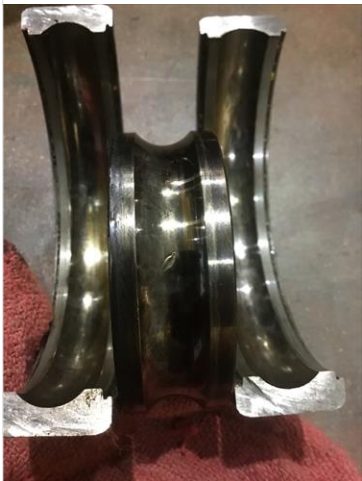
51.	Bearing DE Size	7309

52.	Bearing DE Type	angular contact
53.	DE Bearing Qty.	1
54.	Bearing ODE Size	6208
55.	Bearing ODE Type	deep groove ball
56.	ODE Bearing Qty.	1
57.	Insulated Bearing

58.	Lubrication Type	polyrex
59.	Grease Condition	(F) Fail
60.	Bearing Retainers	(NA) Not Applicable
61.	Shaft Grounding Device	(NA) Not Applicable
62.	DE Seal	(NA) Not Applicable

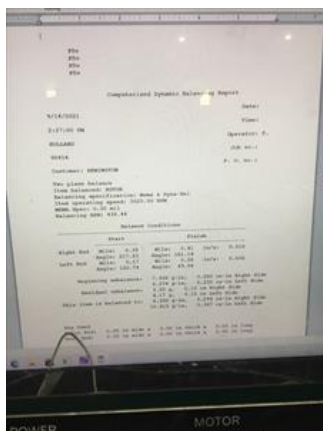
P6

119. Balance Type

nema standard

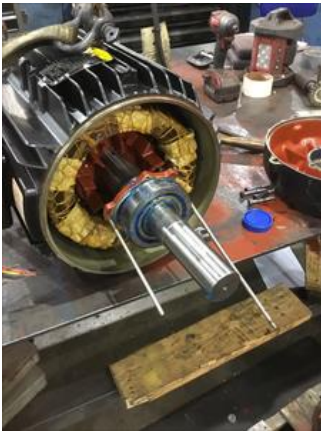
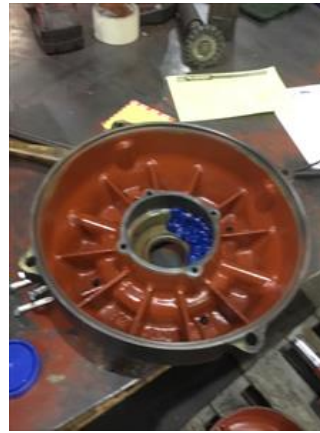
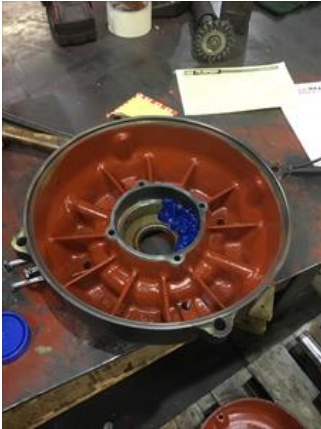
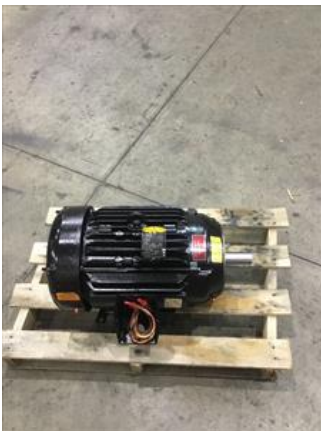
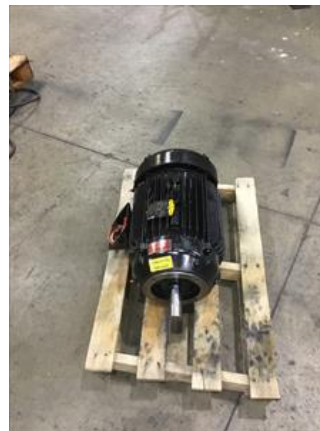
P136

- 127. Meggar Testing Reading
- 128. Surge Test
- 129. Hi-Pot
- 130. Winding Resistance 1-2
- 131. Winding Resistance 2-3
- 132. Winding Resistance 1-3
- 133. Test Run Voltage Phase A

- 158. Motor Paint
