AC Recondition Repair Report

Highland Pellets (012194)
5601 Industrial Dr North
Pine Bluff, AR 71602

1. Job Number	98463
2. Report Date	07/19/2021
3. Customer	12194

4. Manufacturer	NORD	P5
-----------------	------	----

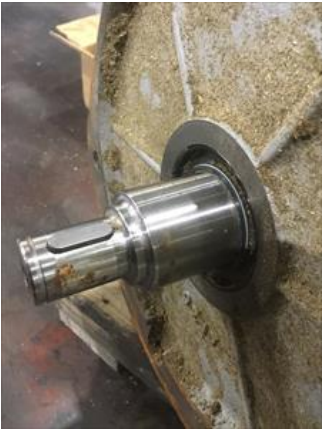
21. Lead Condition	(P) Pass	
	22. Lead Markings	1-9	
	23. Lug Size, Condition, and Type		
	24. Winding RTD's		
	25. Winding Rtd's Condition		
	26. Shaft Run Out		
	27. Does Shaft Turn Freely	no	
	28. Does Shaft Have Visible Damage	no	P94

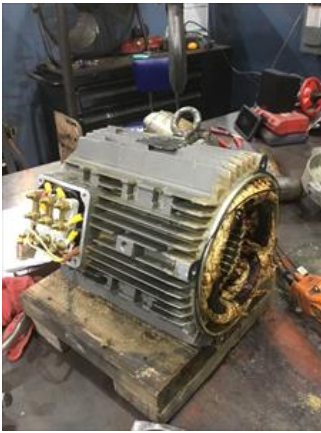
32. Frame Condition	(P) Pass	P106

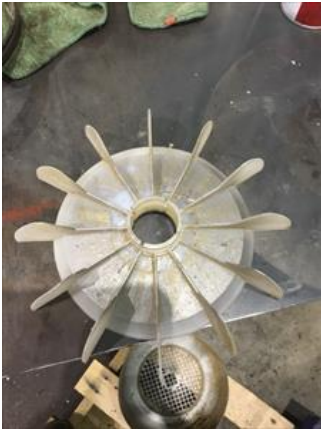
● 33. Fan Condition (P) Pass P109

34. Broken or missing components
Connection block terminal broken

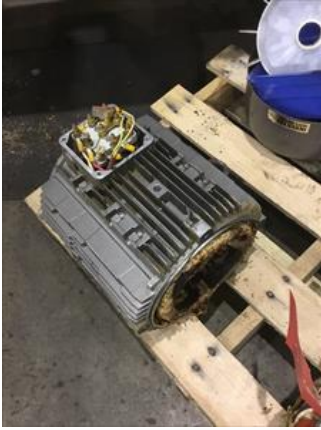
P65

42. Stator Condition

pass

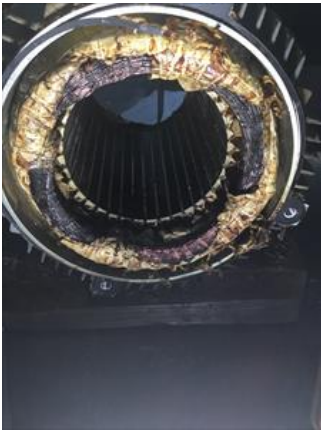
P68

43. Failure Location

windings shorted due to water.

| 67. Cause of Failure | <i>Moisture inside the stator windings.</i> |
| 68. Comments | <i>Motor was wet inside the stator as indicated by numerous rust spots on the rotor and the stator windings.</i> |

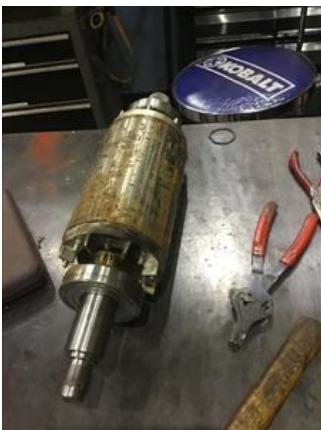
P4

44. Rotor Type

squirrel cage laminate

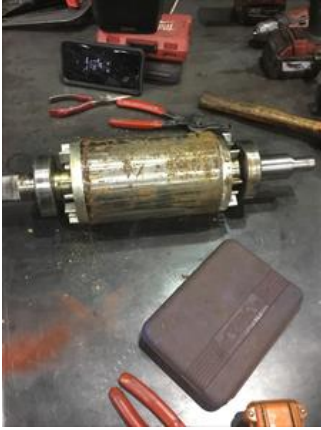
● 48. Growler Test

(P) Pass

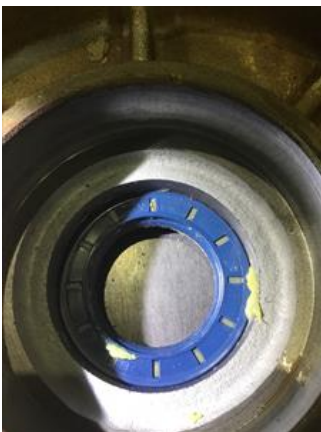
50. Bearing Manufacture	SKF	
51. Bearing DE Size	6308 2Z	
52. Bearing DE Type	regular ball bearing	
53. DE Bearing Qty.	1	
54. Bearing ODE Size	6308 2Z/C3	
55. Bearing ODE Type	1	
56. ODE Bearing Qty.	1	
57. Insulated Bearing	no	
58. Lubrication Type	grease	
59. Grease Condition	(F) Fail	
<div> <i>Water contaminated.</i> </div>		
60. Bearing Retainers	(NA) Not Applicable	
61. Shaft Grounding Device	(NA) Not Applicable	
62. DE Seal	(Y) Yes	
63. DE Seal Type/Size	40*62*7	P90

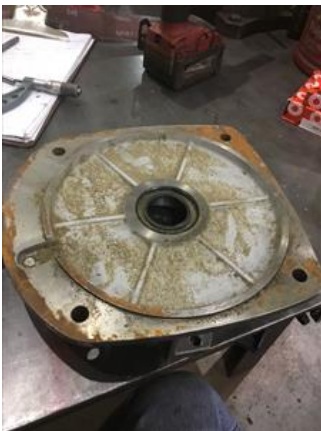
P158

114.	ODE Final Endbell Seal Fit Size	
115.	Foot Flatness	(NA) Not Applicable
116.	Foot Condition	(NA) Not Applicable
117.	Flange Condition	(P) Pass
