## AC Recondition Repair Report

**Bryce Corporation (10053-BRC)**  
450 S. Benton  
Searcy, AR 72143

1. Job Number	98471
2. Report Date	07/19/2021
3. Customer	10053

5. Model	ILG4183.2AA61-Z
6. Serial Number	0504/066571708IMB5
7. Horsepower	25.4 HP
8. KW	24.5
9. Volts	460
10. Amps	38.5
11. RPM	
12. Frame	180M
13. Enclosure	TEFC
14. Cycles	60 HZ
15. Phase	3

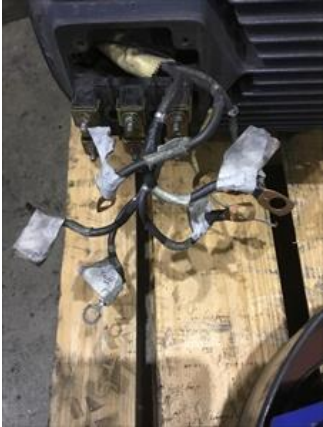
18.	Number of Leads	6	
19.	Lead Length	9 Inches	
20.	Lead Size		
21.	Lead Condition		
22.	Lead Markings	1,2,3-4,5,6	
23.	Lug Size, Condition, and Type		P67

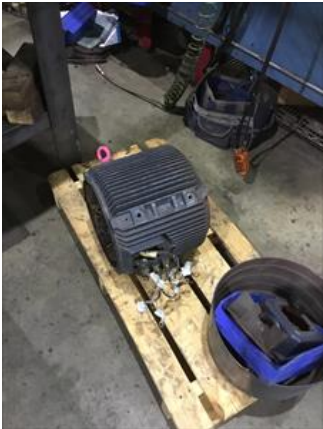
32. Frame Condition	(P) Pass	P106

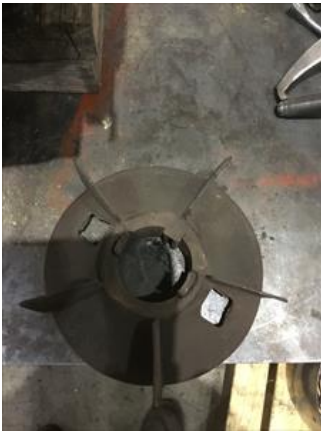
33. Fan Condition	(P) Pass	P109

34. Broken or missing components  
*One lead missing a lug.*

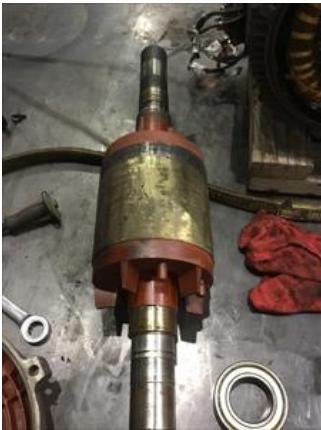
P4

44. Rotor Type

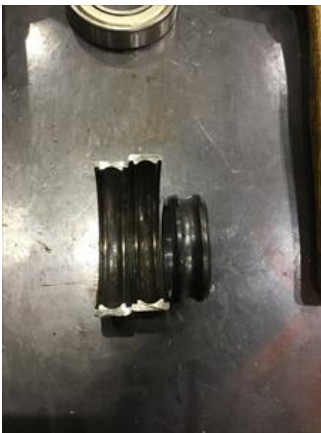
P1

50. Bearing Manufacture

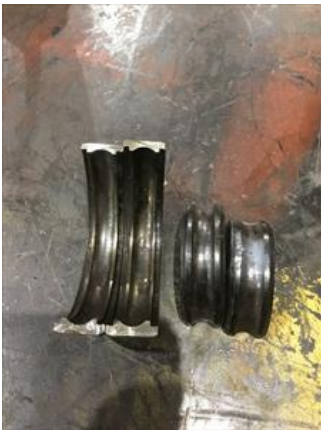
P15

51. Bearing DE Size

6210 2Z/C3

66. Component Failure	D.E. bearing cage.
67. Cause of Failure	<i>D.E. Bearing cage failed caused by poor lubrication and shrapnel took out the windings.</i>
68. Comments	<i>D.E. bearing cage failure caused shrapnel to impact the windings.</i>
69. Service Technician	Terrence. Holland
