AC Recondition Repair Report

DELTA PLASTICS OF THE SOUTH
3104 SOUTH MAIN STREET
STUTT GART, AR 72160

1. Job Number	98487
2. Report Date	07/22/2021
3. Customer	DELTA PLASTICS SOUTH

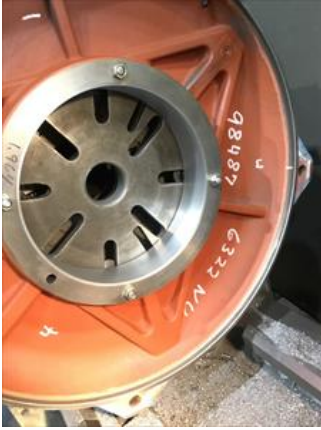
P138

92.	ODE Final Air Seal Shaft Size	
93.	DE Endbell Fit	(F) Fail
94.	DE Initial Endbell Fit Size 1	9.450799999999999 "
95.	DE Initial Endbell Fit Size 2	9.4499 "

96.	DE Initial Endbell Fit Size 3	9.4503 "

97. DE Final Endbell Fit Size 1

9.449199999999999 " "

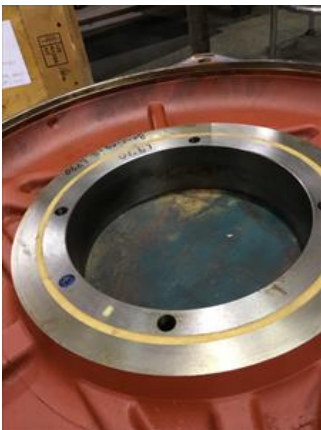
P145

● 104. ODE Endbell Fit

(F) Fail

105. ODE Initial Endbell Fit Size 1

7.8758 "

106. ODE Initial Endbell Fit Size 2

7.8757 "

107. ODE Initial Endbell Fit Size 3

7.8753 "

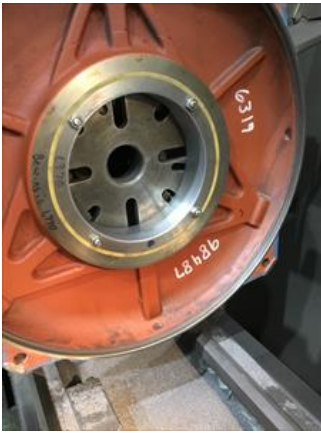
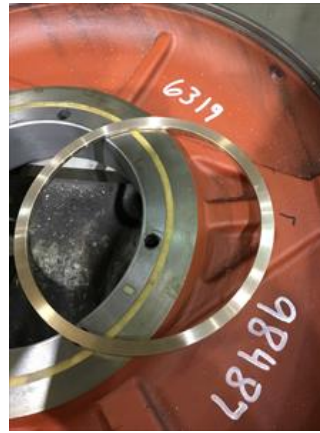
P149

108. ODE Final Endbell Fit Size 1

7.8745 "

.195 spacer to lock bearing in place.

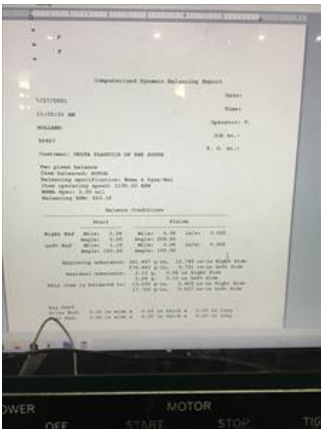
119. Balance Type nema standard P6
