AC Recondition Repair Report

Peco Foods
625 S. Allen Street
Batesville, AR 72501

1. Job Number	50
2. Report Date	08/03/2021
3. Customer	12476

4. Manufacturer	BALDOR	P5
-----------------	--------	----

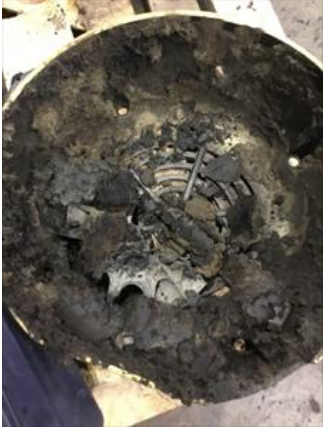
27.	Does Shaft Turn Freely	no	
28.	Does Shaft Have Visible Damage	no	
29.	Bearing Rtd's		
30.	Bearing Rtd's Condition		
31.	Contamination <i>Excessive dirt and debris inside fan cover and windings.</i>		
● 32.	Frame Condition	(P) Pass	
● 33.	Fan Condition	(F) Fail	P109

34.	Broken or missing components <i>Fan</i>		
Initial Electric Test			
35.	Resistance to Ground		
36.	Winding Resistance 1-2		
37.	Winding Resistance 2-3		
38.	Winding Resistance 1-3		
39.	Resistive Imbalance		
40.	Hi-Pot		
● 41.	Surge Test	(F) Fail	
42.	Stator Condition	rewind	
43.	Failure Location	windings	
Initial Rotor Inspection			
44.	Rotor Type	squirrel cage laminate	P4

66.	Component Failure	windings overloaded. bearings worn
67.	Cause of Failure <i>Windings overloaded. Fan destroyed. Bearings worn. O.D.E shaft bearing journal worn. O.D.E. housing fit worn.</i>	
68.	Comments	
69.	Service Technician	Terrence. Holland

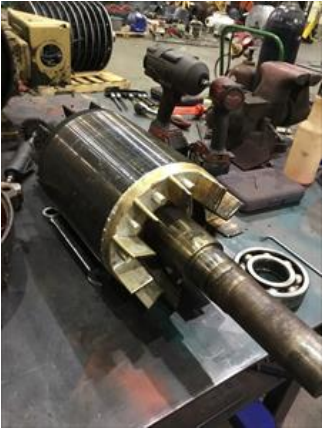
46.	Number of Rotor Bars	40	
47.	Number of Broken Rotor Bars	0	
48.	Growler Test		
● 49.	Rotor Condition	(P) Pass	P50

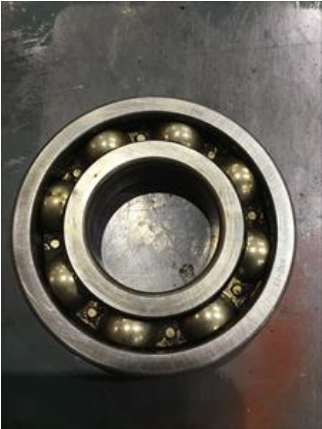
50.	Bearing Manufacture	FAG	
51.	Bearing DE Size	6312 2Z	
52.	Bearing DE Type	regular ball bearing	
53.	DE Bearing Qty.	1	
54.	Bearing ODE Size	6311 2Z	P43

55.	Bearing ODE Type	regular ball bearing	
56.	ODE Bearing Qty.	1	
57.	Insulated Bearing	no	
58.	Lubrication Type	grease	
● 59.	Grease Condition	(F) Fail	
● 60.	Bearing Retainers	(Y) Yes	
61.	Shaft Grounding Device	(NA) Not Applicable	
62.	DE Seal		
63.	DE Seal Type/Size		
64.	ODE Seal		
65.	ODE Seal Type/Size		
Root Cause of Failure
