AC Recondition Repair Report

Peco Foods

625 S. Allen Street
Batesville, AR 72501

1. Job Number	98547
2. Report Date	08/03/2021
3. Customer	12476

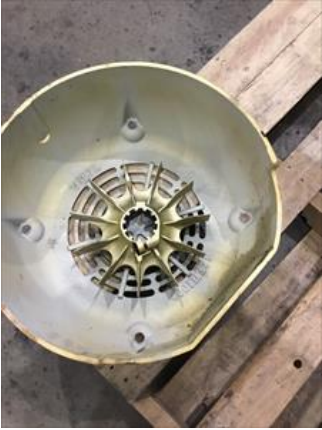
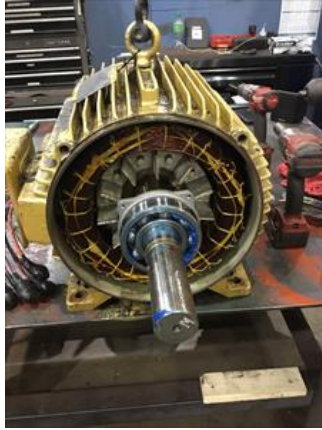
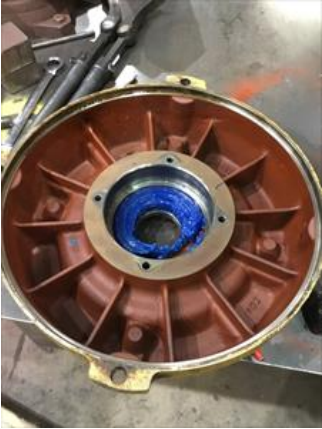
27.	Does Shaft Turn Freely		
28.	Does Shaft Have Visible Damage		
29.	Bearing Rtd's		
30.	Bearing Rtd's Condition		
31.	Contamination		
32.	Frame Condition		
● 33.	Fan Condition	(P) Pass	P109
<div>

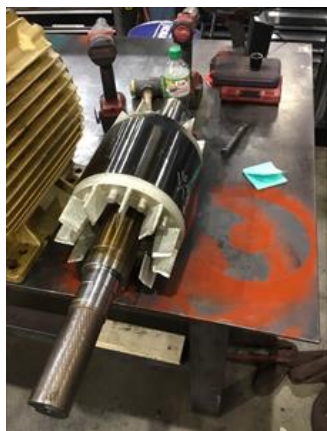
P4

44. Rotor Type

squirrel cage laminate

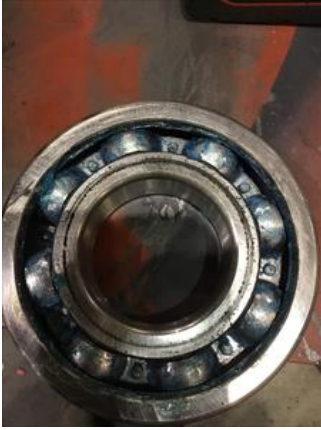
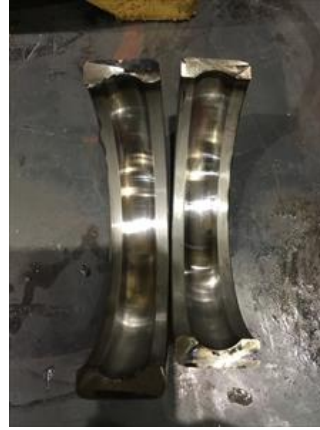
P15

51. Bearing DE Size

6312-B-C3

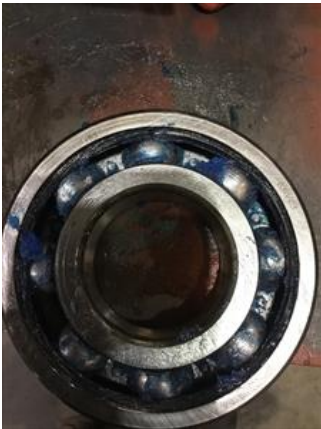
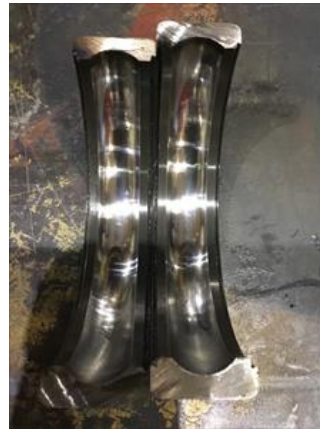
P43

54. Bearing ODE Size

6311/C3

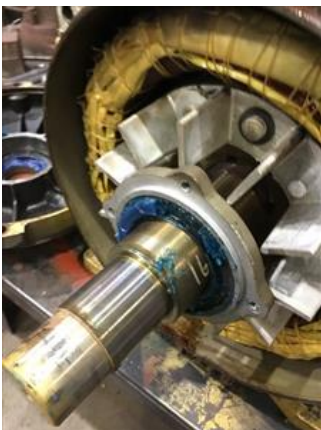
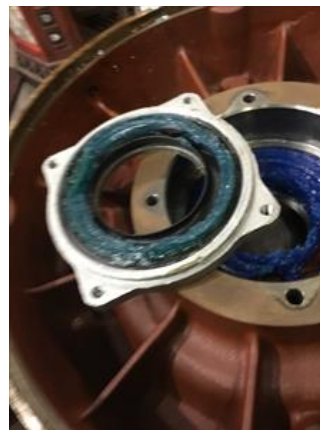
P80

● 60. Bearing Retainers

(Y) Yes

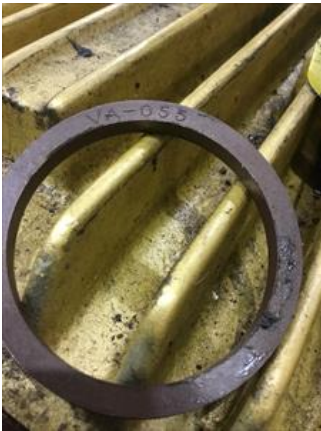
P90

63. DE Seal Type/Size
