## AC Recondition Repair Report

MAPLE CREEK SEWER  
IMPROVEMENT DISTRICT #1  
P.O. BOX 73  
MABELVALE, AR 72103

4. Manufacturer	BARNES	P5
-----------------	--------	----

5. Model	4SE7544L
6. Serial Number	C1857402
7. Horsepower	7.5
8. KW	
9. Volts	460
10. Amps	
11. RPM	1750
12. Frame	
13. Enclosure	
14. Cycles	
15. Phase	3
16. Service Factor	1.15
17. Motor Mount Position	
<b>Initial Inspection</b>	
18. Number of Leads	9
19. Lead Length	
20. Lead Size	
21. Lead Condition	(P) Pass
22. Lead Markings	T1-T9
23. Lug Size, Condition, and Type	
24. Winding RTD's	
25. Winding Rtd's Condition	
26. Shaft Run Out

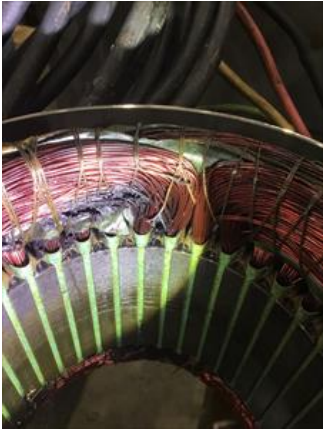
35.	Resistance to Ground		
36.	Winding Resistance 1-2		
37.	Winding Resistance 2-3		
38.	Winding Resistance 1-3		
39.	Resistive Imbalance		
40.	Hi-Pot		
41.	Surge Test	(F) Fail	
42.	Stator Condition	windings blown	P65

43.	Failure Location	coil to coil	
<b>Initial Rotor Inspection</b>

66.	Component Failure	seal failure
67.	Cause of Failure	<i>Seal failure allowed water to enter into stator windings causing the two short circuit.</i>
68.	Comments	<i>Rewind stator, replace all seals and o rings, replace bladder.</i>

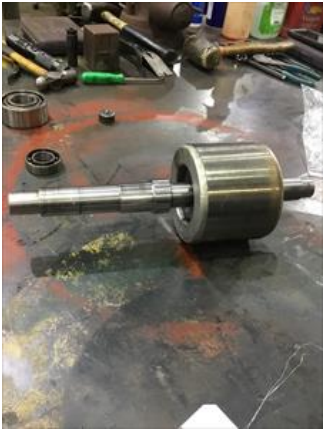
44.	Rotor Type	squirrel cage laminate	P4

45.	Air Gap <10% Variation		
46.	Number of Rotor Bars	45

47.	Number of Broken Rotor Bars	0
● 48.	Growler Test	(P) Pass
● 49.	Rotor Condition	(P) Pass
<b>Mechanical Inspection</b>		
50.	Bearing Manufacture	NSK
51.	Bearing DE Size	5307 C3
