## AC Recondition Repair Report

Union Pacific-Vine St 10945  
1020 N. Vine Street  
North Little Rock, AR

1. Job Number	98592
2. Report Date	08/13/2021
3. Customer	UNION PACIFIC

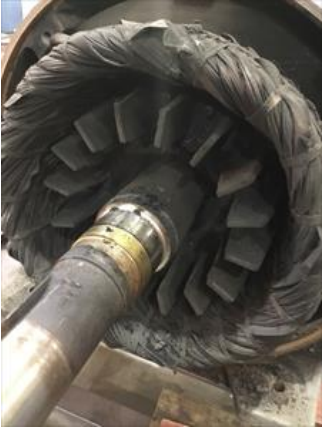
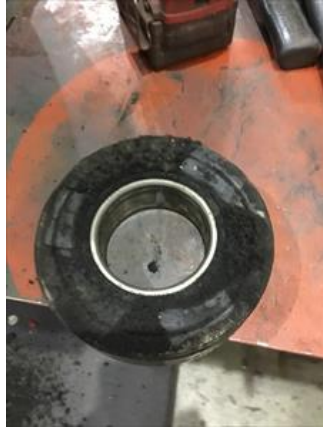
27. Does Shaft Turn Freely		
28. Does Shaft Have Visible Damage	no	
29. Bearing Rtd's		
30. Bearing Rtd's Condition		
31. Contamination		P104
Yes		
<div style="display: flex; justify-content: space-around;">

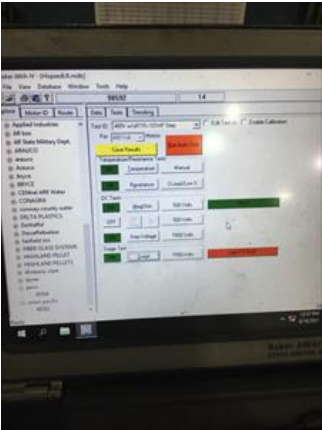
35. Resistance to Ground		
36. Winding Resistance 1-2		
37. Winding Resistance 2-3		
38. Winding Resistance 1-3		
39. Resistive Imbalance		
40. Hi-Pot		
41. Surge Test	(F) Fail	P58

66.	Component Failure	windings	
67.	Cause of Failure		
	<i>Windings shorted</i>		
68.	Comments		
	<i>Rewind stator windings. Re-sleeve D.E. &amp; O.D.E housing fits</i>		
69.	Service Technician	Terrence. Holland

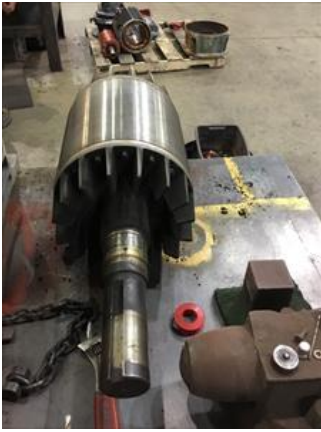
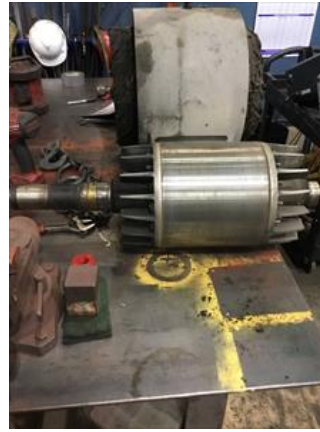
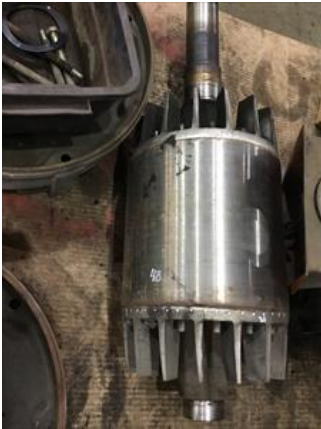
42. Stator Condition	pass	
43. Failure Location		
<b>Initial Rotor Inspection</b>

45. Air Gap &lt;10% Variation

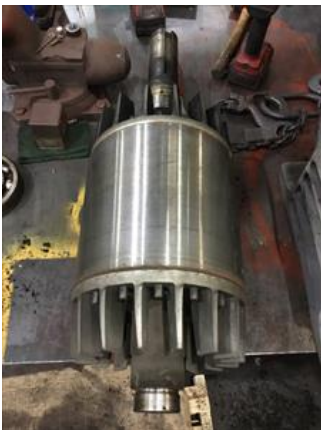
P50

● 48. Growler Test

(P) Pass

● 49. Rotor Condition

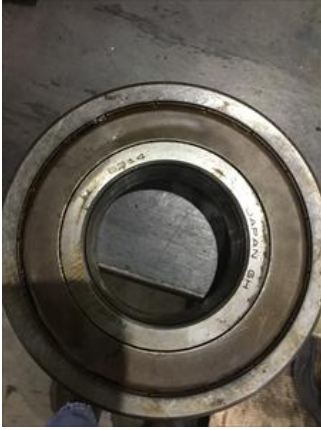
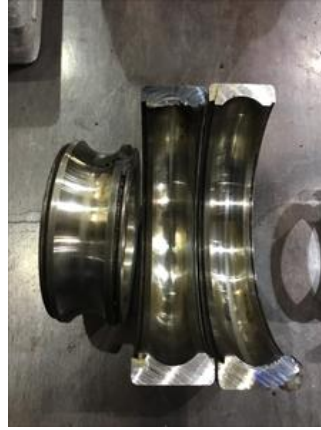
P15

50. Bearing Manufacture

NSK

51. Bearing DE Size

6314

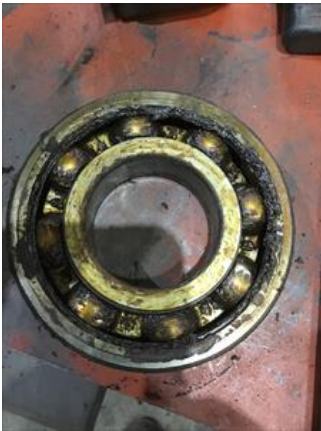
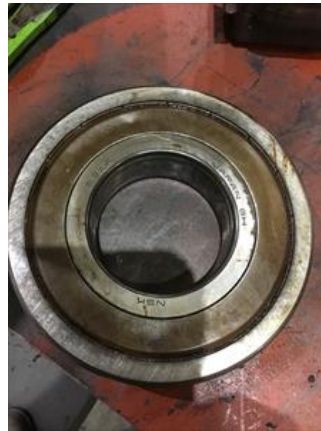
P23

52. Bearing DE Type

regular ball bearing

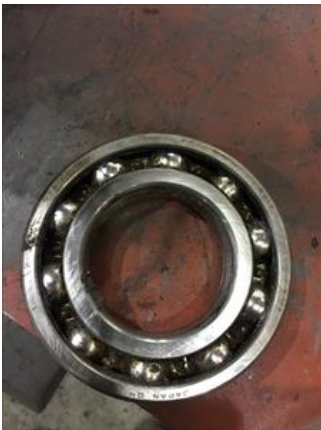
P43

54. Bearing ODE Size

6212

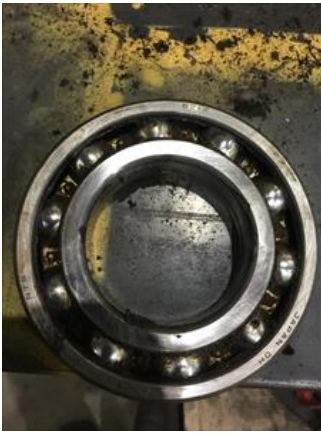
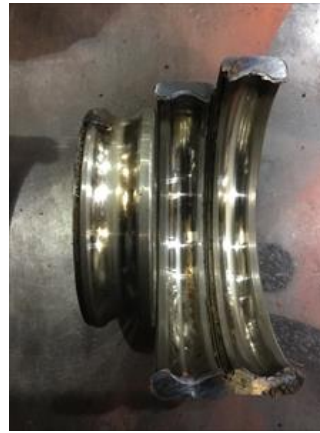
P53

55. Bearing ODE Type

regular ball bearing

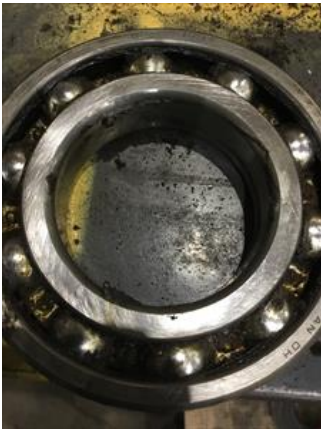
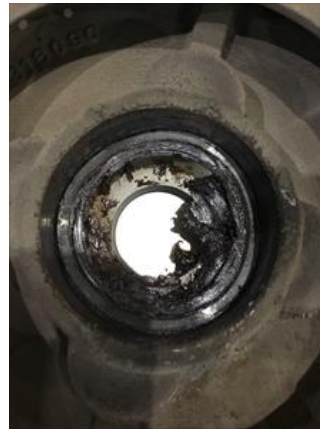
56.	ODE Bearing Qty.	1	
57.	Insulated Bearing	no	
58.	Lubrication Type	grease	
59.	Grease Condition	(F) Fail	P74
