## AC Recondition Repair Report

Huber Specialty Hydrates, LLC  
(11913)  
4750 Alcoa Road  
Bauxite, AR 72011

4.	Manufacturer	SIEMENS
5.	Model	1LA0446SE41
6.	Serial Number	E0510637TE3
7.	Horsepower	100 HP
8.	KW	KW
9.	Volts	460 Volts
10.	Amps	117 Amps
11.	RPM	1185 RPM
12.	Frame	444T
13.	Enclosure	TEFC
14.	Cycles	60 HZ
15.	Phase	3
16.	Service Factor	1.15
17.	Motor Mount Position

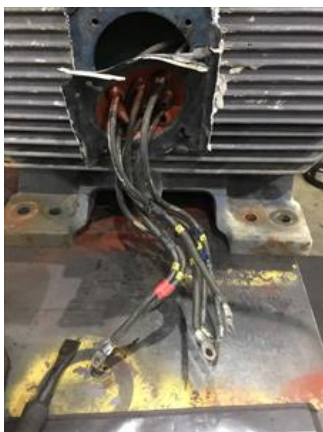
19.	Lead Length	Inches
20.	Lead Size	
● 21.	Lead Condition	(P) Pass
22.	Lead Markings	1-3

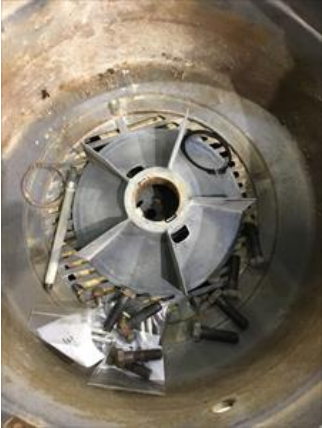
23.	Lug Size, Condition, and Type		
24.	Winding RTD's		
25.	Winding Rtd's Condition		
26.	Shaft Run Out		
27.	Does Shaft Turn Freely		
28.	Does Shaft Have Visible Damage		
29.	Bearing Rtd's		
30.	Bearing Rtd's Condition		
31.	Contamination		
	Yes		
● 32.	Frame Condition	(P) Pass	
● 33.	Fan Condition	(P) Pass	P109

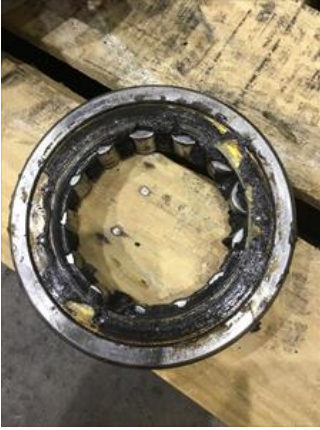
P15

51. Bearing DE Size

NU 318R

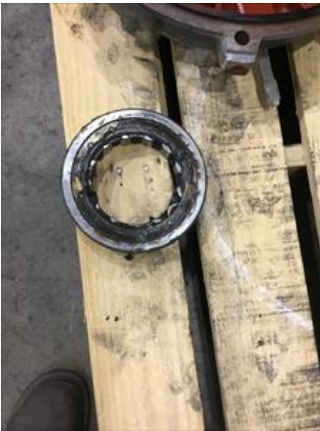
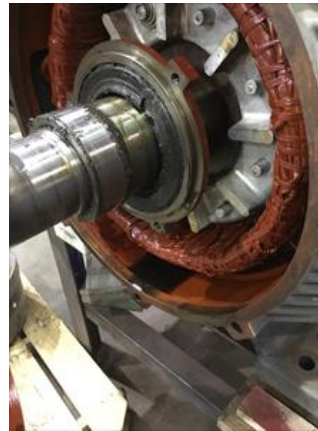
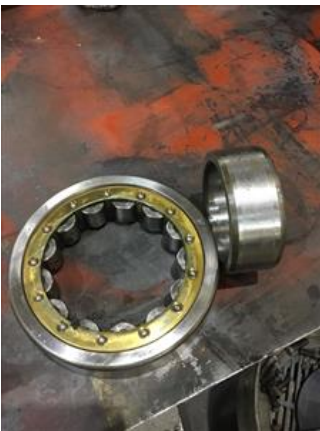
P23

52. Bearing DE Type

roller

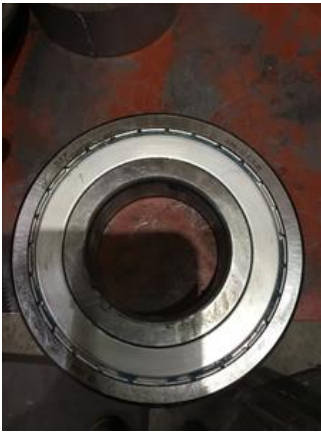
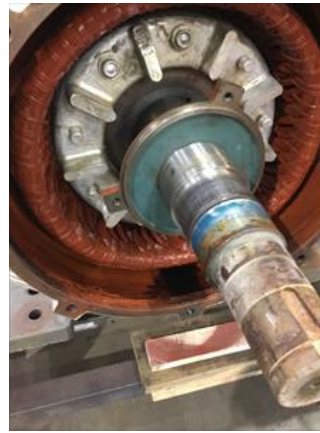
P43

54. Bearing ODE Size

6316-2Z/C3JN

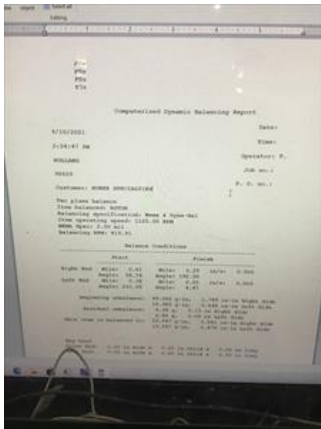
P6

119. Balance Type

nema standard
