Hi-Speed Industrial Service
7030 Ryburn Dr
Millington, Tn 38053
901-873-5300

AC Recondition Repair Report

3M-Main Plant (10001)
310 Walter Road
Little Rock, AR 72216

1. Job Number	98668
2. Report Date	09/01/2021
3. Customer	3M

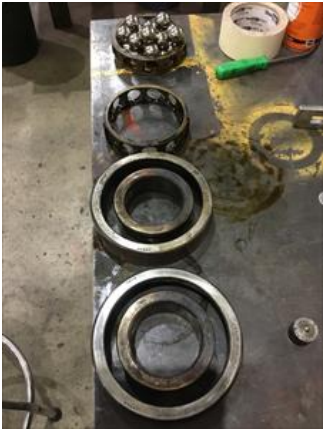
52.	Bearing DE Type	thrust	P23

47.	Number of Broken Rotor Bars	0	
● 48.	Growler Test	(P) Pass	
● 49.	Rotor Condition	(P) Pass	
Mechanical Inspection			
50.	Bearing Manufacture	koyo	
51.	Bearing DE Size	7314B

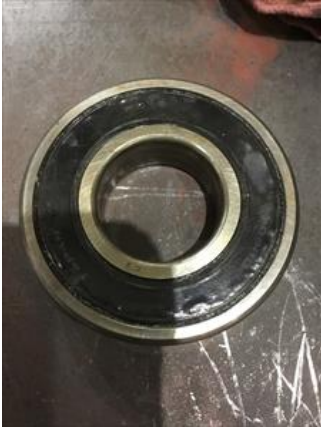
☒ 59. Grease Condition

(F) Fail

*Water contaminated*
☒ 60. Bearing Retainers

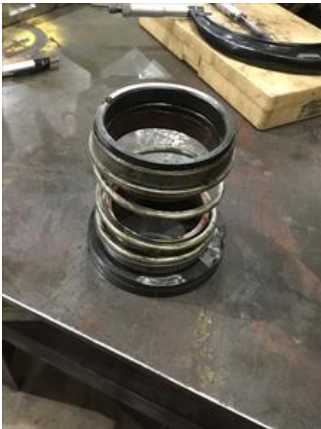
P86

☒ 62. DE Seal

63. DE Seal Type/Size

double sided proprietary seal

68.	Comments	
	<i>Re-sleeve upper & lower housings. Rewind stator. All seal surfaces bad. Upper shaft bearing journal bad. Replace power cord (4c-4AWG, 21' long). Shaft is bent .005</i>

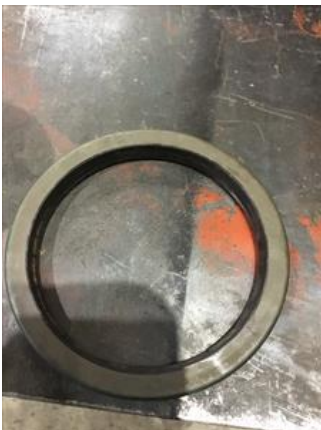
P95

☒ 64. ODE Seal

65.	ODE Seal Type/Size	
Root Cause of Failure		
66.	Component Failure	seals
67.	Cause of Failure	
	<i>Seals failed due to shaft seal surface being worn</i>
