AC Recondition Repair Report

1. Job Number	98689
2. Report Date	09/08/2021
3. Customer	Sage V Foods

4. Manufacturer	Baldor Reliance	P5
-----------------	-----------------	----

5. Model	12H300Y141G1
6. Serial Number	C1408190001
7. Horsepower	50
8. KW	
9. Volts	460
10. Amps	58
11. RPM	1775
12. Frame	326TDZ
13. Enclosure	TEFC
14. Cycles	60
15. Phase	3

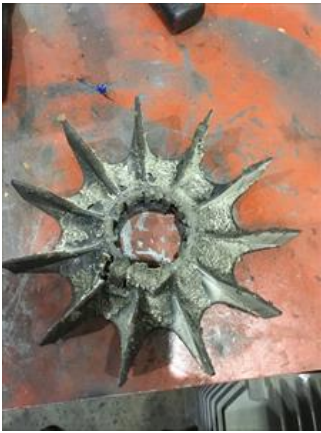
19.	Lead Length	10 Inches	
20.	Lead Size		
 	21.	Lead Condition	(P) Pass
22.	Lead Markings	1-9	
23.	Lug Size, Condition, and Type		
24.	Winding RTD's		
25.	Winding Rtd's Condition		
26.	Shaft Run Out	0.25	
 	Needs new shaft		
27.	Does Shaft Turn Freely	yes	
28.	Does Shaft Have Visible Damage	yes/bent extensively	
29.	Bearing Rtd's		
30.	Bearing Rtd's Condition		
31.	Contamination		P104
	Grease dirty/hardened

32.	Frame Condition	(P) Pass
 	33.	Fan Condition	(P) Pass
			P109

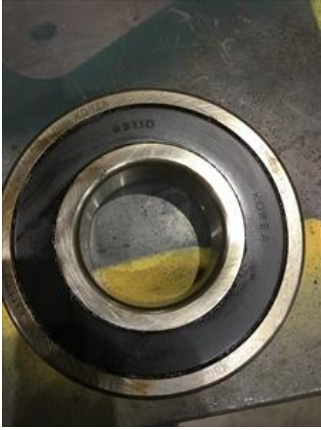
50. Bearing Manufacture	KBC
51. Bearing DE Size	
52. Bearing DE Type	
53. DE Bearing Qty.	
54. Bearing ODE Size	6311D

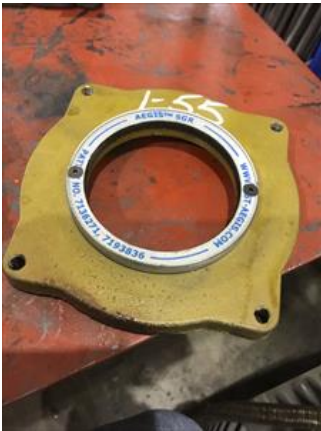
P81

● 61. Shaft Grounding Device

(Y) Yes

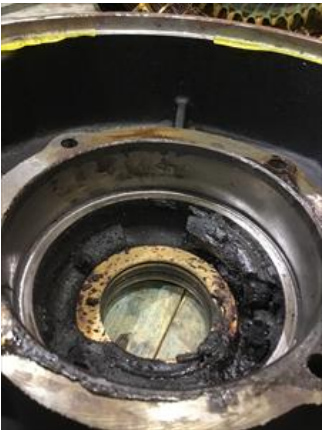
shaft bent out of limits. both
housing fits bad.

92.	ODE Final Air Seal Shaft Size		
93.	DE Endbell Fit	(F) Fail	P129
	Excessive wear spot.

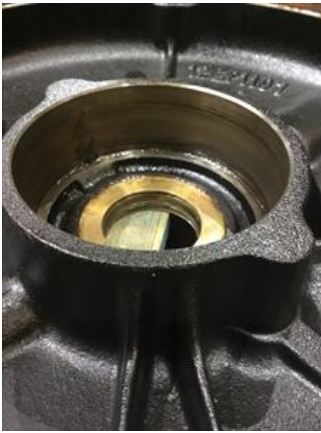
101.	DE Endbell Air Seal Fit		
102.	Initial Endbell Air Seal Fit Size		
103.	Finial Endbell Air Seal Fit Size		
104.	ODE Endbell Fit	(F) Fail	P145
	Lip worn in fit.

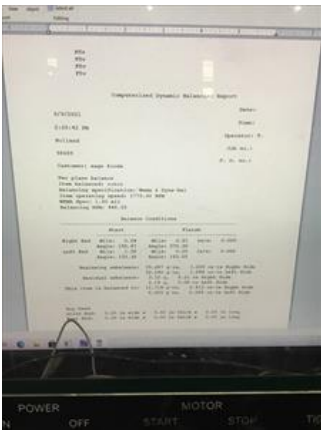
119. Balance Type nema standard P6

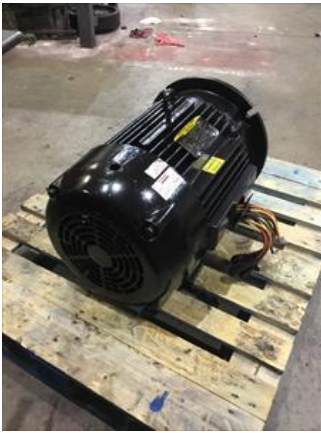
P136

154.	Temp at 45 minutes	
155.	Temp at 50 minutes	
156.	Temp at 55 minutes	
157.	Temp at 60 minutes	
● 158.	Motor Paint	(P) Pass
