AC Recondition Repair Report

1. Job Number	98690
2. Report Date	09/08/2021
3. Customer	Fluid Solutions Inc.

4. Manufacturer	Baldor Reliance
-----------------	-----------------

5. Model	37H246R726G1
6. Serial Number	F2002046272
7. Horsepower	5
8. KW	
9. Volts	460
10. Amps	7
11. RPM	1160
12. Frame	215TCZ
13. Enclosure	OPSB
14. Cycles	60
15. Phase	3

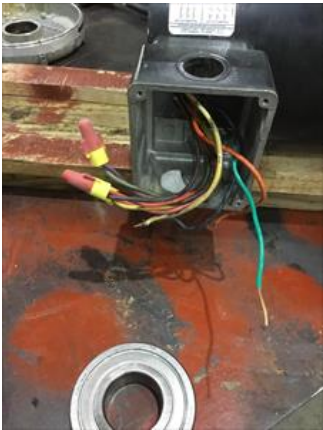
18.	Number of Leads	9	P13

16.	Service Factor	1.15	
17.	Motor Mount Position		
Initial Inspection

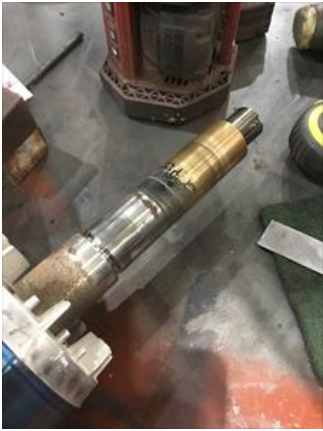
21.	Lead Condition	(P) Pass
	22.	Lead Markings	1-9
	23.	Lug Size, Condition, and Type	
	24.	Winding RTD's	
	25.	Winding Rtd's Condition	
	26.	Shaft Run Out	
	27.	Does Shaft Turn Freely	yes
	28.	Does Shaft Have Visible Damage	no

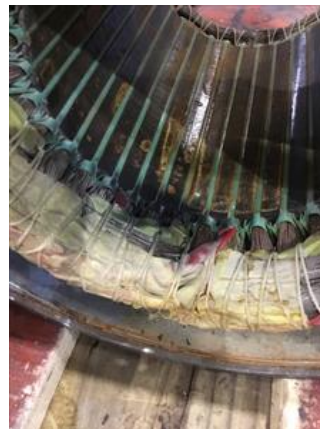
P58

| 35. Resistance to Ground |
| 41. Surge Test |

(F) Fail

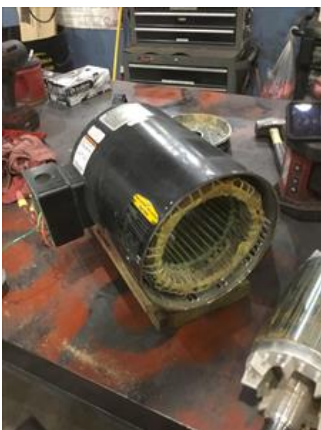
P65

| 42. Stator Condition |

pass

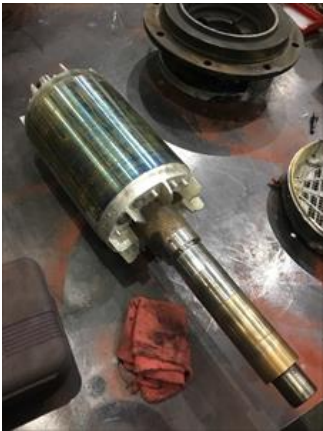
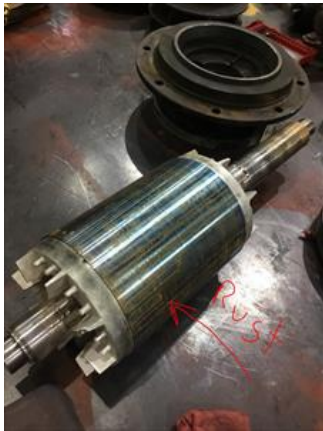
45. Air Gap <10% Variation		
46. Number of Rotor Bars	27	
47. Number of Broken Rotor Bars	0	
● 48. Growler Test	(P) Pass	
● 49. Rotor Condition	(P) Pass	P50

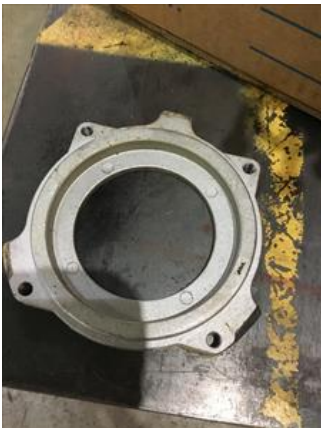
P80

☒ 60. Bearing Retainers

(Y) Yes

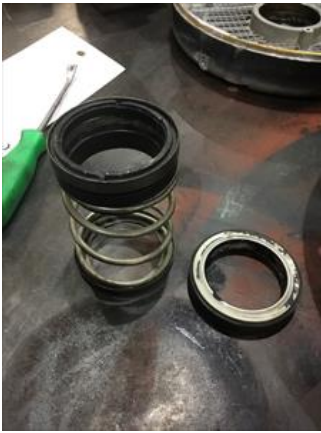
P86

☒ 62. DE Seal

(Y) Yes

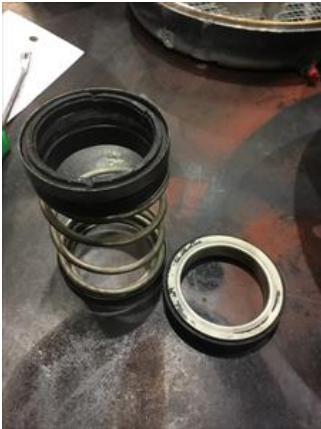
P90

63. DE Seal Type/Size

(O.D. 2.530 / 1.8035)
