Hi-Speed Industrial Service
7030 Ryburn Dr
Millington, Tn 38053
901-873-5300

AC Recondition Repair Report

Delta Plastics (11016)
8801 Frazier Pike
Little Rock, AR 72206

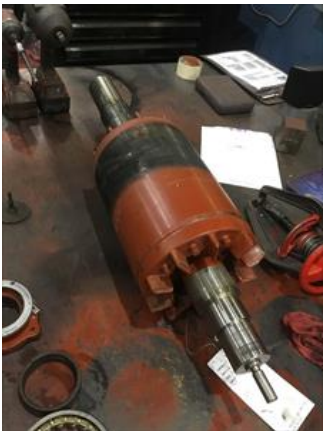
42.	Stator Condition	pass
43.	Failure Location	D.E. bearing fit failed.
Initial Rotor Inspection		
44.	Rotor Type	squirrel cage laminate

- 66. Component Failure **D.E. bearing fit failed causing windings to ground**
- 67. Cause of Failure
D.E. Bearing fit failed.
- 68. Comments
- 69. Service Technician **Terrence. Holland**

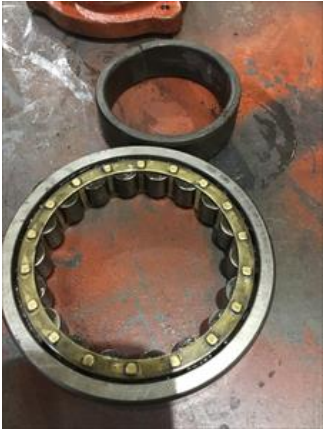
49. Rotor Condition	(P) Pass	
Mechanical Inspection		
50. Bearing Manufacture	FAG	
51. Bearing DE Size	NU215	
52. Bearing DE Type	NU215 LXC M1 C3	P23

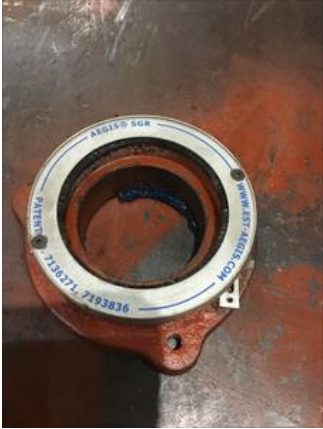
53. DE Bearing Qty.	1	
54. Bearing ODE Size	6211 Z C3	
55. Bearing ODE Type	regular ball bearing	
56. ODE Bearing Qty.	1	
57. Insulated Bearing	no	
58. Lubrication Type	grease	
59. Grease Condition	(F) Fail	
60. Bearing Retainers	(Y) Yes	P80

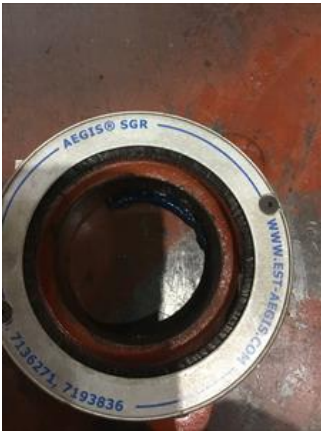
61. Shaft Grounding Device	(Y) Yes	P81
