## AC Recondition Repair Report

Sage V Foods  
5901 SLOAN DRIVE  
LITTLE ROCK, AR 72206

1. Job Number	98820
2. Report Date	10/05/2020
3. Customer	Sage V Foods

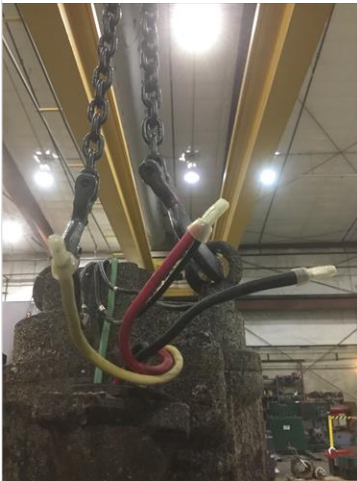
P67

19. Lead Length **24 Inches**

21. Lead Condition **(P) Pass**

22. Lead Markings **1 2 3**

23. Lug Size, Condition, and Type  
*Crimp style*

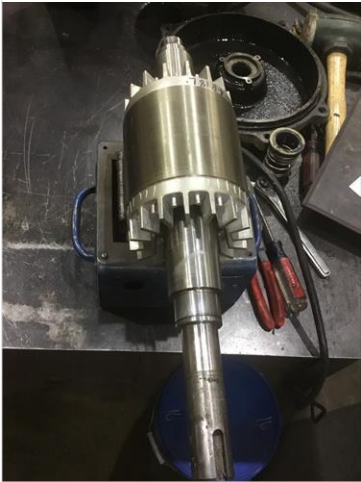
44.	Rotor Type	cast aluminum	P4

45.	Air Gap <10% Variation		
46.	Number of Rotor Bars	40	
47.	Number of Broken Rotor Bars	0	
● 48.	Growler Test	(P) Pass	
● 49.	Rotor Condition	(P) Pass	
<b>Mechanical Inspection</b>

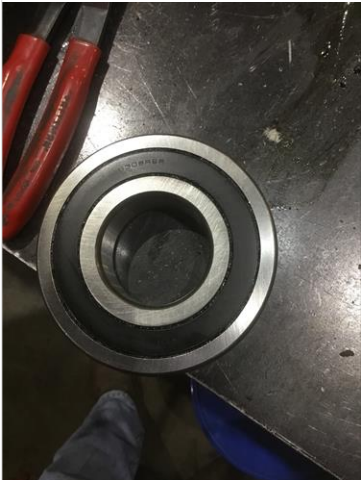
50.	Bearing Manufacture	fag	
51.	Bearing DE Size	6309 rsr sealed	P15

52.	Bearing DE Type	ball	
53.	DE Bearing Qty.	1

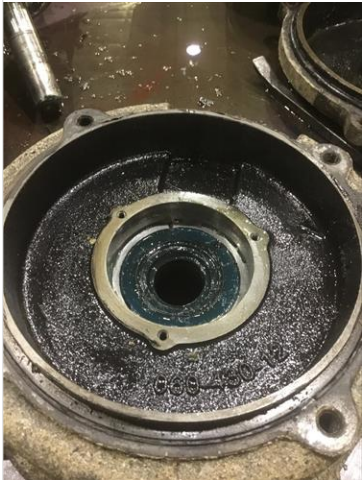
84.	ODE Finial Shaft Bearing Fit Size 1		
85.	ODE Finial Shaft Bearing Fit Size 2		
86.	ODE Finial Shaft Bearing Fit Size 3		
87.	DE Air Seal Shaft Fit		
88.	DE Initial Air Seal Shaft Size		
89.	DE Final Air Seal Shaft Size		
90.	ODE Air Seal Shaft Fit		
91.	ODE Initial Air Seal Shaft Size		
92.	ODE Final Air Seal Shaft Size		
● 93.	DE Endbell Fit	(P) Pass	P129

94.	DE Initial Endbell Fit Size 1	3.9378 "	
95.	DE Initial Endbell Fit Size 2	3.9378 "	
96.	DE Initial Endbell Fit Size 3	3.9378 "	
97.	DE Final Endbell Fit Size 1		
98.	DE Final Endbell Fit Size 2		
99.	DE Final Endbell Fit Size 3		
100.	DE Endbell Fit Insulated		
101.	DE Endbell Air Seal Fit		
102.	Initial Endbell Air Seal Fit Size		
103.	Finial Endbell Air Seal Fit Size		
● 104.	ODE Endbell Fit	(F) Fail	P145

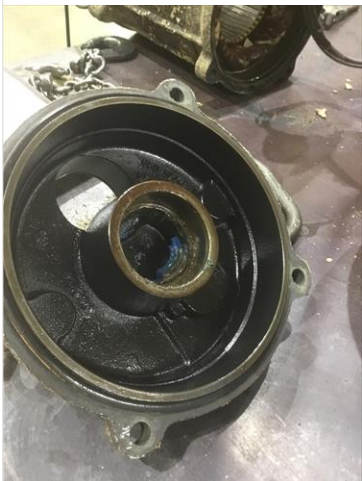
<span>🗨</span> Oversized			
105.	ODE Initial Endbell Fit Size 1	2.8439 "

106. ODE Initial Endbell Fit Size 2	2.8432 "	
107. ODE Initial Endbell Fit Size 3	2.8389 "	
108. ODE Final Endbell Fit Size 1	2.835 "	P149

109. ODE Final Endbell Fit Size 2	2.835 "	
110. ODE Final Endbell Fit Size 3	2.835 "	
111. ODE Endbell Fit Insulated		
112. ODE Endbell Air Seal Fit		
113. ODE Initial Endbell Seal Fit Size		
114. ODE Final Endbell Seal Fit Size		
115. Foot Flatness		
116. Foot Condition		
117. Flange Condition		
118. Service Technician		
<b>Balancing Report</b>		
119. Balance Type		
120. Balance Operating Speed		
121. Start Left End		
122. Start Right End		
123. Balancing Specification		
124. Finish Left End		
125. Finish Right End		
126. Service Technician		
<b>Assembly and Final Test</b>
