AC Recondition Repair Report

Century Flooring
Highway 9 Spur
Melbourne, AR 72556

4. Manufacturer	HOMA	P5
Submersible Pump

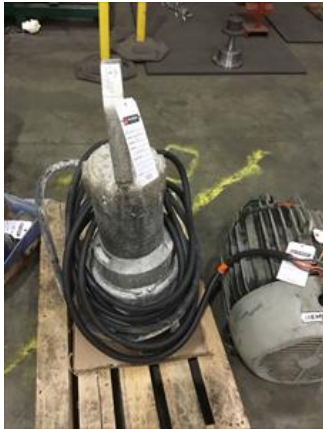
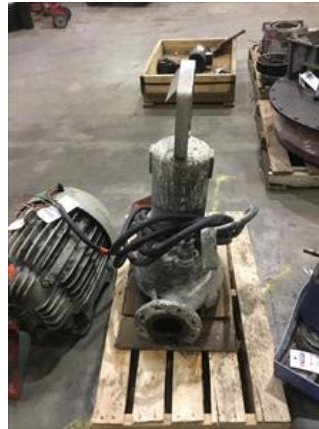
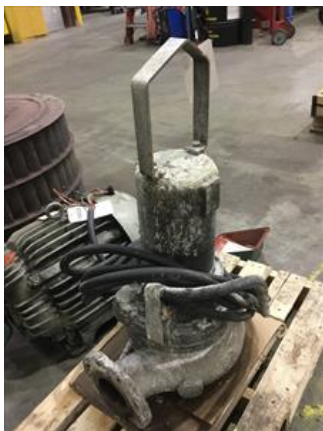
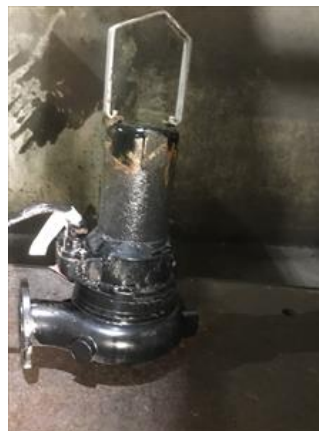
Drive end bearing race cracked

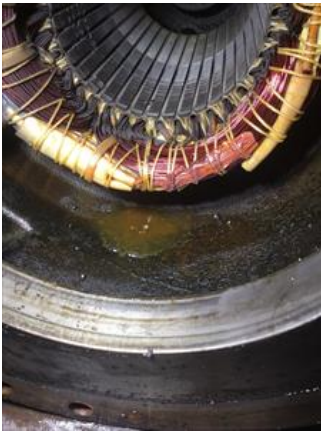
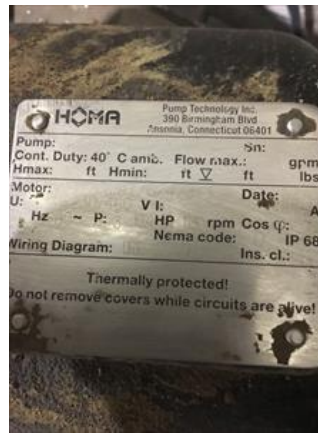
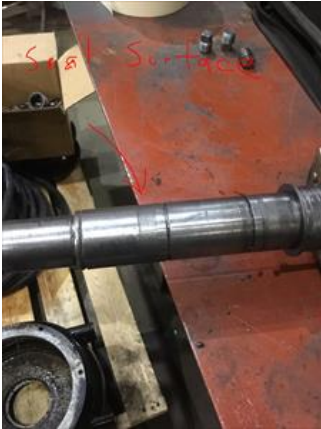
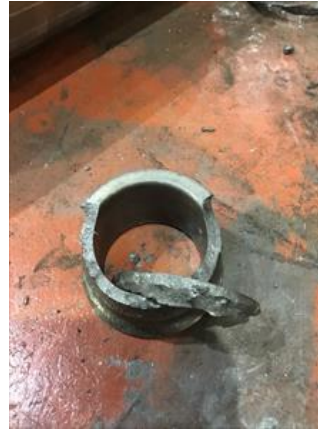
Contaminated grease caused catastrophic race and cage failure. This was caused by seal failure which allowed water inside the stator.

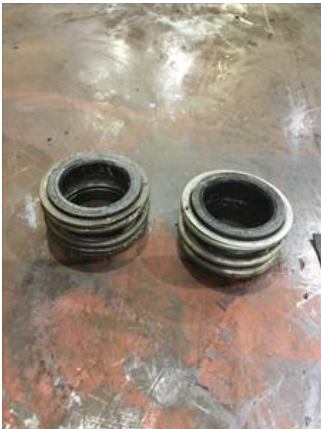
<i>Seal surface bad</i>	
29.	Bearing Rtd's	
30.	Bearing Rtd's Condition

31.	Contamination	
	<i>Yes/water in stator housing</i>

<i>Rewind/core repair</i>

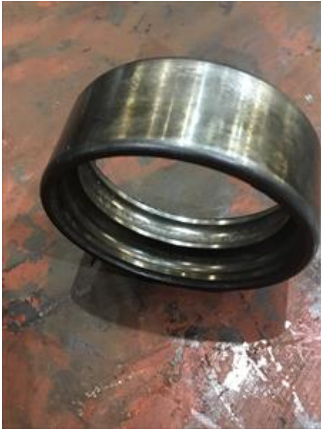
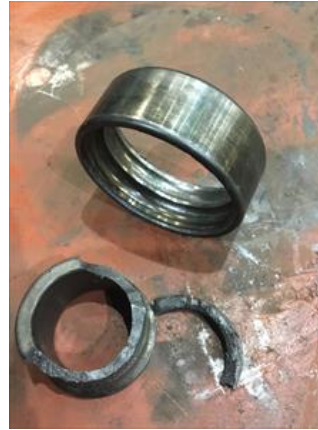
66. Component Failure	D.E. bearing
-----------------------	--------------

Seal surface bad.
