AC Recondition Repair Report

Vulcan Materials
125 Rock Lane
Judsonia, AR 72081

1. Job Number	99041
2. Report Date	11/30/2021
3. Customer	Vulcan Materials

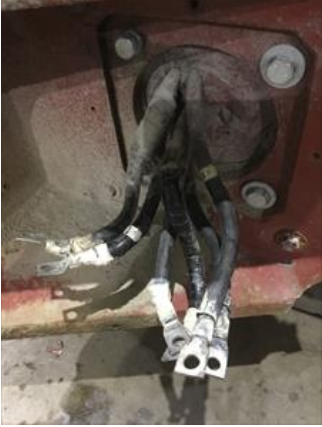
#1-6	
19.	Lead Length	11 Inches
20.	Lead Size	
21.	Lead Condition	P42

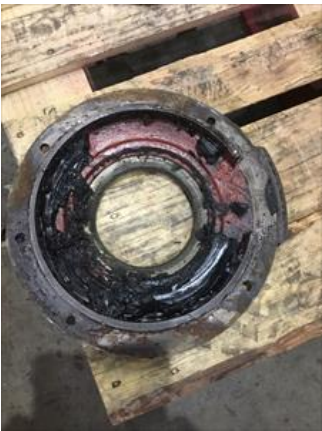
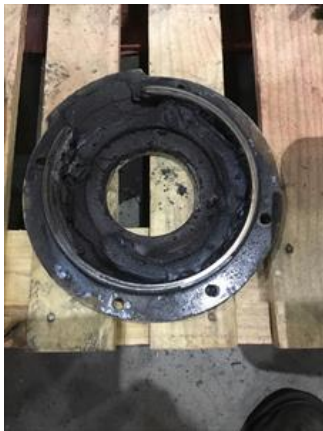
22.	Lead Markings	1-6
23.	Lug Size, Condition, and Type	
24.	Winding RTD's	
25.	Winding Rtd's Condition	
26.	Shaft Run Out	
27.	Does Shaft Turn Freely	
28.	Does Shaft Have Visible Damage	no
29.	Bearing Rtd's	
30.	Bearing Rtd's Condition	
31.	Contamination	P104
	<i>Grease contaminated and dirty</i>

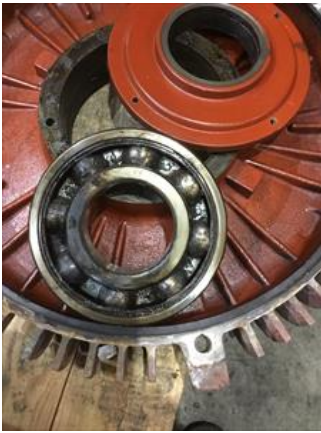
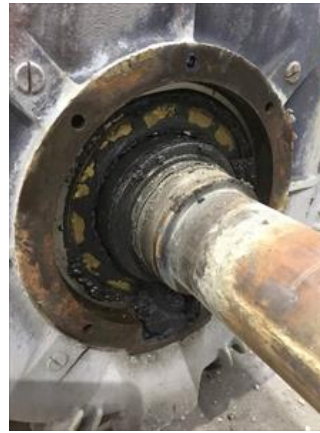
32.	Frame Condition	(P) Pass
33.	Fan Condition	(P) Pass
34.	Broken or missing components	
Initial Electric Test		
35.	Resistance to Ground	
36.	Winding Resistance 1-2	
37.	Winding Resistance 2-3	
38.	Winding Resistance 1-3	
39.	Resistive Imbalance	
40.	Hi-Pot	
41.	Surge Test	(F) Fail
42.	Stator Condition	core repair needed on iron
43.	Failure Location	iron core laminations
Initial Rotor Inspection		
44.	Rotor Type	squirrel cage laminate
45.	Air Gap <10% Variation	
46.	Number of Rotor Bars	
47.	Number of Broken Rotor Bars	
48.	Growler Test	
49.	Rotor Condition	
Mechanical Inspection		
50.	Bearing Manufacture	koyo
51.	Bearing DE Size	324R

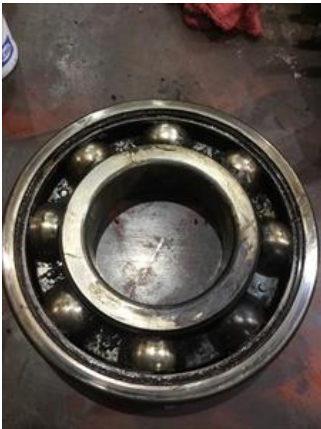
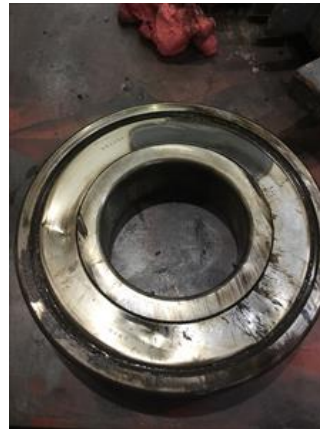
P53

**o.d.e housing fit is grooved
and needs machining.**

Excessive wear. Groove worn in.	
105.	ODE Initial Endbell Fit Size 1	
106.	ODE Initial Endbell Fit Size 2
