AC Recondition Repair Report

Sage V Foods
5901 SLOAN DRIVE
LITTLE ROCK, AR 72206

1. Job Number	99046
2. Report Date	12/01/2021
3. Customer	Sage V Foods

4. Manufacturer	Baldor	P5
-----------------	--------	----

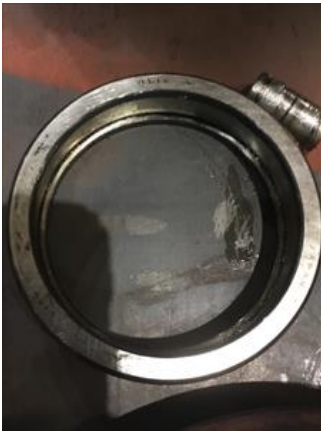
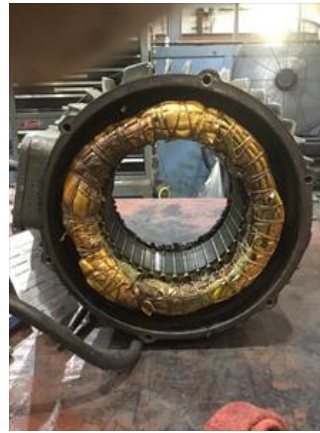
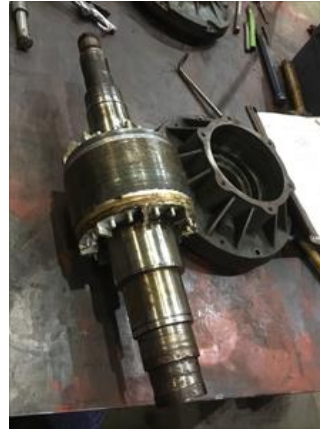
5. Model	07J0152W332G1
6. Serial Number	F1107276584
7. Horsepower	2.5
8. KW	
9. Volts	460
10. Amps	5.1
11. RPM	1120
12. Frame	213Z
13. Enclosure	TENV
14. Cycles	60
15. Phase	3
16. Service Factor	1.00
17. Motor Mount Position	
Initial Inspection	
18. Number of Leads	
19. Lead Length	
20. Lead Size	
21. Lead Condition	
22. Lead Markings	
23. Lug Size, Condition, and Type	
24. Winding RTD's	
25. Winding Rtd's Condition	
26. Shaft Run Out

27.	Does Shaft Turn Freely	yes
28.	Does Shaft Have Visible Damage	no
29.	Bearing Rtd's	
30.	Bearing Rtd's Condition	
31.	Contamination <i>Grease dirty</i>

62.	DE Seal	(NA) Not Applicable
63.	DE Seal Type/Size	
64.	ODE Seal	(Y) Yes
65.	ODE Seal Type/Size	CR31135-L
Root Cause of Failure		
66.	Component Failure	
67.	Cause of Failure <i>Contaminated grease in bearings</i>
