AC Recondition Repair Report

Phelps Fan Manufacturing Co.
10701 Interstate 30
Little Rock, AR 72209

1. Job Number	99081
2. Report Date	12/08/2021
3. Customer	Phelps Fan Manufacturing Co.

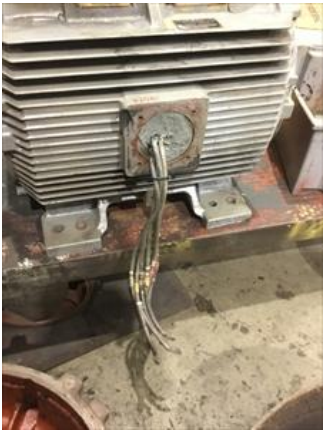
18.	Number of Leads	6	P13

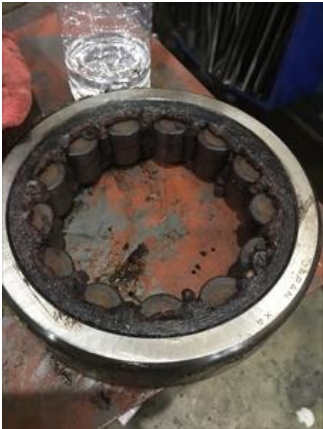
21. Lead Condition	(P) Pass	
	22. Lead Markings	1-3	
	23. Lug Size, Condition, and Type		
	24. Winding RTD's		
	25. Winding Rtd's Condition		
	26. Shaft Run Out	0.002	
	27. Does Shaft Turn Freely		
	28. Does Shaft Have Visible Damage		
	29. Bearing Rtd's		
	30. Bearing Rtd's Condition		
	31. Contamination		P104

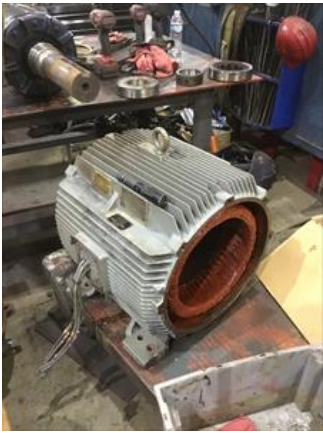
32. Frame Condition	(P) Pass	P106

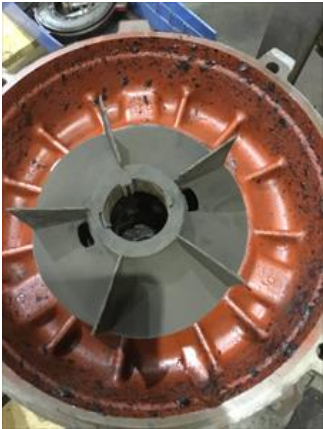
33. Fan Condition

(P) Pass

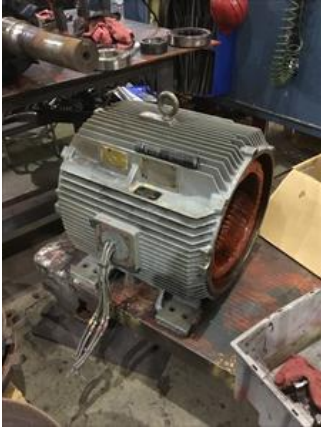
42. Stator Condition

good

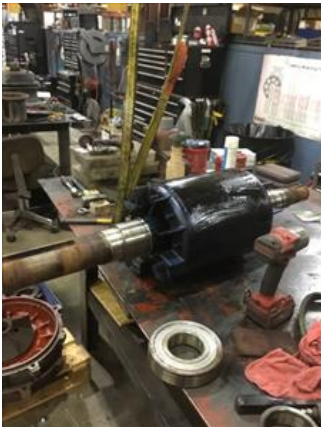
● 49. Rotor Condition

(P) Pass

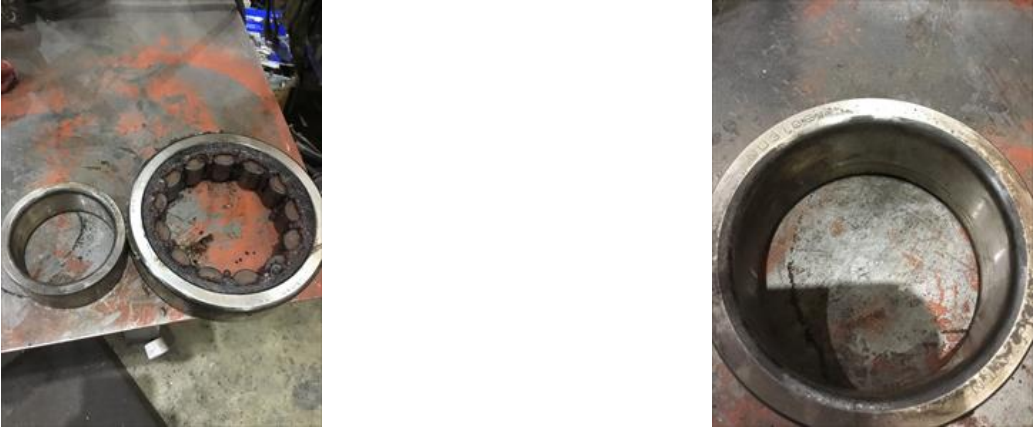
51. Bearing DE Size	Nu318	P15

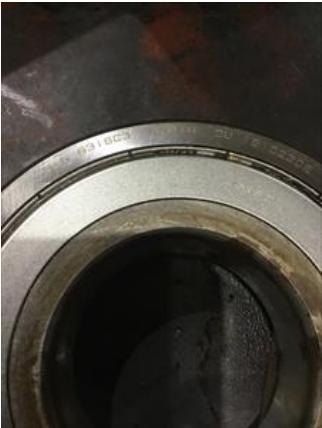
52. Bearing DE Type	N.u	
53. DE Bearing Qty.	1	
54. Bearing ODE Size	6316	P43

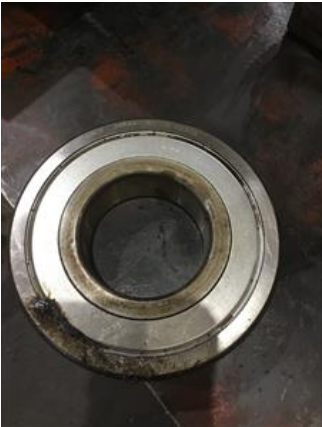
55. Bearing ODE Type	regular ball bearing	P53

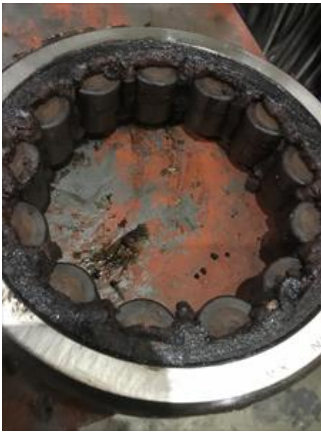
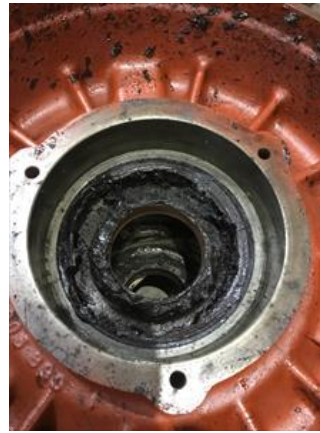
56. ODE Bearing Qty.	1	
57. Insulated Bearing	no	
58. Lubrication Type	grease	
59. Grease Condition	(F) Fail	P74

66. Component Failure	d.e. bearing	
--	-----------------------	--------------	--

67. Cause of Failure <i>Contaminated grease</i>		
--	----------------------------------------------------	--	--

68. Comments
Recondition/bearings.

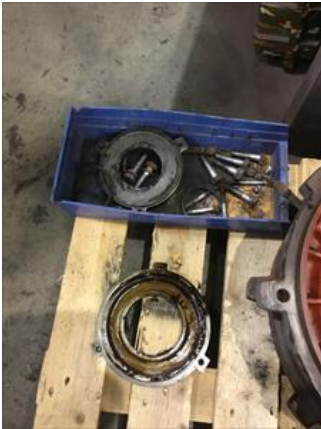
<input checked="" type="radio"/>	60. Bearing Retainers	(Y) Yes	P80
----------------------------------	-----------------------	---------	-----

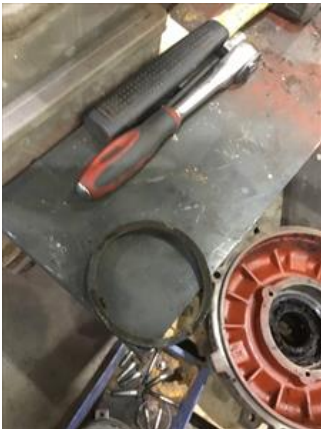
62. DE Seal		P86
--	-------------	--	-----
