FolderID: 99132  
FormID: 12413094

### General

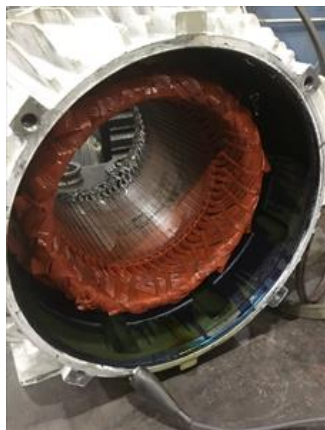
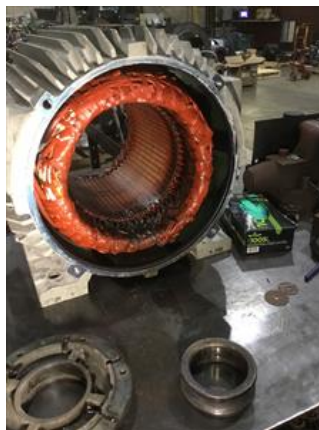
42. Stator Condition

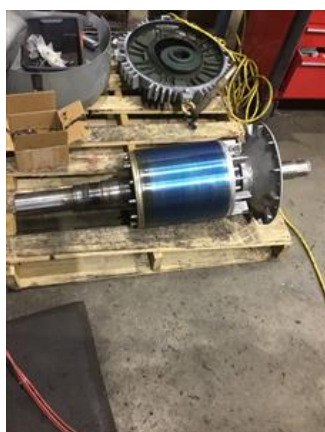
44. Rotor Type

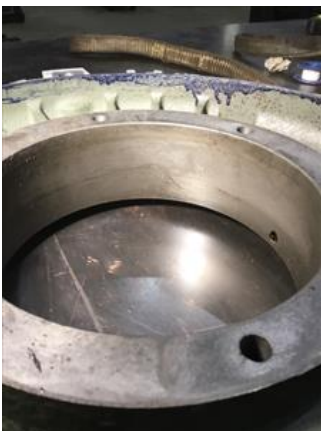
92. ODE Final Air Seal Shaft Size

67. Cause of Failure  
Cause of failure is undetermined.
