AC Recondition Repair Report

3M-Main Plant (10001)
310 Walter Road
Little Rock, AR 72216

1. Job Number	99152
2. Report Date	12/22/2021
3. Customer	3M

5. Model	5KG509SN602P
6. Serial Number	WM6362002
7. Horsepower	100
8. KW	
9. Volts	460
10. Amps	134
11. RPM	595
12. Frame	509Z
13. Enclosure	TEFC
14. Cycles	60
15. Phase	3

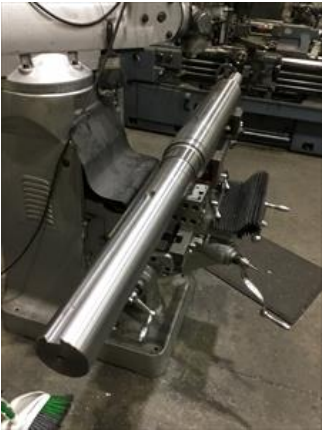
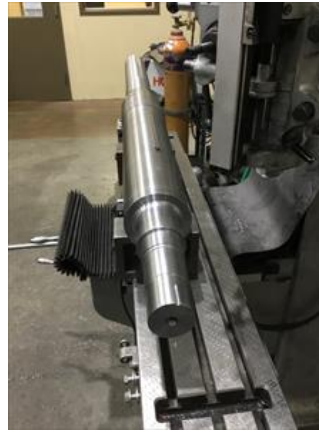
P84

26. Shaft Run Out

Broken shaft. Machine new shaft.

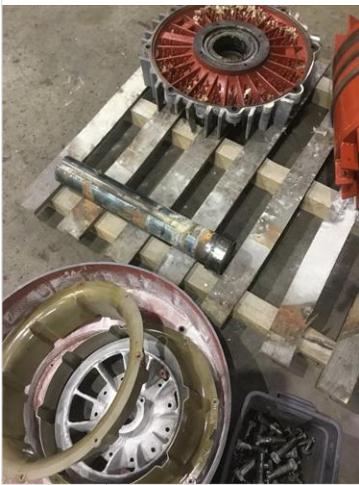
P94

28. Does Shaft Have Visible Damage

yes Shaft broken behind bearing

Shaft broke behind drive bearing. Rotor drag iron caused motor to go to ground

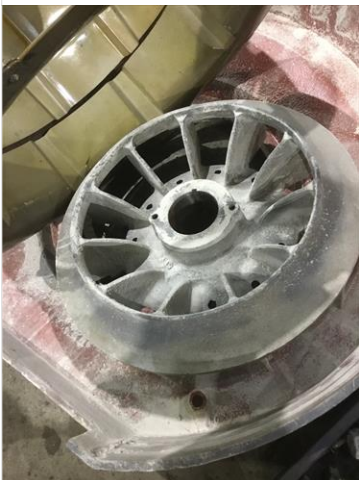
P109

33. Fan Condition

(P) Pass

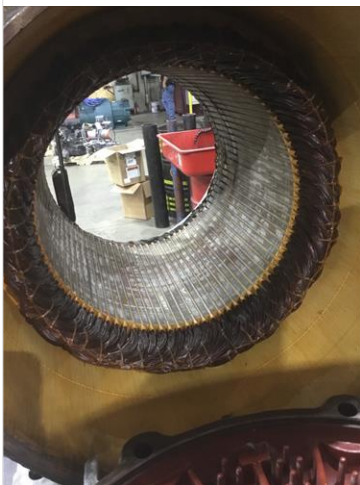
35.	Resistance to Ground	0 Mohm
36.	Winding Resistance 1-2	
37.	Winding Resistance 2-3	
38.	Winding Resistance 1-3	
39.	Resistive Imbalance	
40.	Hi-Pot	
41.	Surge Test	(F) Fail
	<i>Rewind</i>	
42.	Stator Condition	rewind with core repair P65

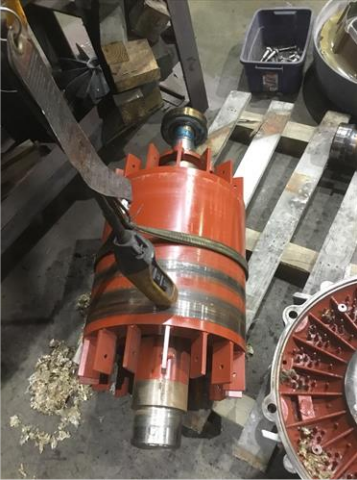
P4

44. Rotor Type

cast aluminum

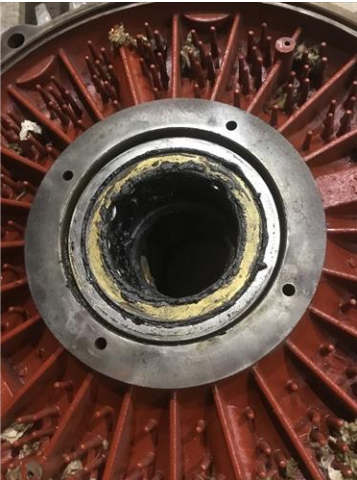
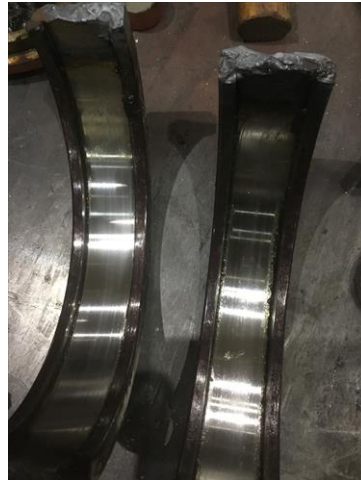
P15

51. Bearing DE Size

NU320

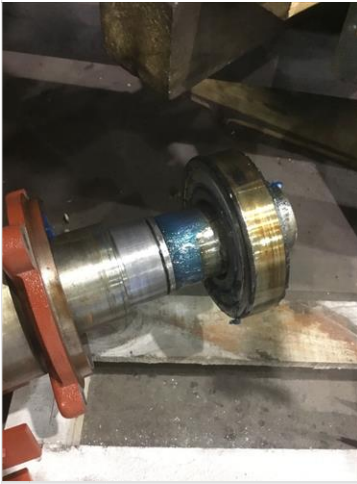
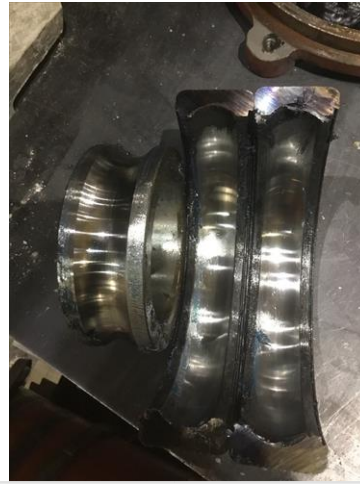
P43

54. Bearing ODE Size

6315ZC3

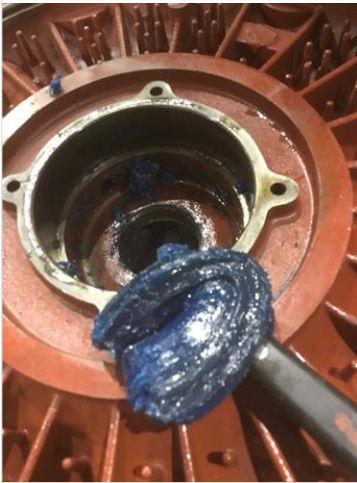
P74

59. Grease Condition

(P) Pass

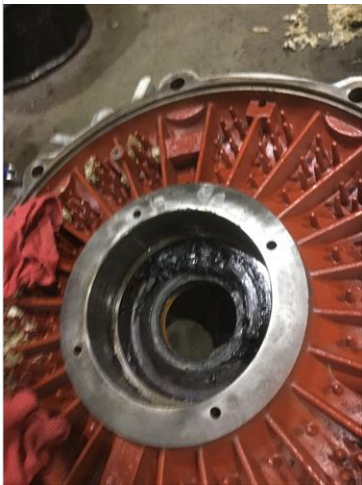
89.	DE Final Air Seal Shaft Size		
90.	ODE Air Seal Shaft Fit		
91.	ODE Initial Air Seal Shaft Size		
92.	ODE Final Air Seal Shaft Size		
93.	DE Endbell Fit	(F) Fail	P129
<div>

<i>Resleeve bearing housing and output hole in end bell</i> </div> <div>

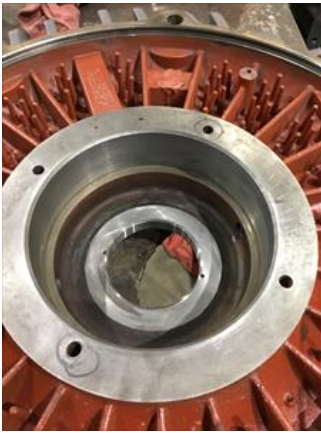
94.	DE Initial Endbell Fit Size 1	8.466200000000001 "	
95.	DE Initial Endbell Fit Size 2	8.466200000000001 "	
96.	DE Initial Endbell Fit Size 3	8.466200000000001 "

97.	DE Final Endbell Fit Size 1	8.465 "	P138
