## AC Recondition Repair Report

**Sage V Foods**  
5901 SLOAN DRIVE  
LITTLE ROCK, AR 72206

1. Job Number	99171
2. Report Date	01/03/2022
3. Customer	Sage V Foods

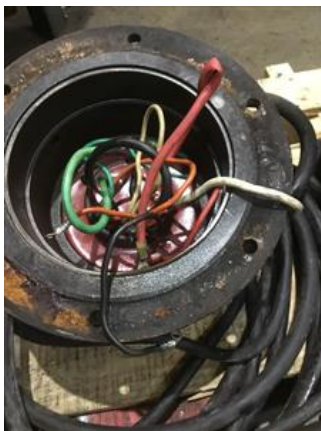
21. Lead Condition	(F) Fail	P42

Leads swelled from moisture.

22.	Lead Markings		
23.	Lug Size, Condition, and Type	Replace power and sensor cords. Power: 25' 4c 12Awg. Sensor: 5C 18awg	
24.	Winding RTD's

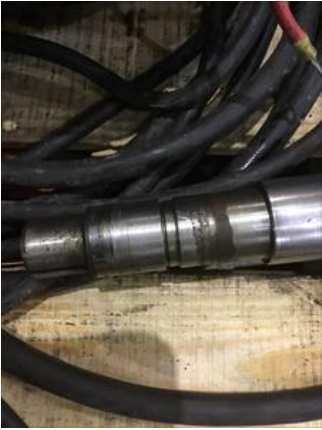
25.	Winding Rtd's Condition		
26.	Shaft Run Out	0.001	
27.	Does Shaft Turn Freely	yes	
28.	Does Shaft Have Visible Damage	yes: seal surfaces worn	P94

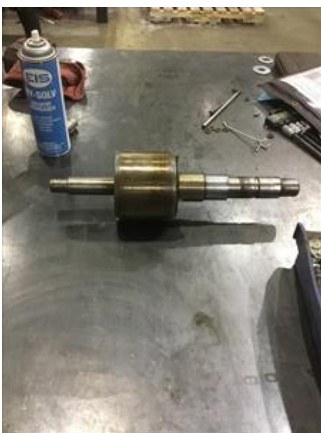
44. Rotor Type

squirrel cage laminate

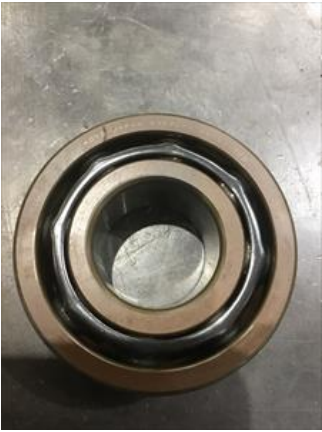
50. Bearing Manufacture	koyo	
51. Bearing DE Size	5309CD3	P15

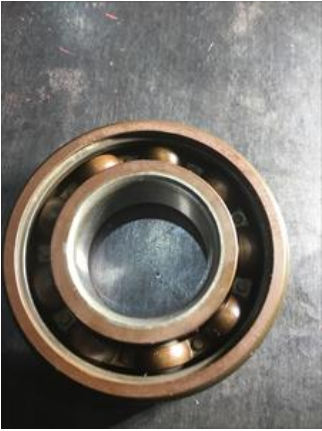
52. Bearing DE Type	open double wide/double row	
53. DE Bearing Qty.	1	
54. Bearing ODE Size	6205	P43
