AC Recondition Repair Report

Arauco-Malvern MDF (10298)
1275 Willamette Rd
Malvern, AR 72104

1. Job Number	99272
2. Report Date	01/21/2022
3. Customer	Arauco

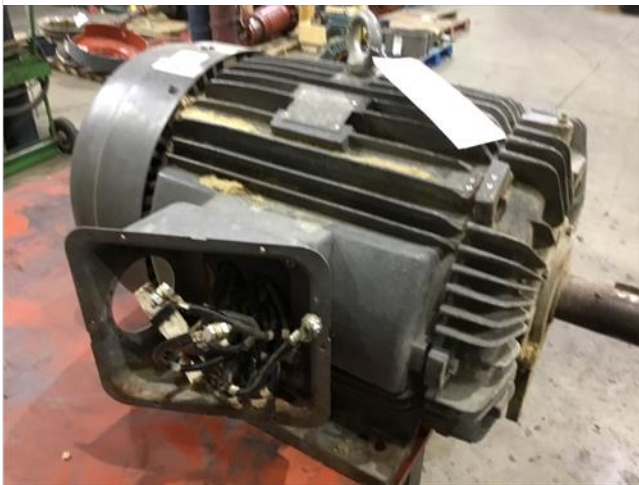
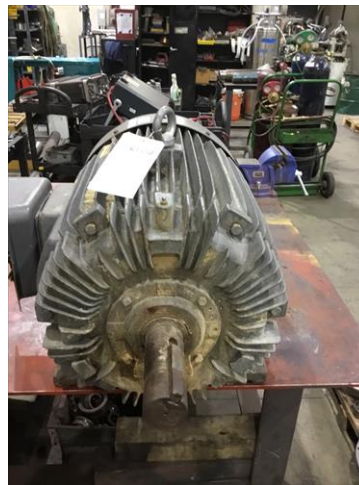
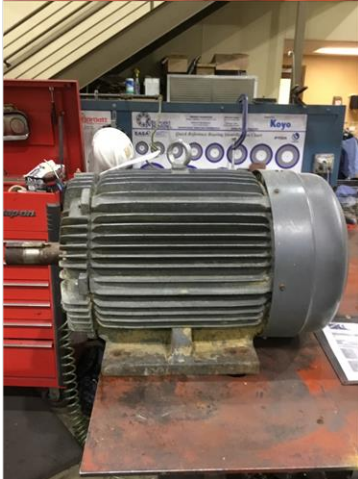
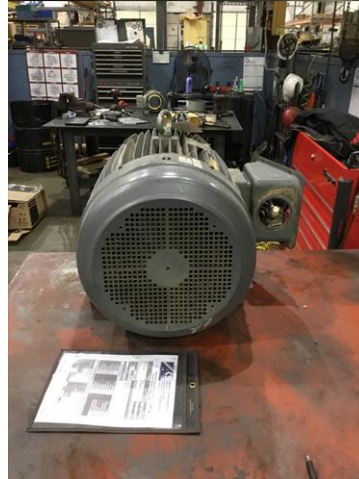
P5

TECO Westinghouse

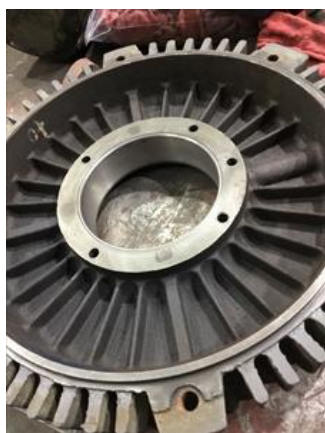
90.	ODE Air Seal Shaft Fit		
91.	ODE Initial Air Seal Shaft Size		
92.	ODE Final Air Seal Shaft Size		
93.	DE Endbell Fit	(F) Fail	
94.	DE Initial Endbell Fit Size 1	5.5142 "

95.	DE Initial Endbell Fit Size 2	5.5143 "	
96.	DE Initial Endbell Fit Size 3	5.5148 "	
97.	DE Final Endbell Fit Size 1	5.5125 "	P138

67.	Cause of Failure <i>Overload</i>	
68.	Comments <i>Rewind, sleeve BOTH end bells, 6313, 6213</i>	
69.	Service Technician	David Maclin

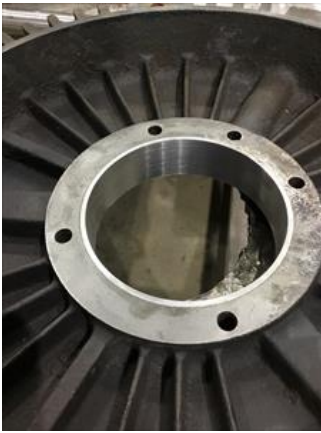
98.	DE Finial Endbell Fit Size 2	5.5125 "	
99.	DE Final Endbell Fit Size 3	5.5125 "	
100.	DE Endbell Fit Insulated		
101.	DE Endbell Air Seal Fit		
102.	Initial Endbell Air Seal Fit Size		
103.	Finial Endbell Air Seal Fit Size		
104.	ODE Endbell Fit	(F) Fail	
105.	ODE Initial Endbell Fit Size 1	4.7265 "	
106.	ODE Initial Endbell Fit Size 2	4.7266 "	
107.	ODE Initial Endbell Fit Size 3	4.7267 "	
108.	ODE Final Endbell Fit Size 1	4.725 "	P149

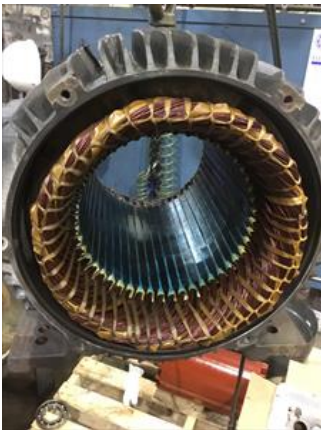
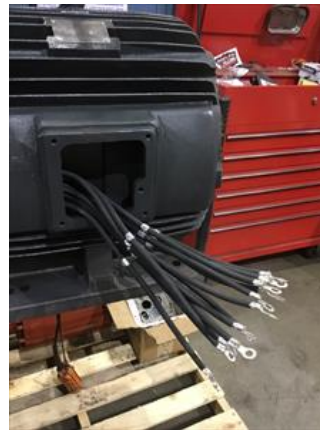
P136

158. Motor Paint
