## AC Recondition Repair Report

Phelps Fan Manufacturing Co.  
10701 Interstate 30  
Little Rock, AR 72209

1. Job Number	99304
2. Report Date	01/27/2022
3. Customer	Phelps Fan Manufacturing Co.

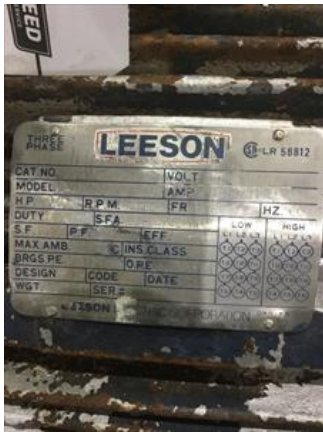
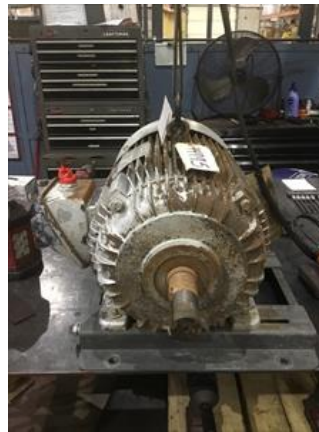
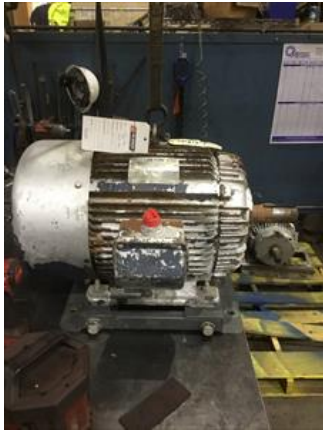
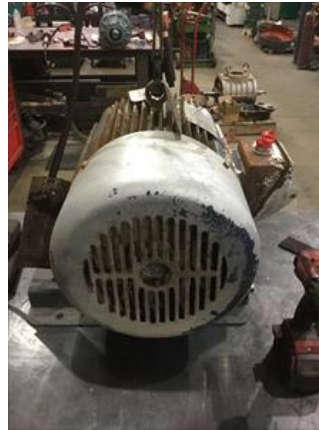
4. Manufacturer	Leeson	P5
-----------------	--------	----

5. Model	N286T17FB2C
6. Serial Number	U64301496
7. Horsepower	30
8. KW	
9. Volts	460
10. Amps	37
11. RPM	1780
12. Frame	286T
13. Enclosure	TEFC
14. Cycles	60
15. Phase	3
16. Service Factor	1.15
17. Motor Mount Position

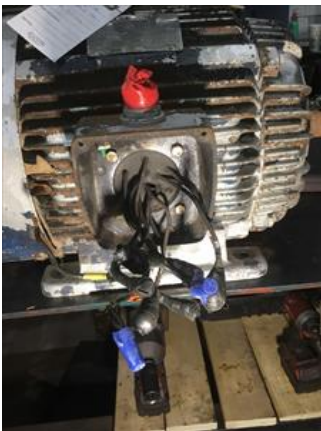
P13

18. Number of Leads

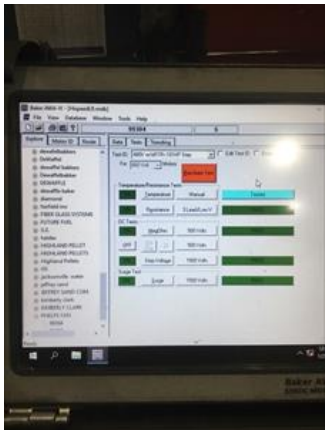
41. Surge Test	(P) Pass	P58

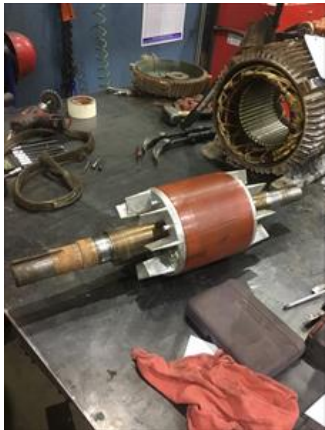
44.	Rotor Type	squirrel cage laminate	P4

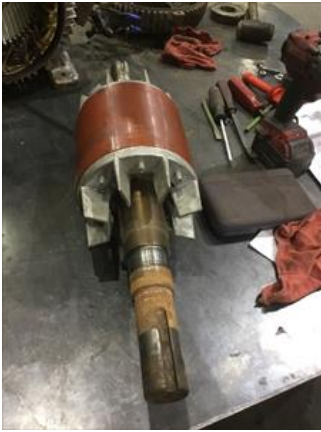
P50

48. Growler Test

49. Rotor Condition

(P) Pass

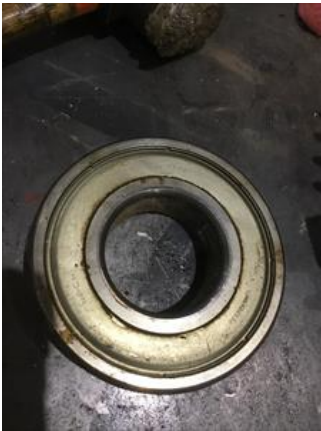
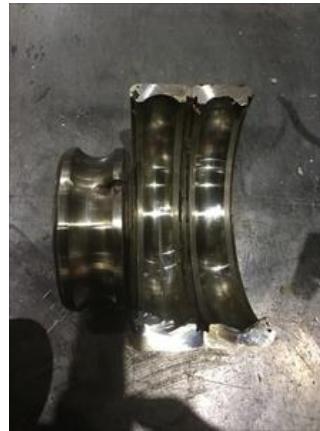
P15

50. Bearing Manufacture

Nachi

51. Bearing DE Size

6311 Z

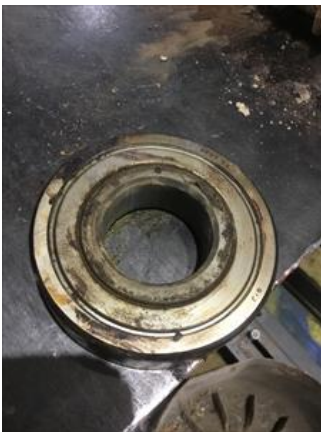
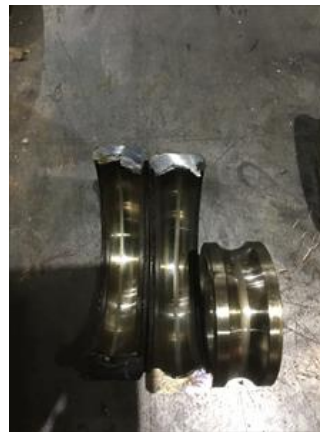
P43

54. Bearing ODE Size

6309 C3

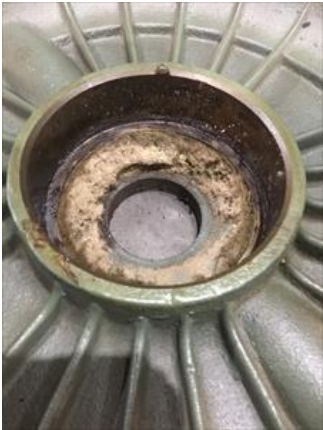
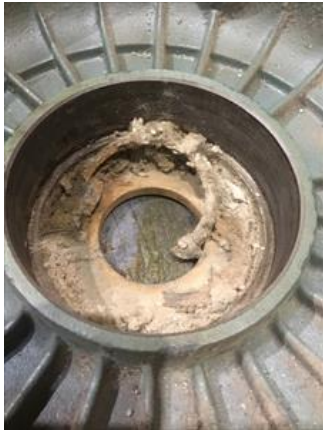
58. Lubrication Type	grease	
59. Grease Condition	(F) Fail	P74

66. Component Failure	bearings worn and bearing grease dirty
67. Cause of Failure	<i>Bearings/O.d.e housing fitbad.</i>
68. Comments	
69. Service Technician	Terrence. Holland
