## AC Recondition Repair Report

**US MOTORS WARRANTY REPAIR**  
8100 W. FLORISSENT  
ST. LOUIS, MO 63136

1. Job Number	99353
2. Report Date	02/07/2022
3. Customer	US Motors Warranty Division
For Lone Star Blower Co.

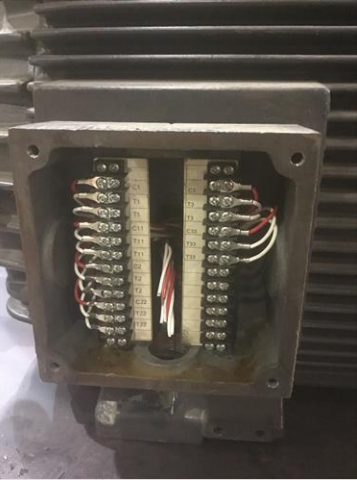
<div> <div></div> <div>24. Winding RTD's</div> </div>

(Y) Yes	P73
<div> <div></div> <div>25. Winding Rtd's Condition</div> </div>	(P) Pass	
<div> <div></div> <div>26. Shaft Run Out</div> </div>	0.001	
<div> <div></div> <div>27. Does Shaft Turn Freely</div> <div> <div></div> <div>Locked up</div> </div> </div>	no	
<div> <div></div> <div>28. Does Shaft Have Visible Damage</div> </div>

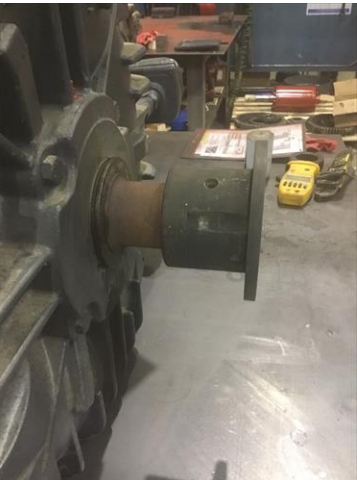
no	P94
<div> <div></div> <div>29. Bearing Rtd's</div> </div>

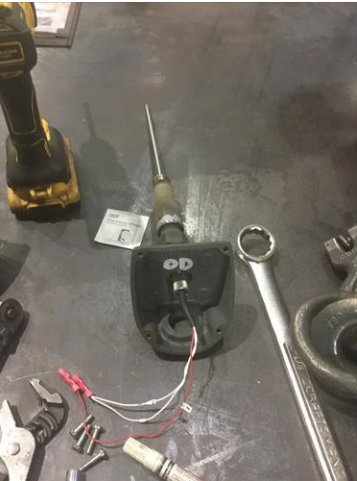
(Y) Yes	P97
<div> <div></div> <div>30. Bearing Rtd's Condition</div> <div> <div></div> <div>108 ohms</div> </div> </div>	(P) Pass	
<div> <div></div> <div>31. Contamination</div> <div>A small amount of melted grease</div> </div>		P104

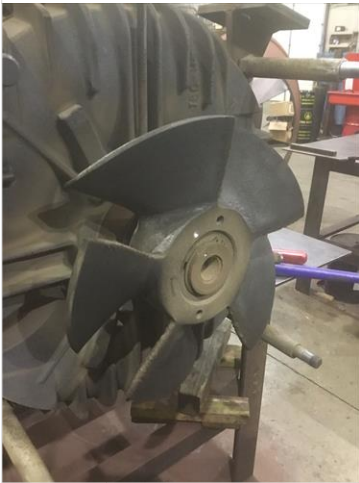
32. Frame Condition

(P) Pass

33. Fan Condition

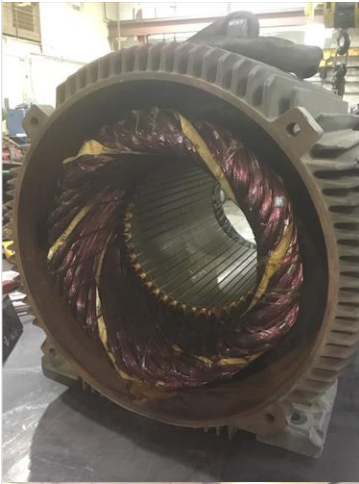
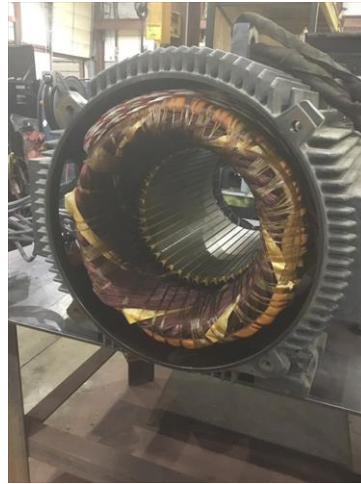
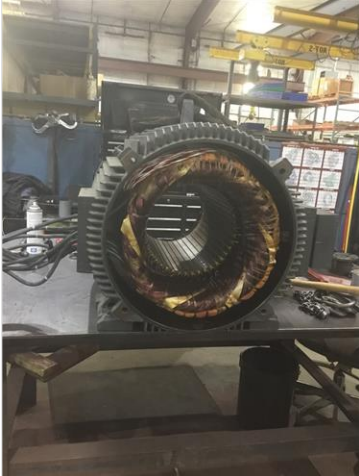
## 42. Stator Condition

recondition

P65

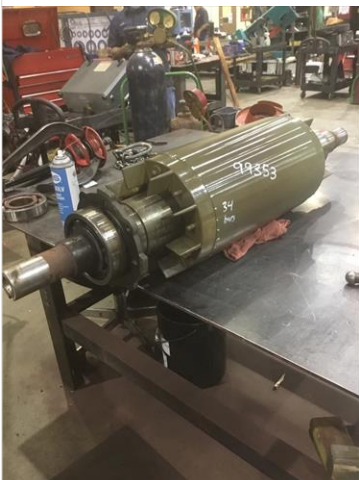
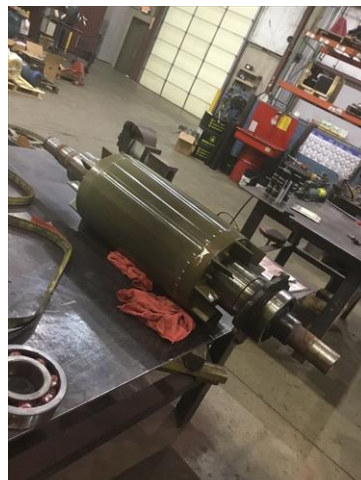
## 48. Growler Test

(P) Pass

P41

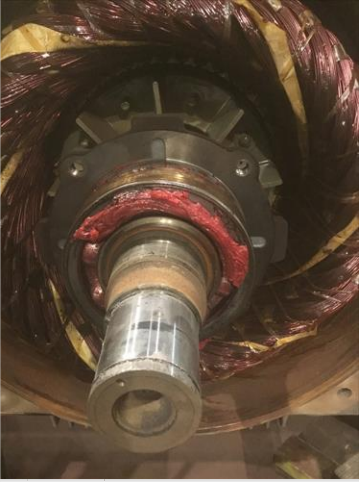
50. Bearing Manufacture	kbc	P1

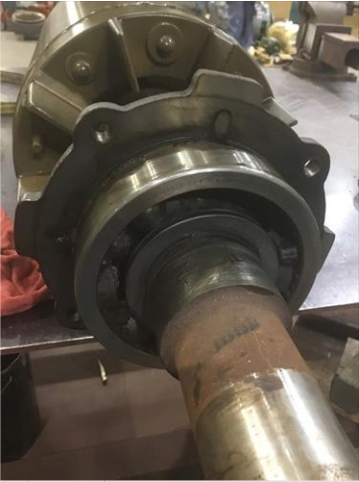
51. Bearing DE Size	6315-b-c3	P15

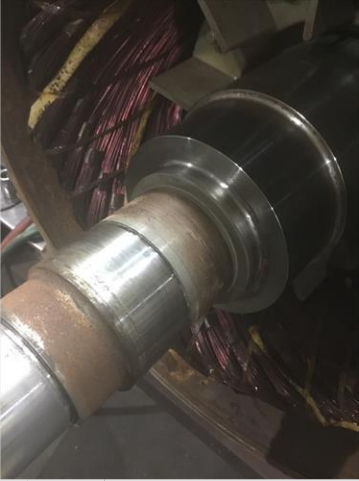
52. Bearing DE Type	ball	
53. DE Bearing Qty.	1	
54. Bearing ODE Size	6315-b-c3	
55. Bearing ODE Type	ball	
56. ODE Bearing Qty.	1	
57. Insulated Bearing	no	P62

<i>Shaft is insulated</i>

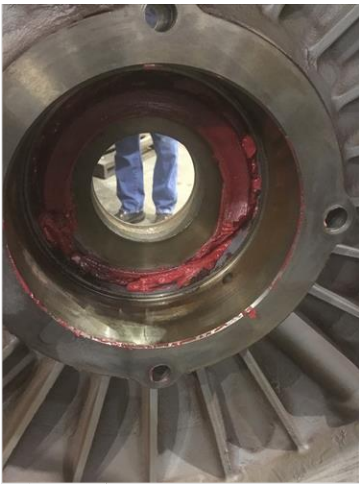
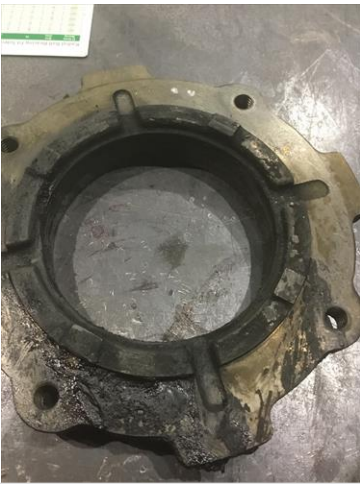
58. Lubrication Type	pink grease

59. Grease Condition	(F) Fail	P74

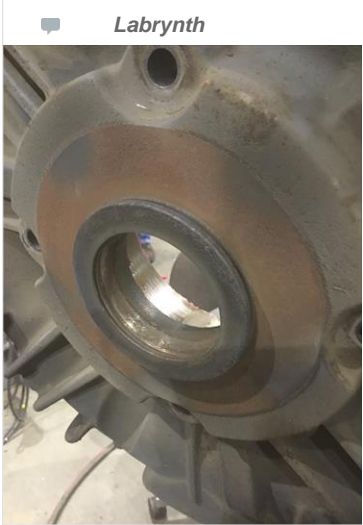
66. Component Failure

drive end shaft, bearings, bearing cap

Drive end bearing crashed likely due to lack of lubrication. When the bearing dropped this damaged the shaft fit and the drive end bearing cap.

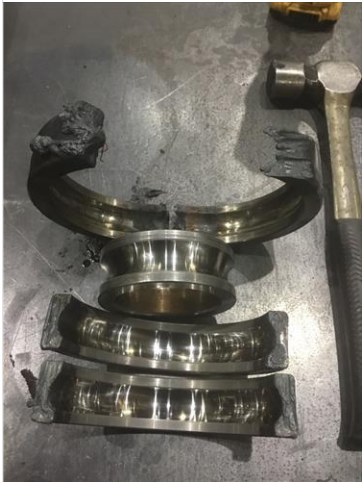
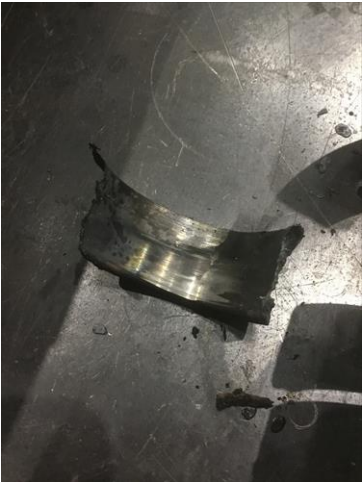
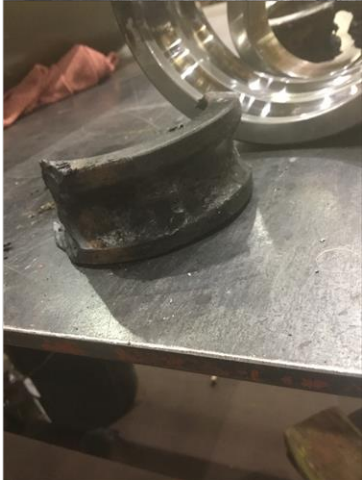
P2

67. Cause of Failure

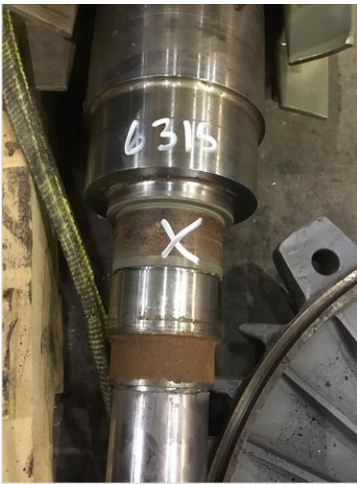
70.	Shaft Run Out	(P) Pass	
71.	Initial Shaft Run Out	0.001 "	
72.	Final Shaft Run Out		
73.	DE Bearing Shaft Fit	(F) Fail	P39

74.	DE Initial Shaft Bearing Fit Size 1	2.9515 "	
75.	DE Initial Shaft Bearing Fit Size 2	2.9515 "	
76.	DE Initial Shaft Bearing Fit Size 3	2.9515 "	
77.	DE Finial Shaft Bearing Fit Size 1	2.9532 "	P71

78.	DE Finial Shaft Bearing Fit Size 2	2.9532 "	
79.	DE Finial Shaft Bearing Fit Size 3	2.9532 "	
80.	ODE Bearing Shaft Fit	(F) Fail	P93
	Undersized

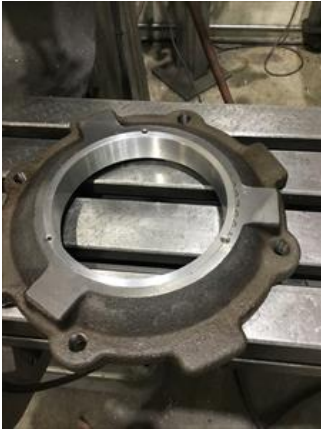
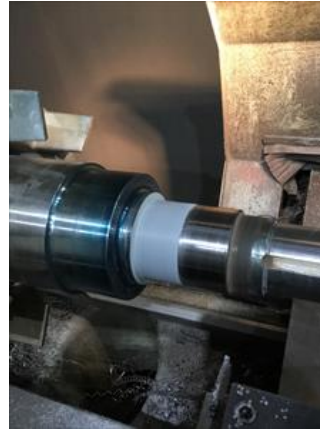
81.	ODE Initial Shaft Bearing Fit Size 1	2.9527 "	
82.	ODE Initial Shaft Bearing Fit Size 2	2.9523 "	
83.	ODE Initial Shaft Bearing Fit Size 3	2.952 "	
84.	ODE Finial Shaft Bearing Fit Size 1	2.9533 "	P107

<i>Sleeved bearing cap.</i>

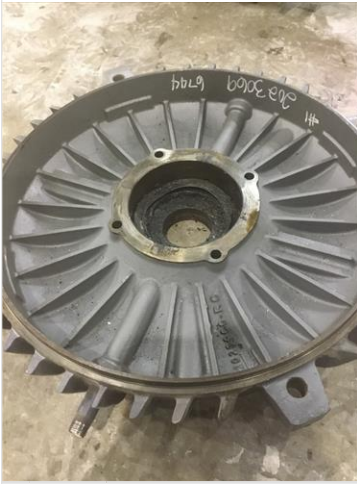
85.	ODE Finial Shaft Bearing Fit Size 2	2.9533 "
86.	ODE Finial Shaft Bearing Fit Size 3	2.9533 "
87.	DE Air Seal Shaft Fit	
88.	DE Initial Air Seal Shaft Size	
89.	DE Final Air Seal Shaft Size	
90.	ODE Air Seal Shaft Fit	
91.	ODE Initial Air Seal Shaft Size	
92.	ODE Final Air Seal Shaft Size
