AC Recondition Repair Report

Peco Foods

1. Job Number	99373
2. Report Date	02/10/2022
3. Customer	PECO Foods Batesville

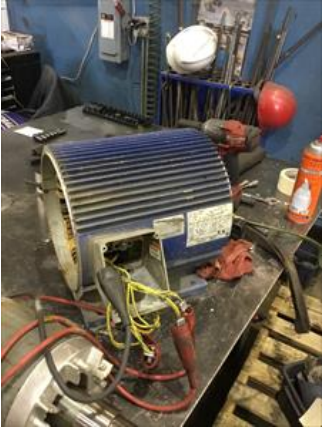
18.	Number of Leads	12	
19.	Lead Length	8 Inches	
20.	Lead Size		
● 21.	Lead Condition	(P) Pass	
22.	Lead Markings	1-12	
23.	Lug Size, Condition, and Type		
24.	Winding RTD's		
25.	Winding Rtd's Condition		
26.	Shaft Run Out		
27.	Does Shaft Turn Freely	no	
28.	Does Shaft Have Visible Damage		
29.	Bearing Rtd's		
30.	Bearing Rtd's Condition		
31.	Contamination <i>Water</i>		
32.	Frame Condition		P106

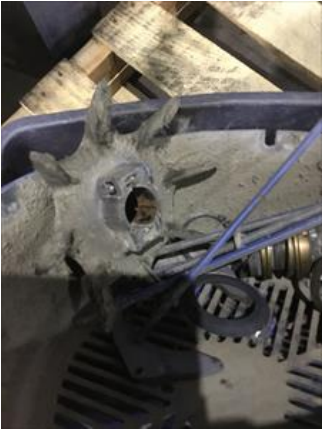
● 33.	Fan Condition	(P) Pass	P109

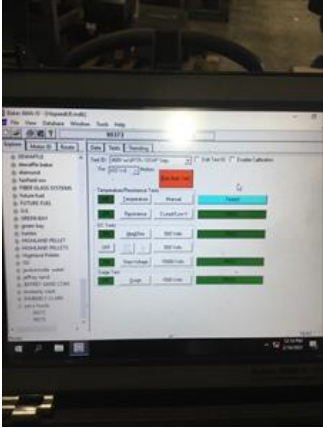
36.	Winding Resistance 1-2		
37.	Winding Resistance 2-3		
38.	Winding Resistance 1-3		
39.	Resistive Imbalance		
40.	Hi-Pot		
41.	Surge Test	(P) Pass	P58

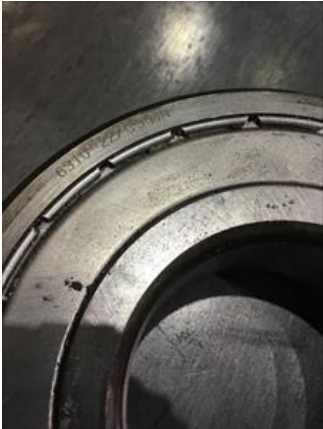
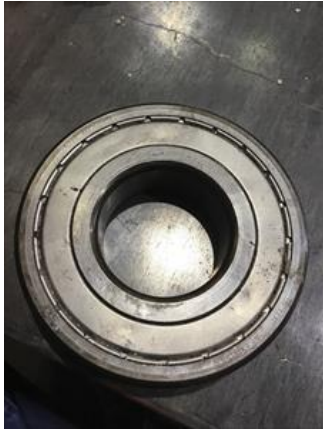
42.	Stator Condition	good	
43.	Failure Location	pump impeller	
Initial Rotor Inspection			
44.	Rotor Type	squirrel cage laminate	
45.	Air Gap <10% Variation		
46.	Number of Rotor Bars	0	
47.	Number of Broken Rotor Bars	0	
48.	Growler Test	(P) Pass	
49.	Rotor Condition	(P) Pass	
Mechanical Inspection			
50.	Bearing Manufacture	skf	
51.	Bearing DE Size	6310	P15

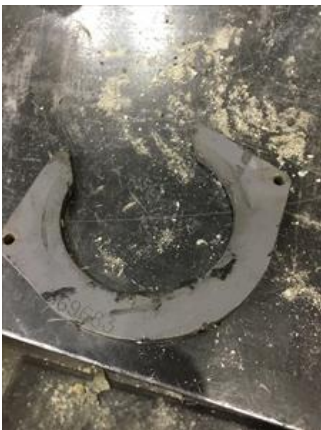
● 59. Grease Condition **(F) Fail**

■ *Water contaminated*

● 60. Bearing Retainers **(Y) Yes**

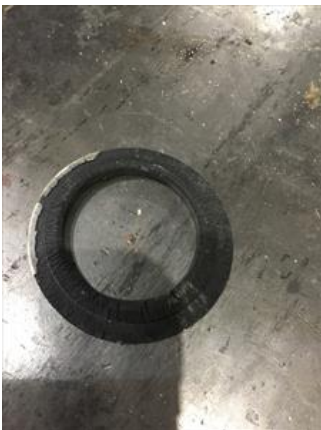
● 62. DE Seal **(Y) Yes**

63. DE Seal Type/Size **dust seal worn**

64.	ODE Seal	
65.	ODE Seal Type/Size	
Root Cause of Failure		
66.	Component Failure	seal/impeller
67.	Cause of Failure <i>Worn</i>	
68.	Comments	
69.	Service Technician	Terrence. Holland
