**Arauco-Malvern MDF (10298)**  
1275 Willamette Rd  
Malvern, AR 72104

1.	Job Number	99399
2.	Report Date	02/16/2022
3.	Customer	Arauco

5. Model	1LA03244FP21
6. Serial Number	K06T0138EU 11
7. Horsepower	40
8. KW	
9. Volts	460
10. Amps	47.1
11. RPM	1770
12. Frame	324T
13. Enclosure	TEFC
14. Cycles	60
15. Phase	3
16. Service Factor	1.15
17. Motor Mount Position

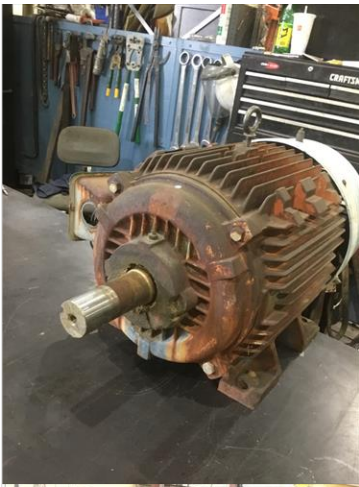
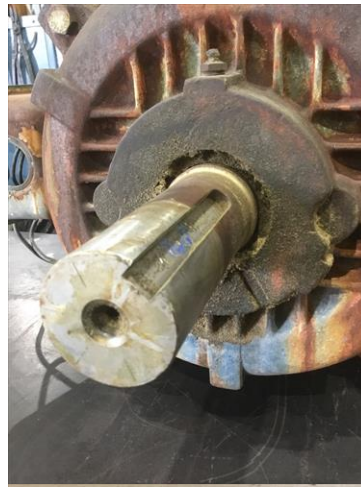
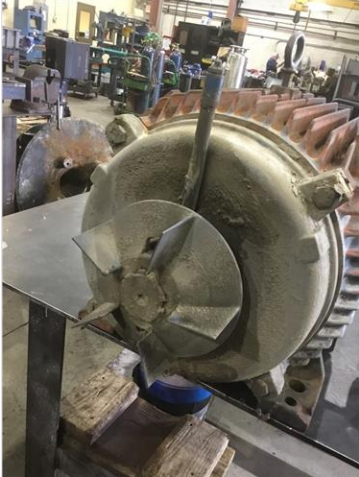
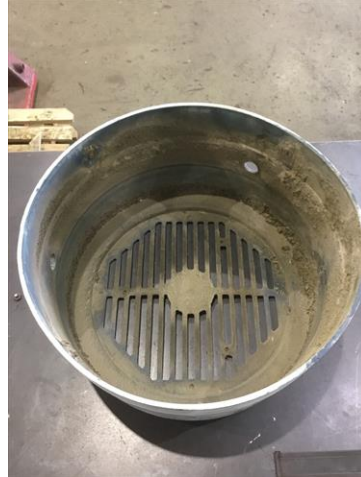
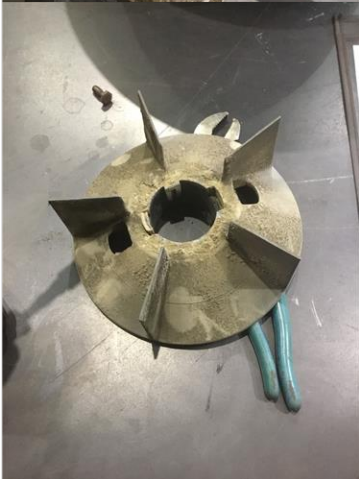
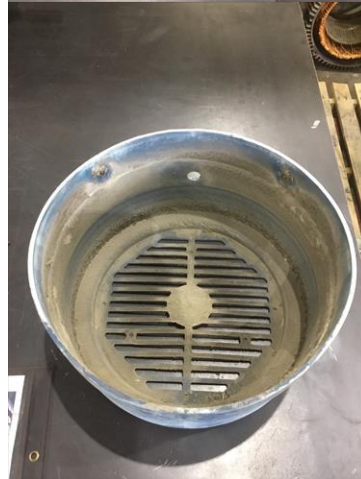
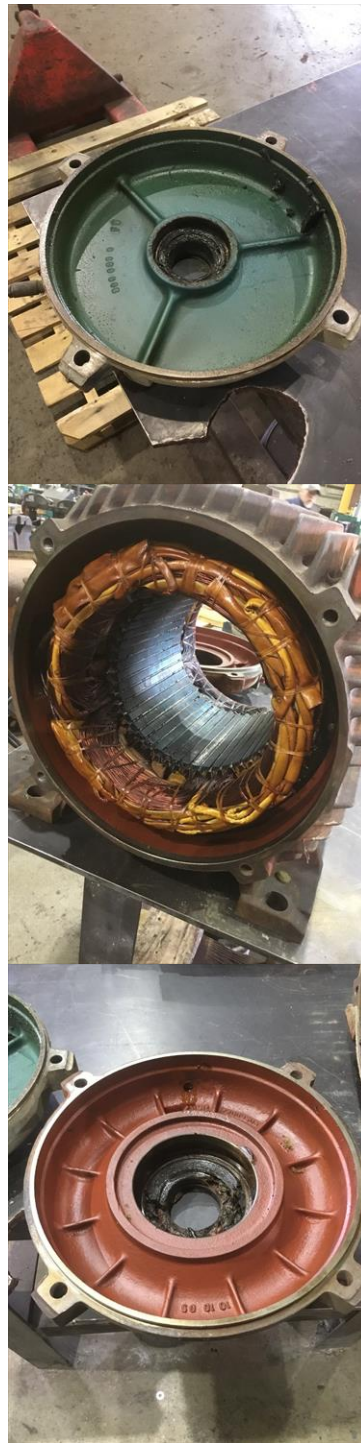
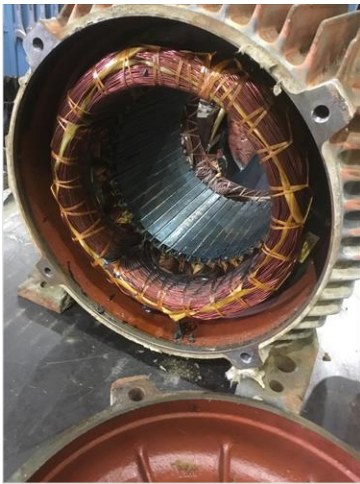
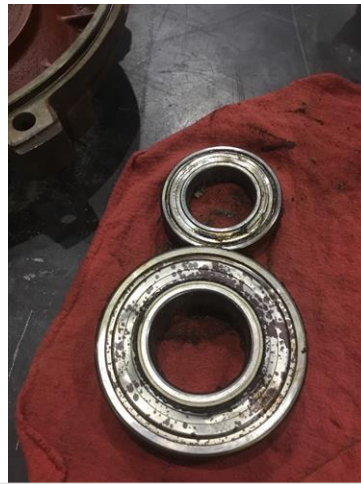
33.	Fan Condition	(P) Pass	
34.	Broken or missing components <i>Broke fan cover bolt in ode</i>		
<b>Initial Electric Test</b>

59. Grease Condition	(F) Fail

<i>Mixed</i>	
60.	Bearing Retainers	(NA) Not Applicable
61.	Shaft Grounding Device	
62.	DE Seal	(NA) Not Applicable

63.	DE Seal Type/Size	
64.	ODE Seal	(NA) Not Applicable
65.	ODE Seal Type/Size	
<b>Root Cause of Failure</b>		
66.	Component Failure	bearings and both end bells are over sized

67.	Cause of Failure	<i>Wear and mixing grease</i>
68.	Comments	<i>Recommend new bearings and reconditioning</i>
69.	Service Technician	
<b>Machine Fit Inspection Report</b>

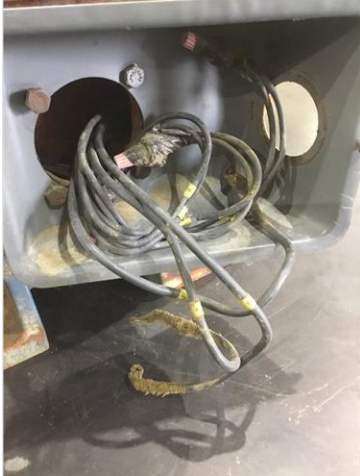
18. Number of Leads	9	P13
---------------------	---	-----

19. Lead Length	14 Inches
20. Lead Size	
21. Lead Condition	(P) Pass
22. Lead Markings	
23. Lug Size, Condition, and Type	
24. Winding RTD's	
25. Winding Rtd's Condition	
26. Shaft Run Out

27.	Does Shaft Turn Freely	yes	
28.	Does Shaft Have Visible Damage	no	
29.	Bearing Rtd's		
30.	Bearing Rtd's Condition		
31.	Contamination <i>Grease</i>		
32.	Frame Condition	(P) Pass

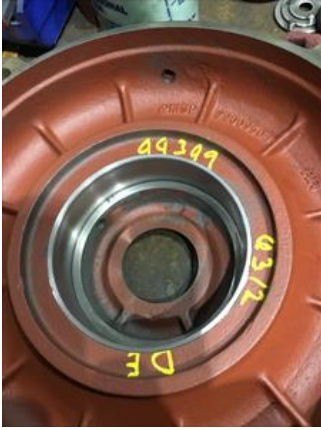
92.	ODE Final Air Seal Shaft Size	
 	93. DE Endbell Fit	(F) Fail
94.	DE Initial Endbell Fit Size 1	5.1194 "
95.	DE Initial Endbell Fit Size 2	5.1198 "
96.	DE Initial Endbell Fit Size 3	5.1189 "

97.	DE Final Endbell Fit Size 1	5.1186 "
98.	DE Finial Endbell Fit Size 2	5.1186 "

100. DE Endbell Fit Insulated	(NA) Not Applicable
-------------------------------	---------------------

● 104. ODE Endbell Fit	(F) Fail
------------------------	----------

105. ODE Initial Endbell Fit Size 1	3.5454 "
-------------------------------------	----------

106. ODE Initial Endbell Fit Size 2	3.5452 "
-------------------------------------	----------

107. ODE Initial Endbell Fit Size 3	3.5449 "
-------------------------------------	----------

108. ODE Final Endbell Fit Size 1	3.5434 "
-----------------------------------	----------

109. ODE Final Endbell Fit Size 2	3.5434 "
-----------------------------------	----------

110. ODE Final Endbell Fit Size 3	3.5434 "
-----------------------------------	----------
