## AC Recondition Repair Report

ARKANSAS INDUSTRIAL  
MACHINERY  
3804 N. NONA ST  
NORTH LITTLE ROCK, AR 72118

1. Job Number	99561
2. Report Date	03/25/2022
3. Customer	Arkansas Industrial Machinery

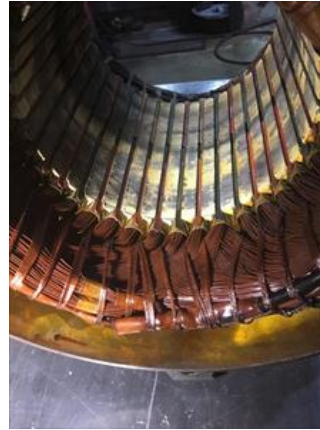
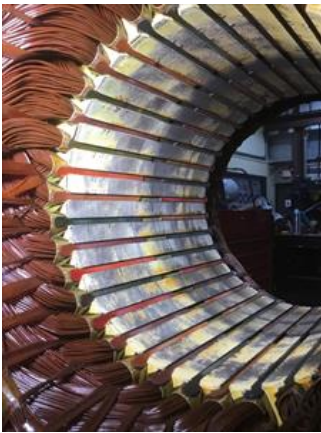
P58

**NOTE:** Stator windings have what appear to be "popsicle sticks" in place of top sticks. However the Stator windings did test good. See photos below.

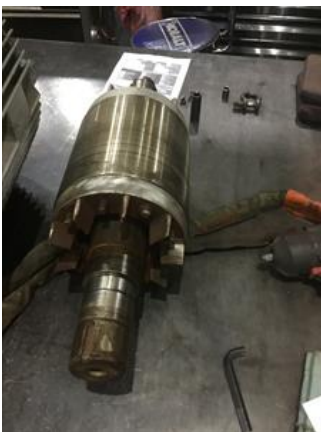
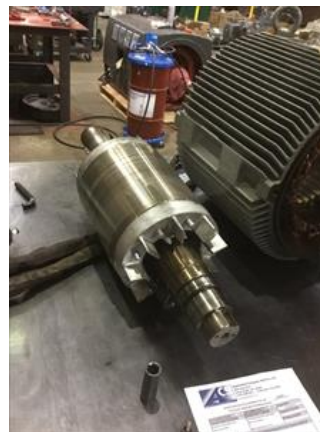
P4

44. Rotor Type

squirrel cage laminate

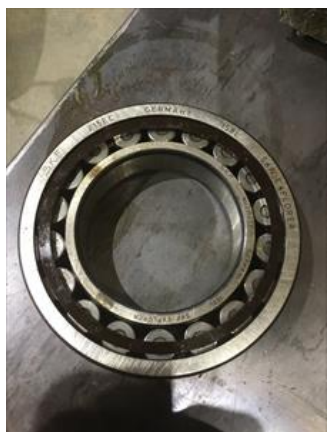
P1

50. Bearing Manufacture

skf

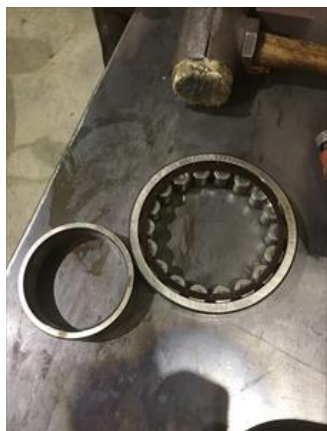
P23

51. Bearing DE Size

215ec

52. Bearing DE Type

NU

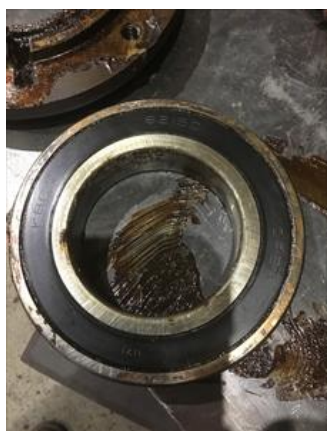
P43

54. Bearing ODE Size

6215D

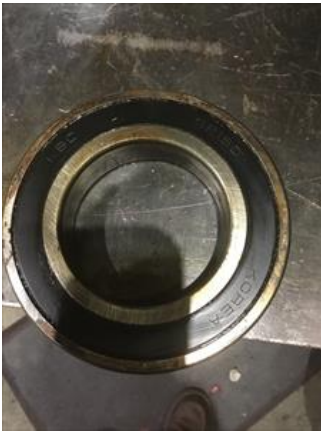
P53

55. Bearing ODE Type

sealed

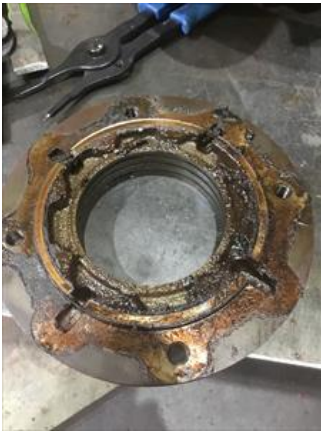
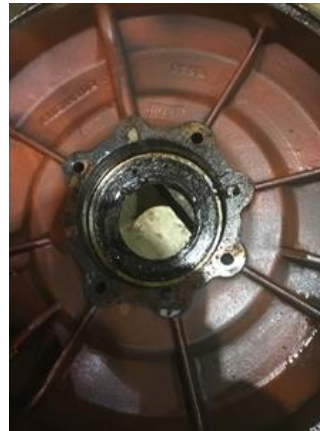
P74

59. Grease Condition

(F) Fail

Dirty

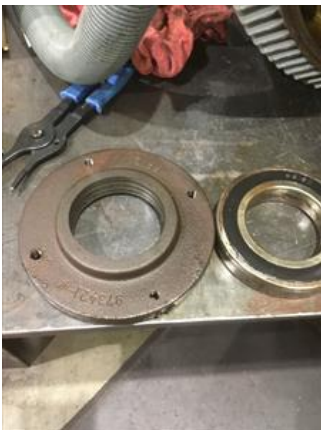
P80

60. Bearing Retainers

(Y) Yes

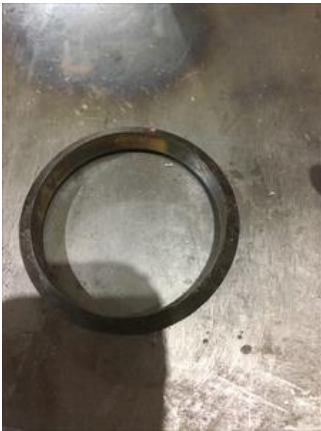
P102

65. ODE Seal Type/Size

Lip seal
