Submersible Pump Repair Report

Sage V Foods
5901 SLOAN DRIVE
LITTLE ROCK, AR 72206

1. Job Number	99564
2. Report Date	03/25/2022
3. Customer	Sage V Foods

4. Manufacturer	Pentair	P1
Hydromatic

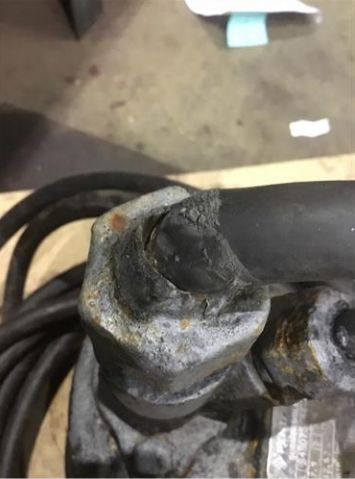
25.	Power Cord Condition	(F) Fail
		P39

**rewind, replace broken shaft,
and both cords.**

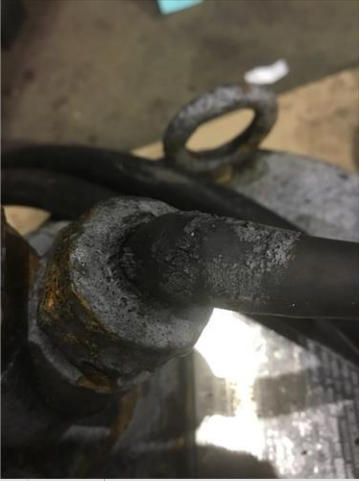
27. Sensor Cord # of Conductors	4	
28. Sensor Cord Length	42 ft	
● 29. Sensor Cord Condition	(F) Fail	P70

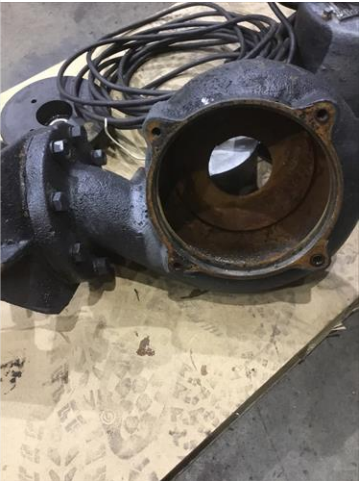
30. Sensor Cord for Thermal Protection?		
31. Sensor Cord for Water Protection		
● 32. Bowl Condition	(P) Pass	P90

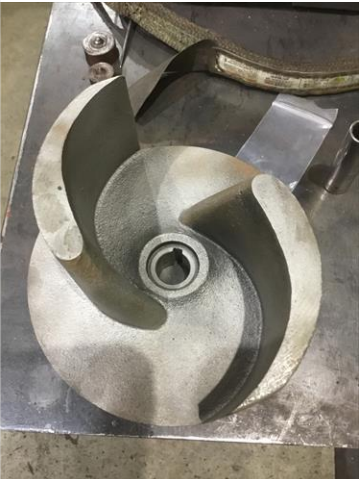
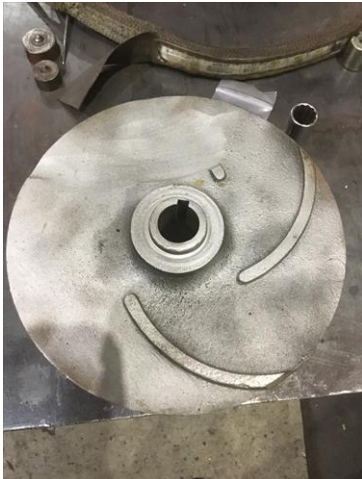
● 33. Impeller Condition	(P) Pass	P95

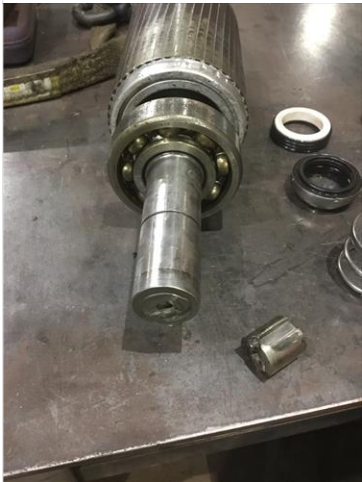
56.	Lead Markings		
57.	Lead Size for Oil Filled Stator		
58.	Lug Size, Condition, and Type		
59.	Overload Required?		
60.	Winding RTD's		
61.	Winding Rtd's Condition		
62.	Shaft Run Out		
63.	Does Shaft Turn Freely	no	
64.	Does Shaft Have Visible Damage	yes: broken.	P115

Impeller mount bolt sheared off

*Replace broken shaft*

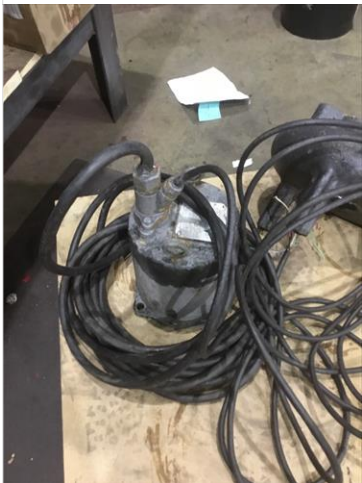
65.	Bearing Rtd's		
66.	Bearing Rtd's Condition		
67.	Contamination <i>Water</i>		
68.	Frame Condition	(P) Pass	P136

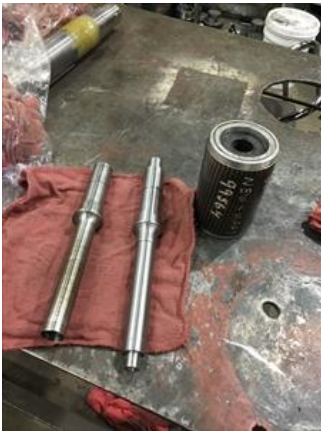
69.	Fan Condition	(NA) Not Applicable	
70.	Broken or missing components <i>D.E shaft broken. Impeller mount bolt broken Machined new shaft.</i>		P144

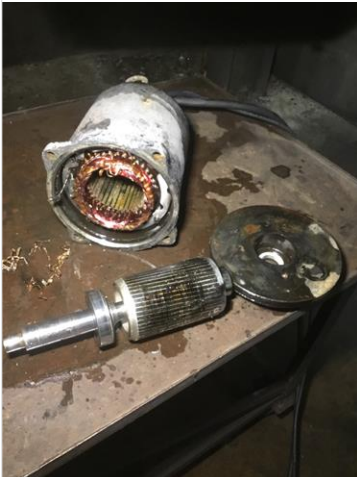
71.	Resistance to Ground		
72.	Winding Resistance 1-2		
73.	Winding Resistance 2-3		
74.	Winding Resistance 1-3		
75.	Resistive Imbalance		
76.	Hi-Pot		
77.	Surge Test	(NA) Not Applicable	
78.	Stator Condition	rewind	
79.	Failure Location	windings	P75

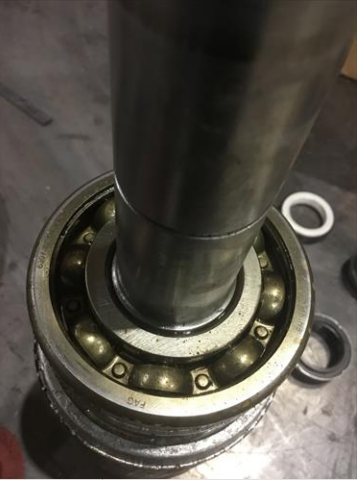
86.	Bearing Manufacturer	fag	
87.	Bearing DE Size	6307

88. Bearing DE Type	open ball bearing	P22

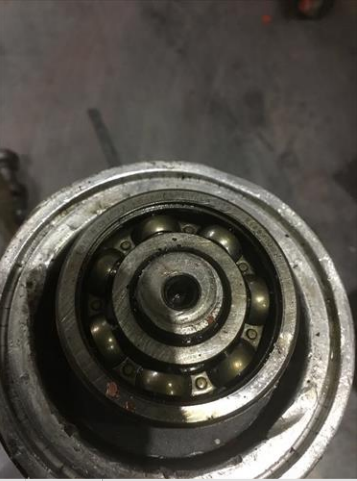
89. DE Bearing Qty.	1	
90. Bearing ODE Size	6303	P48

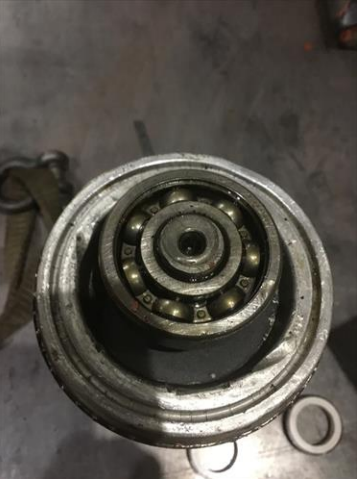
91. Bearing ODE Type	open ball bearing	P55

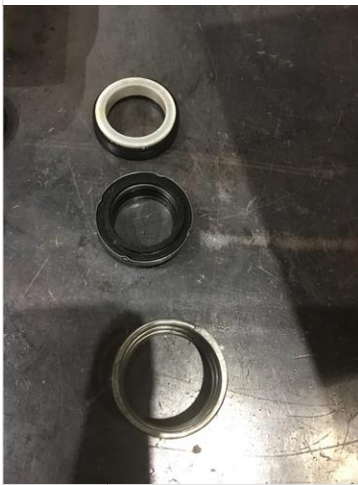
92. ODE Bearing Qty.	1	
93. Insulated Bearing	no	
94. Lubrication Type	oil	
<input checked="" type="radio"/> 95. Grease Condition	(NA) Not Applicable	
96. Bearing Retainers	(NA) Not Applicable	
97. Shaft Grounding Device	(NA) Not Applicable	
<input checked="" type="radio"/> 98. DE Seal	(Y) Yes	P98
