## AC Recondition Repair Report

Green Bay Packaging, Pinecrest  
(11362)  
P.O. Box 37  
Plummerville, AR 72127

1. Job Number	99577
2. Report Date	03/30/2022
3. Customer	Green Bay Packaging

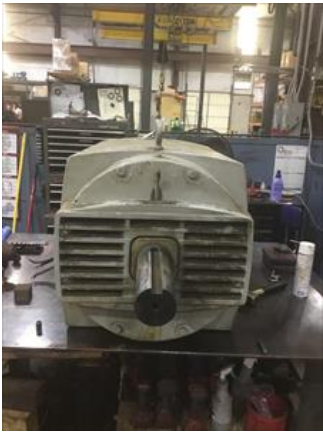
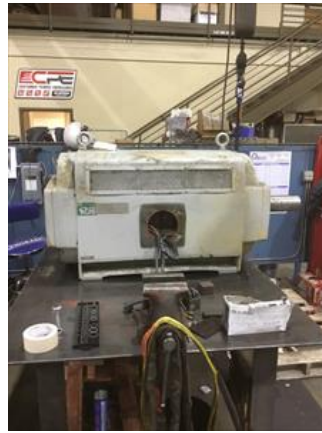
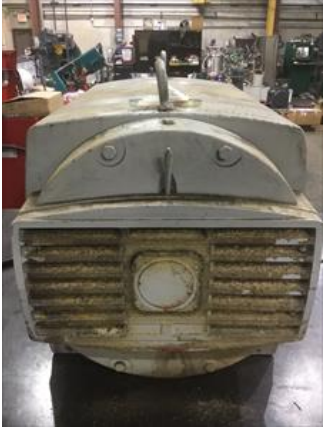
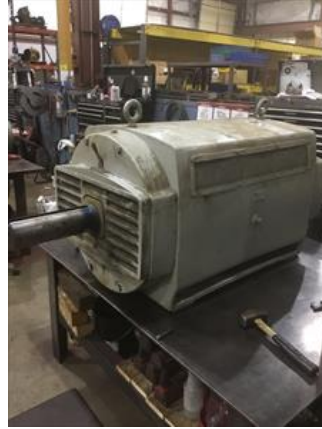
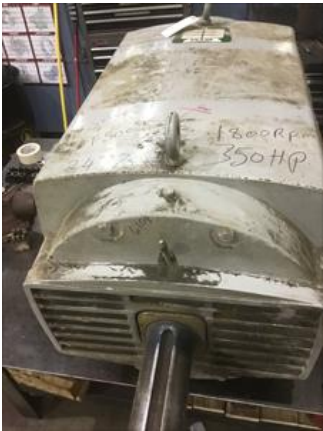
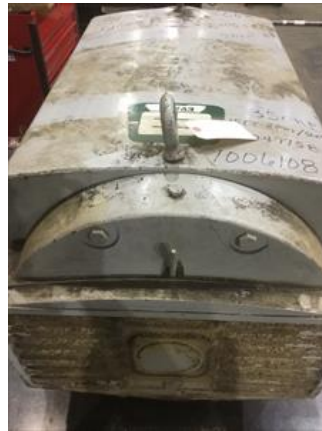
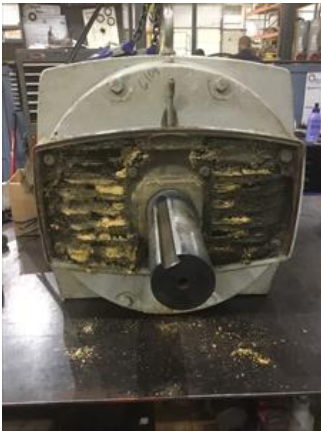
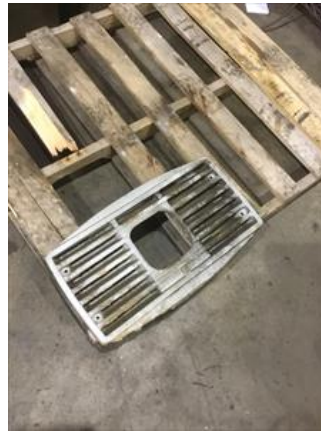
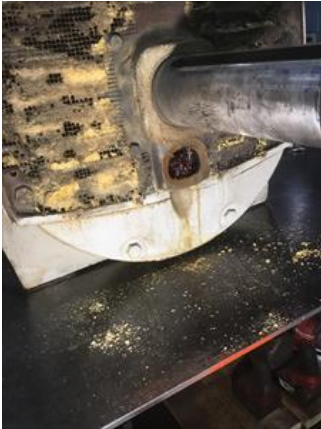
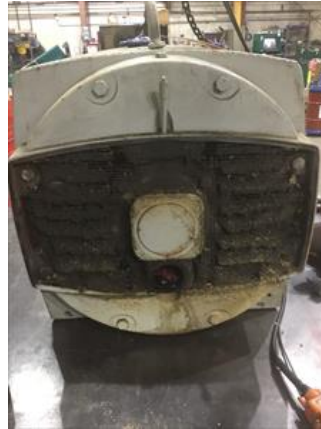
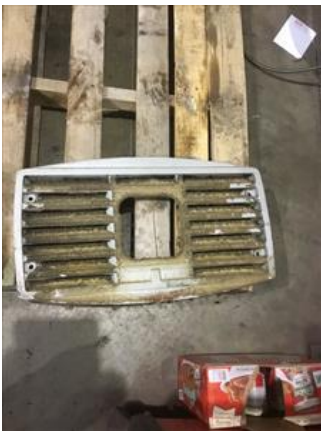
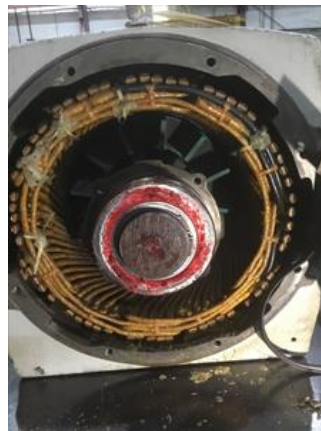
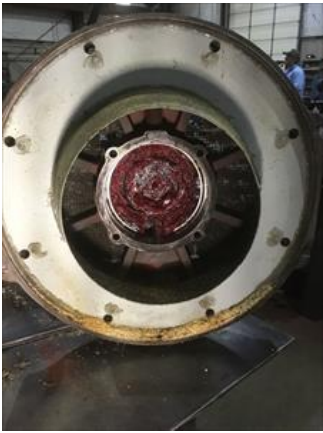
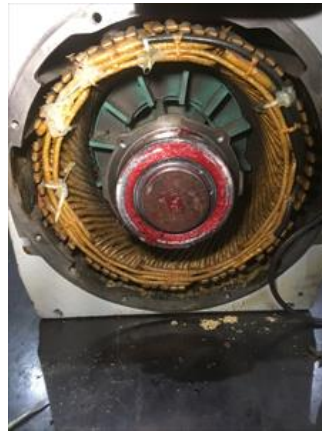
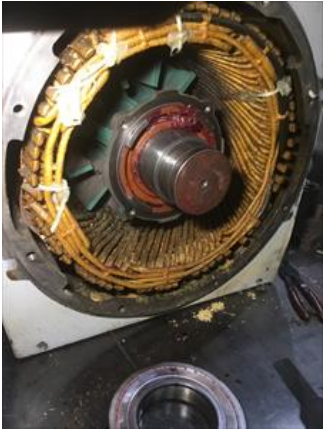
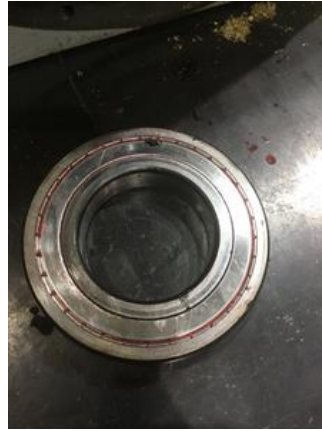
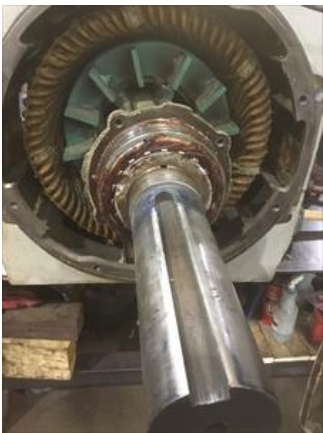
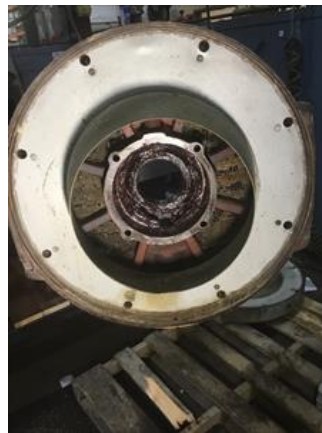
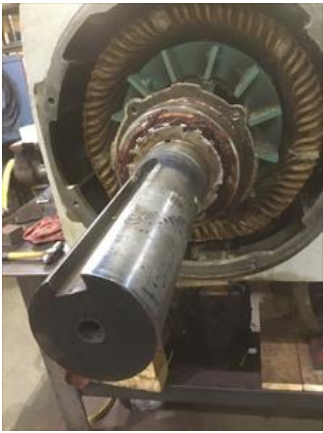
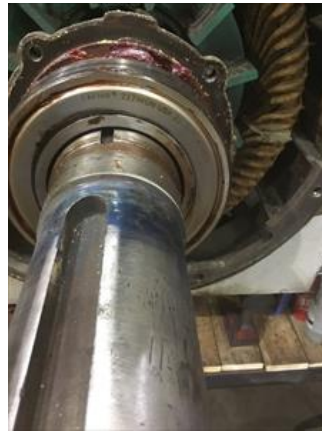
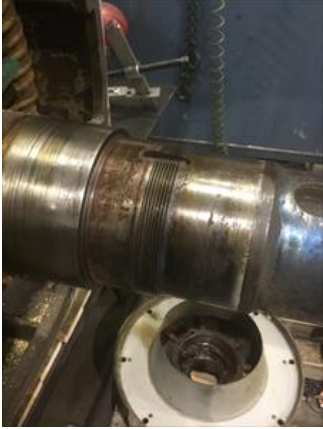
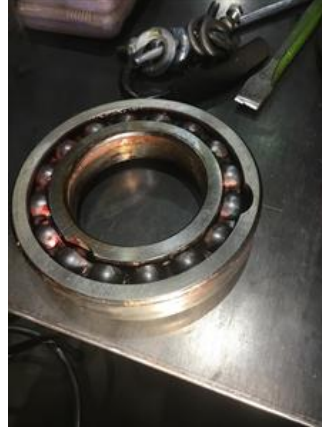
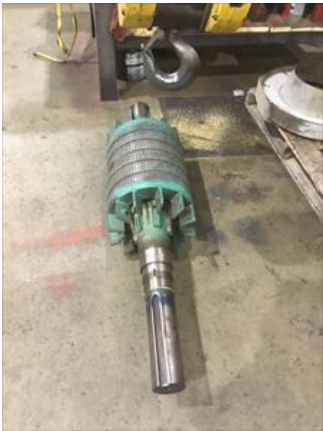
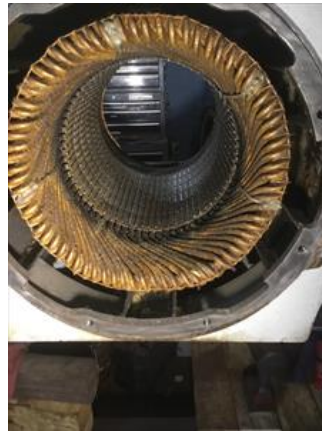
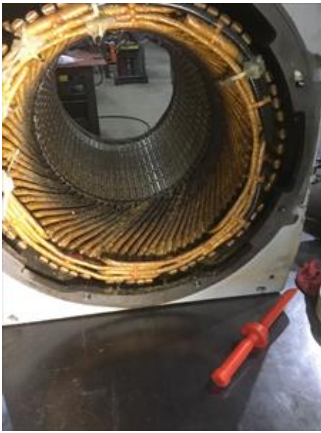
4. Manufacturer	US Motors	P5
-----------------	-----------	----

5. Model	53-00851	
6. Serial Number		
7. Horsepower	350	
8. KW		
9. Volts	4160	
10. Amps	45	
11. RPM	1800	
12. Frame	5009	
13. Enclosure	ODP	
14. Cycles	60	
15. Phase	3	
16. Service Factor	1.15	
17. Motor Mount Position		
<b>Initial Inspection</b>

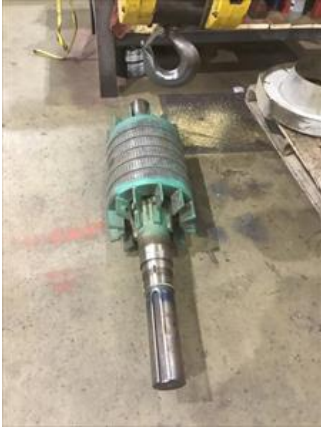
45. Air Gap &lt;10% Variation

46. Number of Rotor Bars

47. Number of Broken Rotor Bars

● 49. Rotor Condition

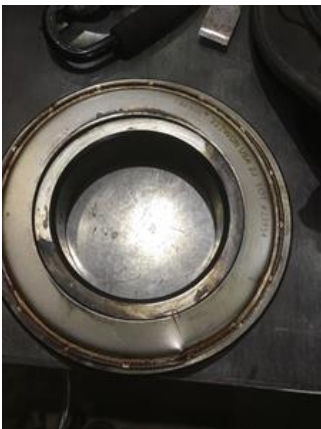
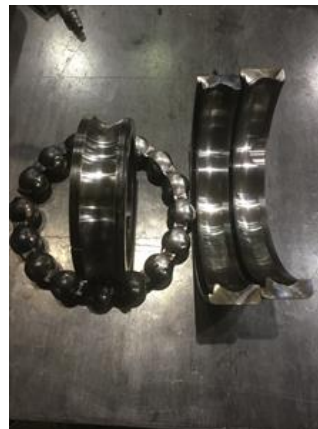
51. Bearing DE Size

🗨 *Notch in bearing goes toward the shaft shoulder.*

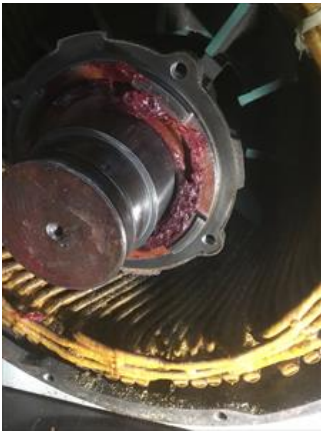
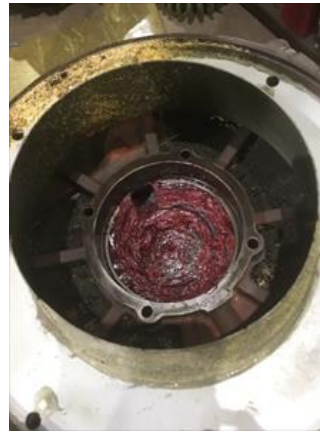
59. Grease Condition

60.	Bearing Retainers	(Y) Yes
61.	Shaft Grounding Device	(NA) Not Applicable
62.	DE Seal	
63.	DE Seal Type/Size	
64.	ODE Seal	
65.	ODE Seal Type/Size	
<b>Root Cause of Failure</b>		
66.	Component Failure	bearings
67.	Cause of Failure <i>Contaminated grease/ dirty</i>	
68.	Comments	
69.	Service Technician	Terrence. Holland
