AC Recondition Repair Report

Almatis Inc/RCP Bauxite (10014)
4701 Alcoa Road
Bauxite, AR 72011

1. Job Number	99578
2. Report Date	03/30/2022
3. Customer	Almatis

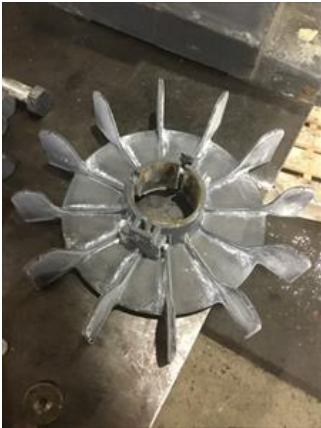
P109

● 32. Frame Condition **(P) Pass**

● 33. Fan Condition **(P) Pass**

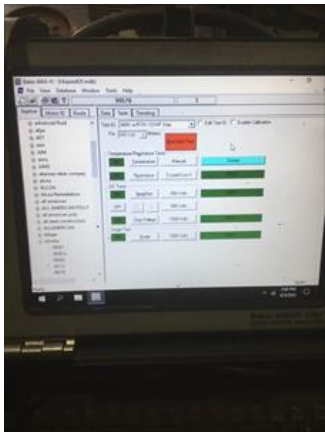
P58

41. Surge Test

(P) Pass

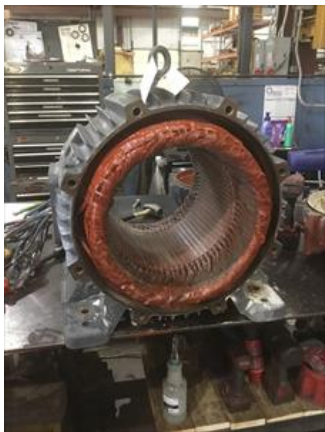
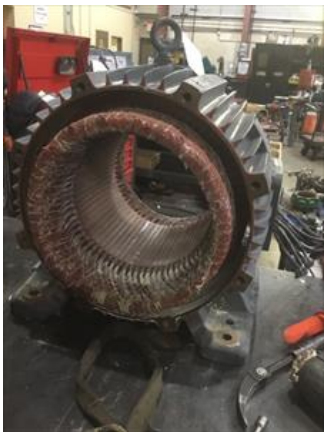
P65

42. Stator Condition

43. Failure Location

bearings

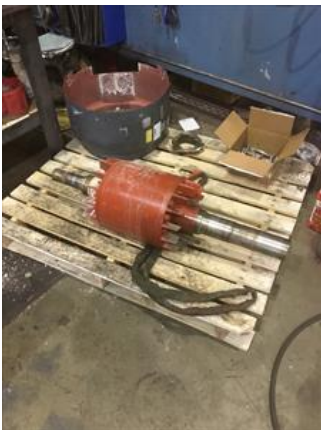
P50

● 49. Rotor Condition

(P) Pass

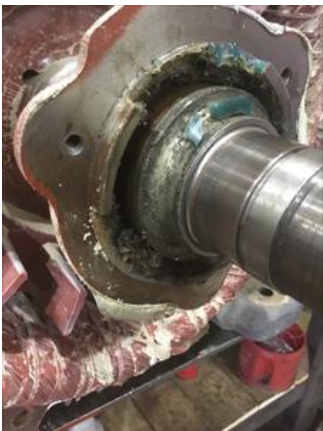
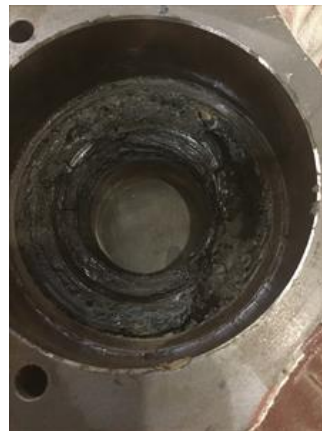
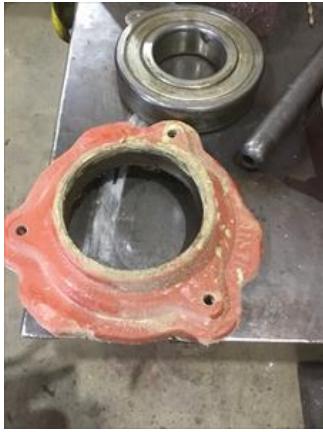
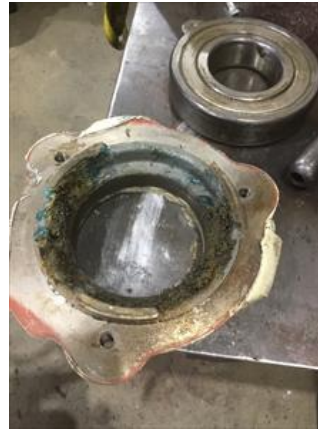
P74

● 59. Grease Condition

(F) Fail

bearings

Contaminated grease
