AC Recondition Repair Report

FUTURE FUEL CHEMICAL
2800 GAP RD HWY 394 SO
BATESVILLE, AR 72501

1. Job Number	99847
2. Report Date	
3. Customer	Future Fuel

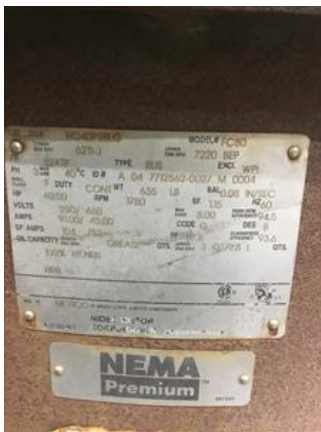
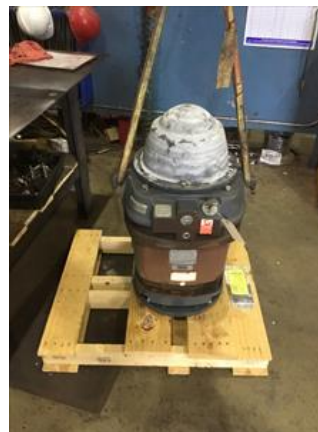
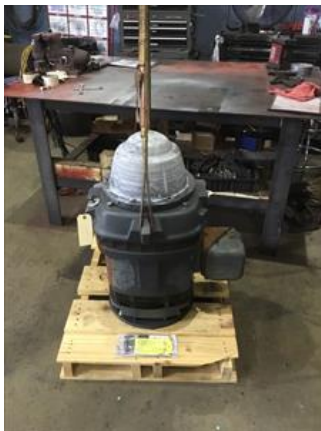
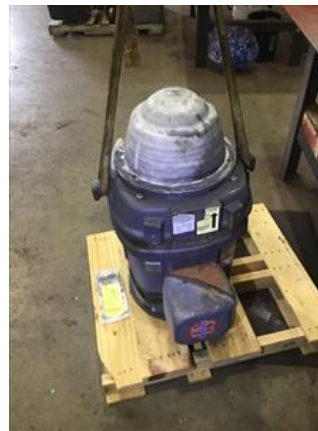
4. Manufacturer	U.S. Motors	P5
-----------------	-------------	----

5. Model	FC80
6. Serial Number	HO40P2BLG
7. Horsepower	40 HP
8. KW	
9. Volts	460 Volts
10. Amps	45 Amps
11. RPM	1780 RPM
12. Frame	324TP
13. Enclosure	WPI
14. Cycles	60 HZ
15. Phase	3 PH
16. Service Factor	1.15
17. Motor Mount Position

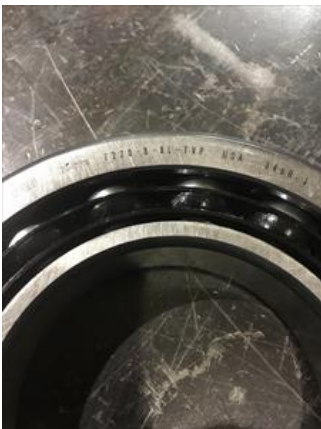
P23

50. Bearing Manufacture Fag

51. Bearing DE Size 6211 Z

52. Bearing DE Type 7220

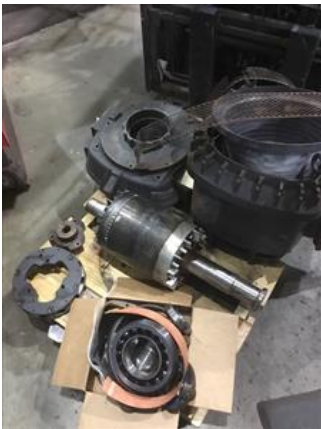
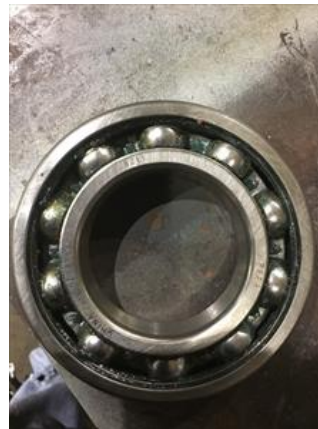
P74

59. Grease Condition
