Hi-Speed Industrial Service  
7030 Ryburn Dr  
Millington, Tn 38053  
901-873-5300

## AC Recondition Repair Report

Phelps Fan Manufacturing Co.  
10701 Interstate 30  
Little Rock, AR 72209

1. Job Number	97868
2. Report Date	
3. Customer	Phelps Fan

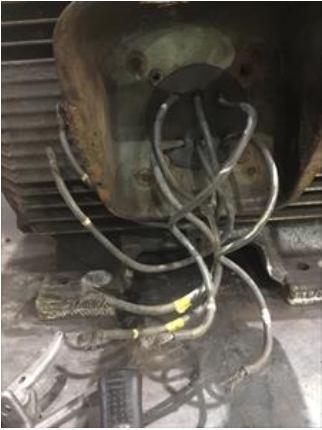
18.	Number of Leads	6	P13

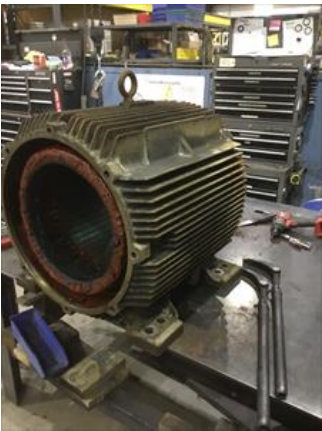
32. Frame Condition	(P) Pass	P106

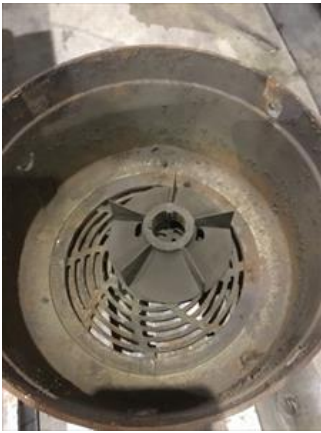
33. Fan Condition	(P) Pass	P109

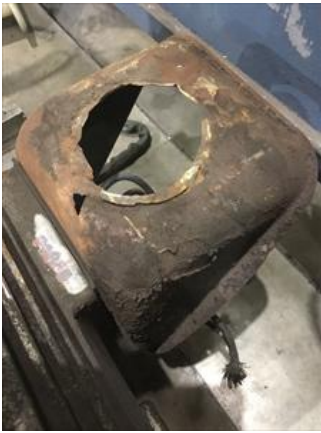
P113

34. Broken or missing components  
*Connection box rusted with holes on the surface.*

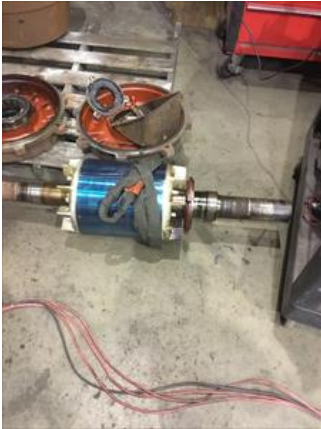
P4

44. Rotor Type

squirrel cage

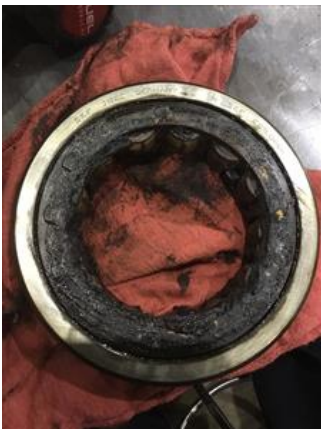
P1

50. Bearing Manufacture

Skf

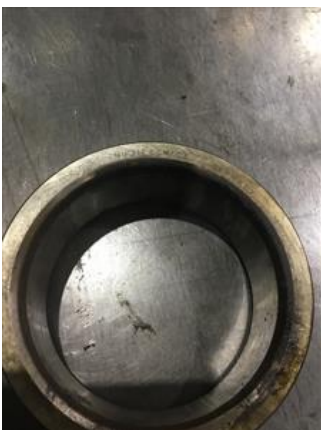
P15

51. Bearing DE Size

NU 318 ECM/C3

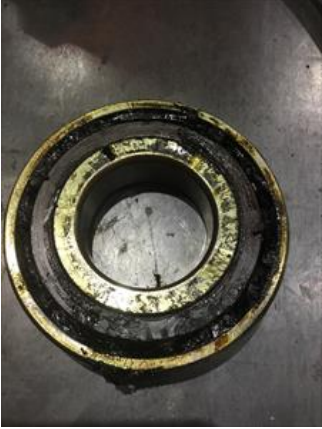
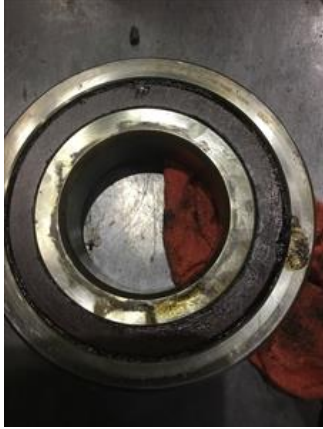
52. Bearing DE Type	NU	
53. DE Bearing Qty.	1	
54. Bearing ODE Size	MRC 316R thrust	P43
<div>

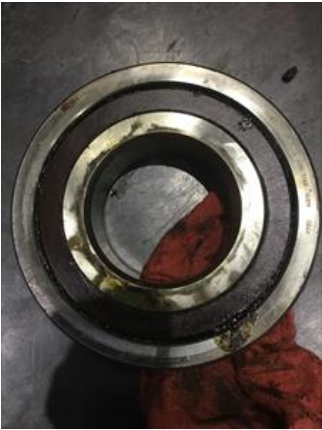
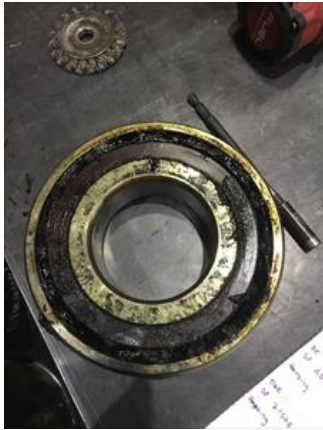
</div>		
55. Bearing ODE Type	thrust	P53
<div>

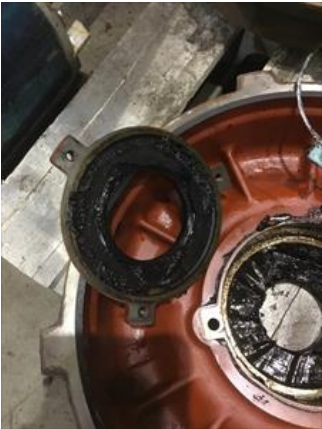
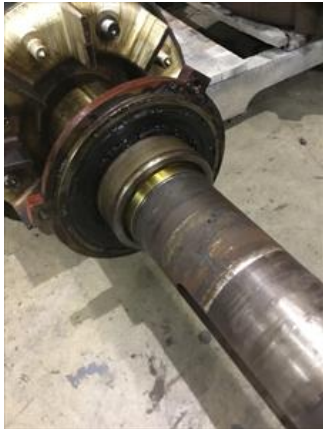
</div>		
56. ODE Bearing Qty.	1	
57. Insulated Bearing	no	
58. Lubrication Type	grease	
59. Grease Condition	(F) Fail	
<div> <span></span> Dirty         </div>		
60. Bearing Retainers	(Y) Yes	P80
<div>

*Contaminated bearing grease*

*Bearings failed due to grease dirty/ contaminated*
