AC Recondition Repair Report

Kimberly Clark (10176-KCM)
 500 Murphy Dr.
 Maumelle, AR 72113

4. Manufacturer	GE	P5
-----------------	-----------	----

5. Model	
6. Serial Number	RK6173045
7. Horsepower	150
8. KW	
9. Volts	460
10. Amps	161
11. RPM	1785
12. Frame	449T
13. Enclosure	TEFC
14. Cycles	60
15. Phase	3

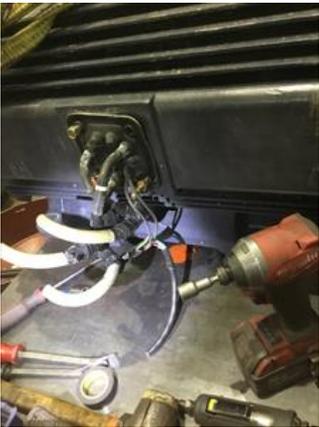
16. Service Factor	1.15	
17. Motor Mount Position		
Initial Inspection		
18. Number of Leads	3	P13

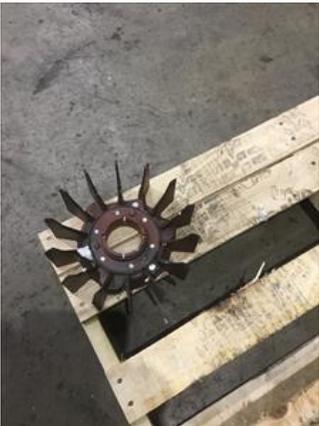
19. Lead Length	7 Inches	
20. Lead Size		
● 21. Lead Condition	(P) Pass	
22. Lead Markings		
23. Lug Size, Condition, and Type		
24. Winding RTD's		
25. Winding Rtd's Condition		
26. Shaft Run Out		
27. Does Shaft Turn Freely	yes	
28. Does Shaft Have Visible Damage	no	
29. Bearing Rtd's		
30. Bearing Rtd's Condition		
31. Contamination		
	<i>Grease dirty</i>	
● 32. Frame Condition	(P) Pass	
● 33. Fan Condition	(P) Pass	P109

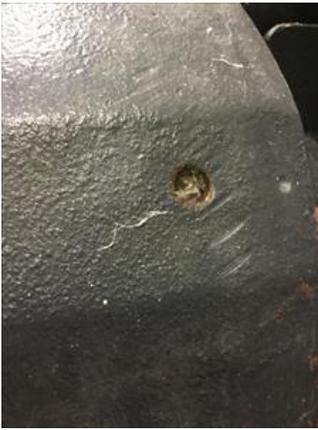
34. Broken or missing components P113
Fan cover bolt broken off

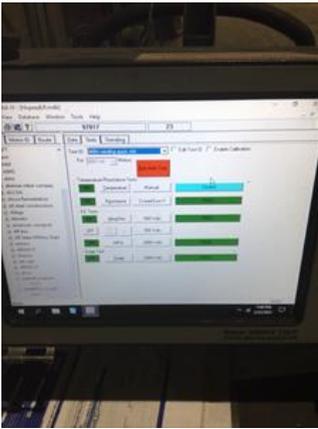
P7

35. Resistance to Ground

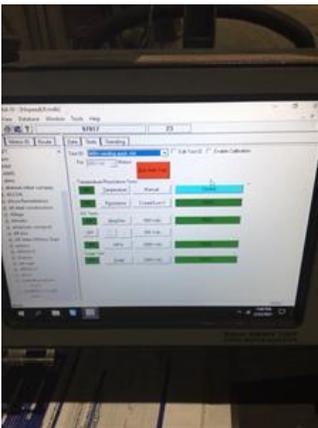
P58

● 41. Surge Test

(P) Pass

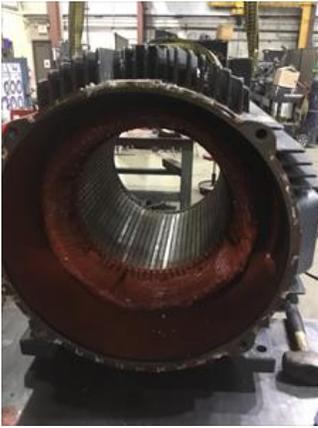
P65

42. Stator Condition

pass

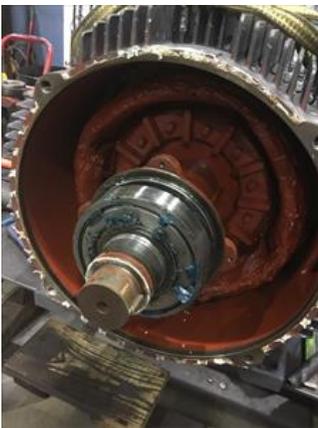
P4

44. Rotor Type

squirrel cage

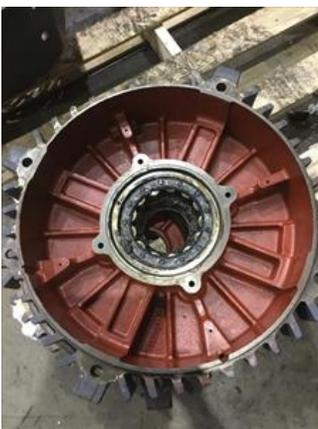
P1

50. Bearing Manufacture

koyo

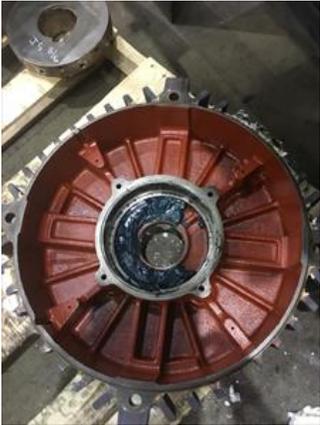
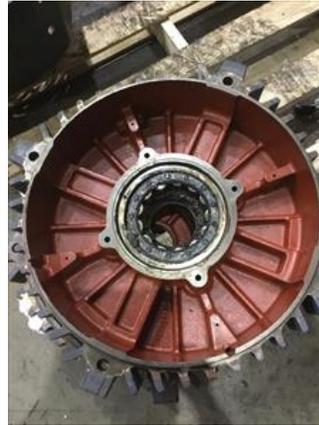
51. Bearing DE Size	nu6318	
52. Bearing DE Type	NU	
53. DE Bearing Qty.	1	
54. Bearing ODE Size	6318Z/C3	
55. Bearing ODE Type	regular ball bearing	
56. ODE Bearing Qty.	1	
57. Insulated Bearing	no	
58. Lubrication Type	grease	
● 59. Grease Condition	(F) Fail	P74

66. Component Failure	bearings	
67. Cause of Failure	<i>Contaminated grease</i>	
68. Comments	<i>Customer request modification for tach attachment on ode.</i>	
69. Service Technician	Terrence Holland

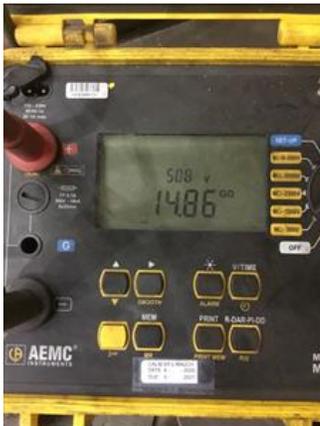
P3

127. Meggar Testing Reading
