AC Recondition Repair Report

Process & Power

General			
1. Job Number	97331		
2. Report Date			
3. Customer			
Name Plate Information			
4. Manufacturer	BALDOR		
5. Model			
6. Serial Number	B9066374-020

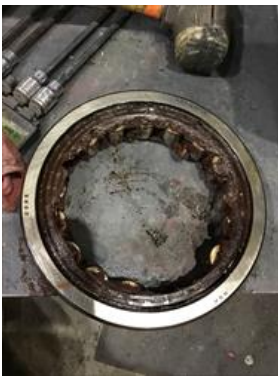
P1.1

50.	Bearing Manufacture	NSK	P1
51.	Bearing DE Size	nu 222E/c3	P14
52.	Bearing DE Type	Roller	
53.	Bearing ODE Size	6318	P30
54.	Bearing ODE Type	regular ball bearing

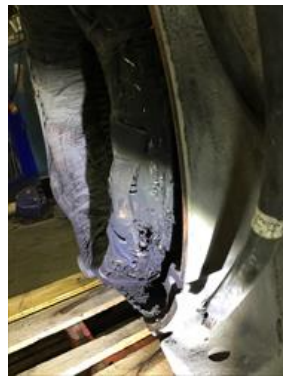
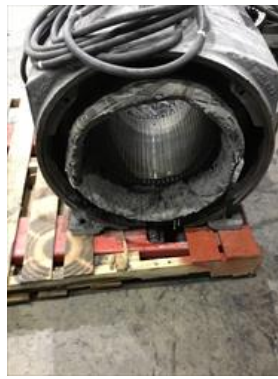
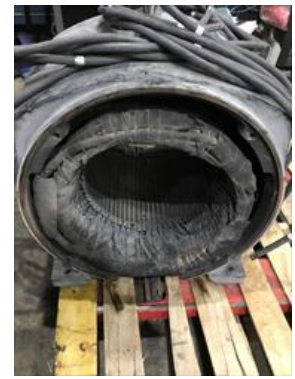
P2.2

64.	Component Failure	windings	P2

65.	Cause of Failure		
	Possible debris.		
66.	Comments		
67.	Service Technician	Terrence Holland	
	.

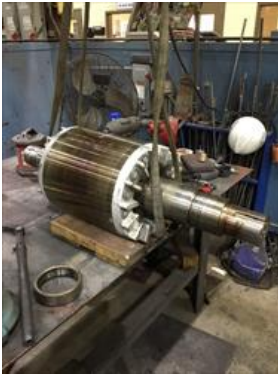
P4.5

44.	Rotor Type	Squirrel cage	P4
45.	Air Gap <10% Variation		
46.	Number of Rotor Bars	58	
47.	Number of Broken Rotor Bars	0	
● 48.	Growler Test	(P) Pass	
● 49.	Rotor Condition	(P) Pass	
Mechanical Inspection

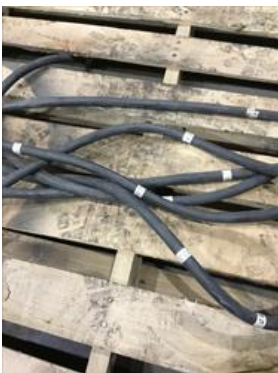
P50.13

22. Lead Markings	T1-T6	P50	
23. Lug Size, Condition, and Type	N/A		
24. Winding RTD's	(NA) Not Applicable		
25. Winding Rtd's Condition	(NA) Not Applicable

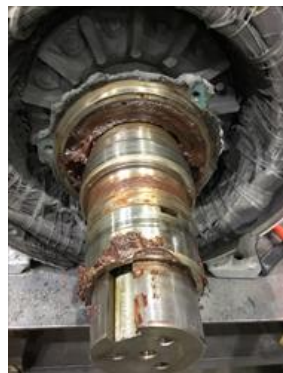
P57.14

55.	Insulated Bearing	no	
56.	Lubrication Type	grease. unknown type	P57
● 57.	Grease Condition	(F) Fail	P64
● 58.	Bearing Retainers	(Y) Yes	
■	Pass		
59.	Shaft Grounding Device	(NA) Not Applicable	
● 60.	DE Seal	(Y) Yes	P77

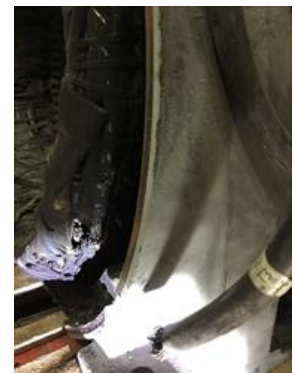
P66.16

39.	Resistive Imbalance		
40.	Hi-Pot	Ua	
● 41.	Surge Test	(F) Fail	
42.	Stator Condition	good	
43.	Failure Location	Drive end bottom right, facing motor, coil head.	P66
Initial Rotor Inspection

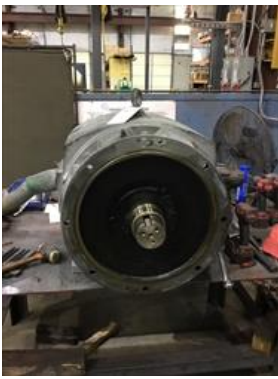
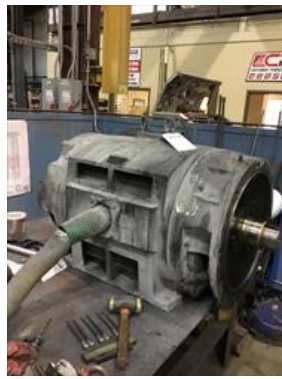
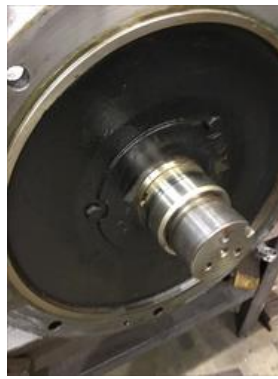
P74.17

7. Horsepower	300		
8. KW			
9. Volts	460		
10. Amps	350		
11. RPM	1725		
12. Frame	447TDZ		
13. Enclosure	ODP	P74	
14. Cycles	60		
15. Phase	3		
16. Service Factor	1.15

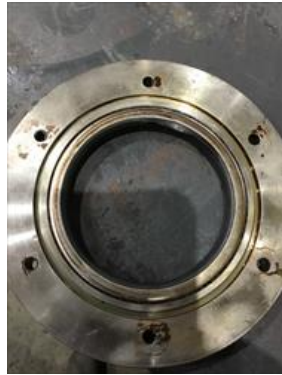
P81.22

61.	DE Seal Type/Size	107 95*130*12	P81
62.	ODE Seal	(NA) Not Applicable	
63.	ODE Seal Type/Size	N/A	
Root Cause of Failure

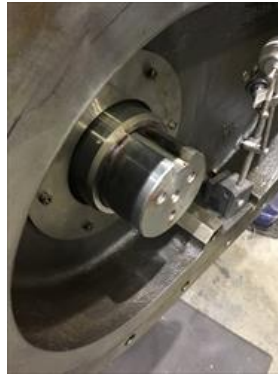
P93.23

26. Shaft Run Out	0.001		
27. Does Shaft Turn Freely	Yes		
28. Does Shaft Have Visible Damage	no	P93	
29. Bearing Rtd's	(NA) Not Applicable		
30. Bearing Rtd's Condition	(NA) Not Applicable

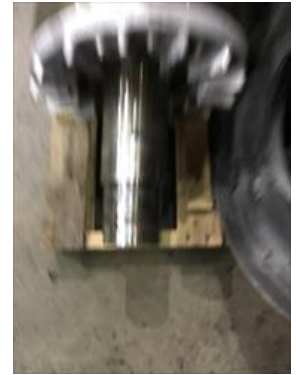
P101.24

80.	ODE Initial Shaft Bearing Fit Size 2	3.5436 "	
81.	ODE Initial Shaft Bearing Fit Size 3	3.5435 "	P101
82.	ODE Finial Shaft Bearing Fit Size 1		
83.	ODE Finial Shaft Bearing Fit Size 2

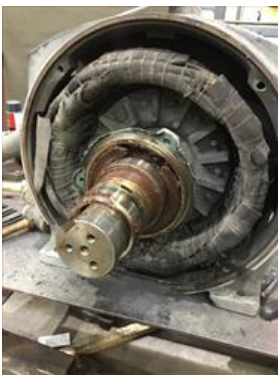
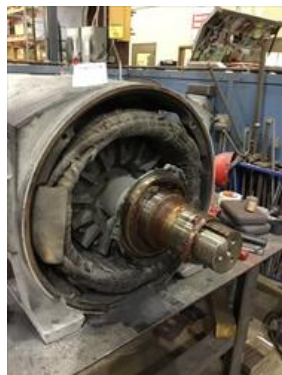
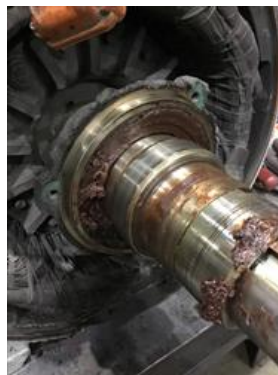
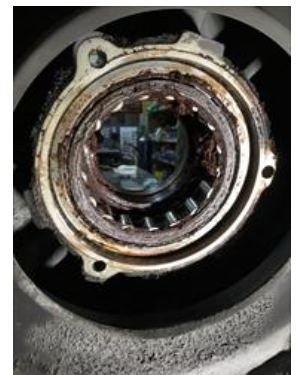
P102.25

31. Contamination	P102		
32. Frame Condition	(P) Pass P104		
33. Fan Condition	(NA) Not Applicable
