Hi-Speed Industrial Service
7030 Ryburn Dr
Millington, Tn 38053
901-873-5300

AC Recondition Repair Report

Saint Jean Industries, Inc. (11653)
424 Industrial Park Road
Heber Springs, AR 72543

4. Manufacturer	TECO	P5
-----------------	------	----

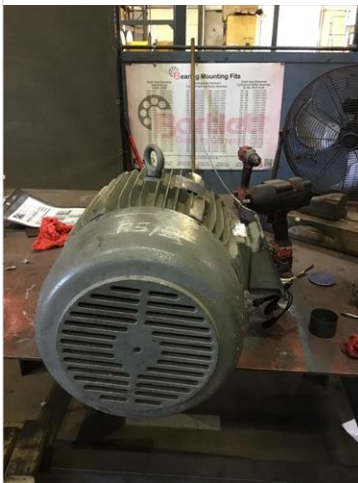
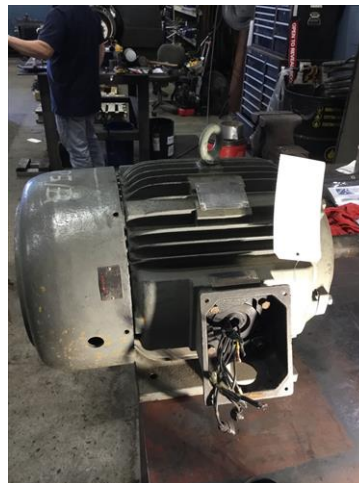
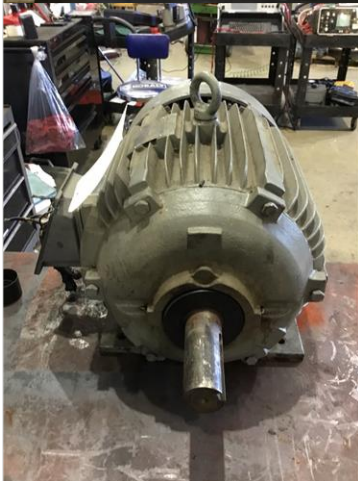
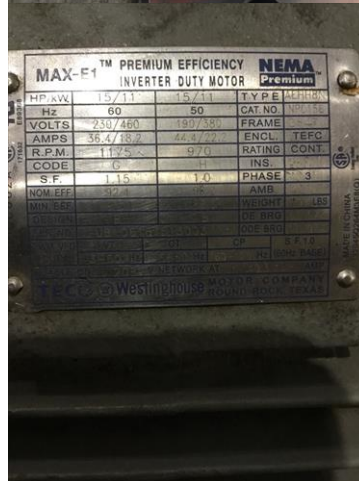
5. Model	TYPE: AEHH8N
6. Serial Number	UBQ6167513003
7. Horsepower	HP
15/11	
8. KW	
9. Volts	230460

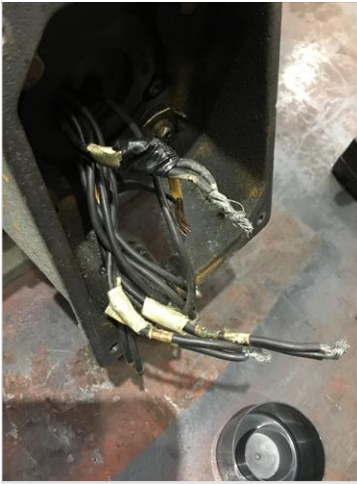
21. Lead Condition	(P) Pass

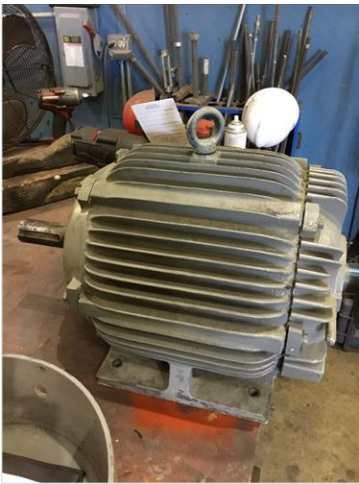
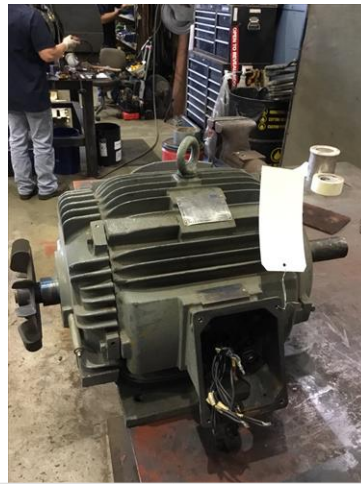
P104

● 32. Frame Condition

(P) Pass

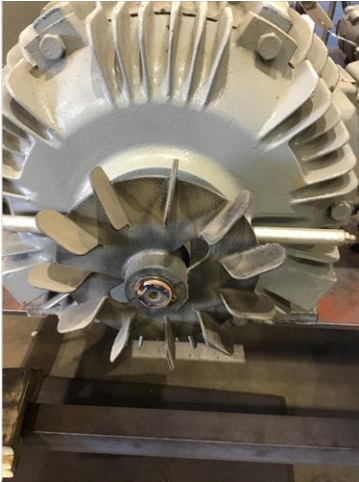
P107

33. Fan Condition

(P) Pass

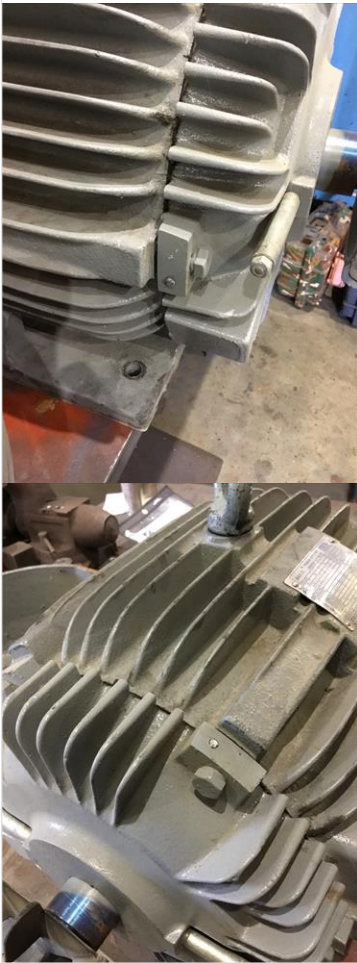
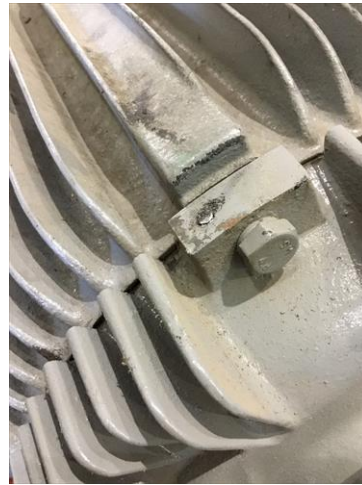
P109

Additional Notes: 3 broken fan cover
bolts in o.d.e.

34. Broken or missing components
Fan cover has 3ea broken mount bolts.

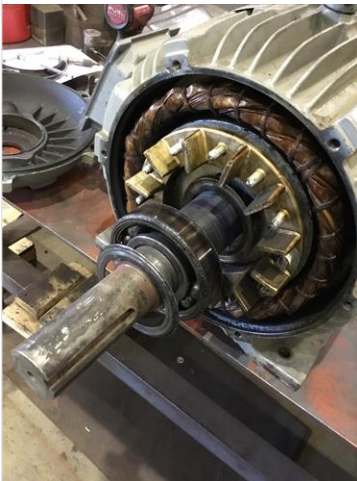
P1

50. Bearing Manufacture

NTN

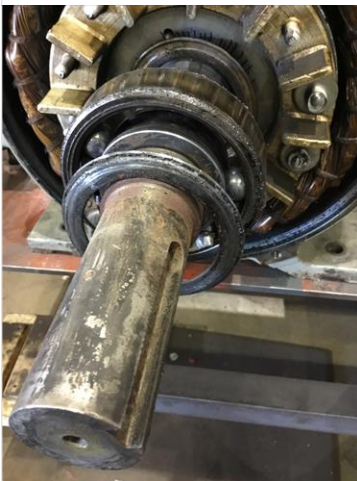
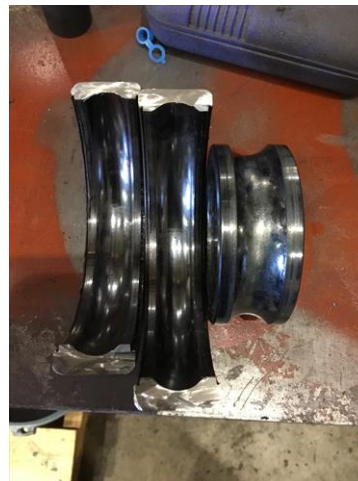
P14

51. Bearing DE Size

6311 Z

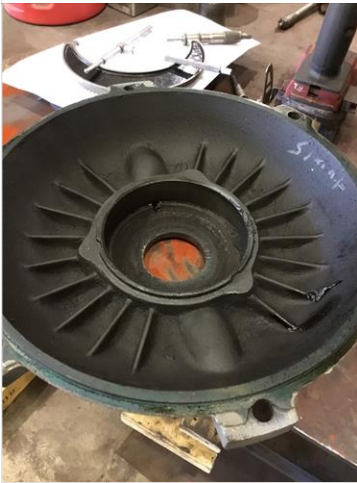
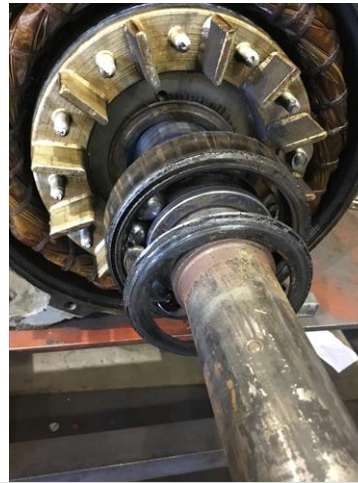
P64

☒ 57. Grease Condition

(F) Fail

Zero amount of grease present on drive end bearing.

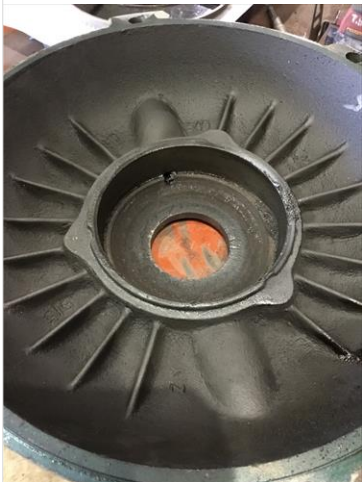
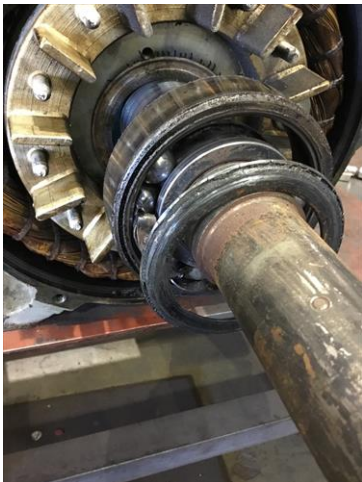
64.	Component Failure	D.E bearing cage failed due to no lubrication.
65.	Cause of Failure <i>No lubrication.</i>	P15

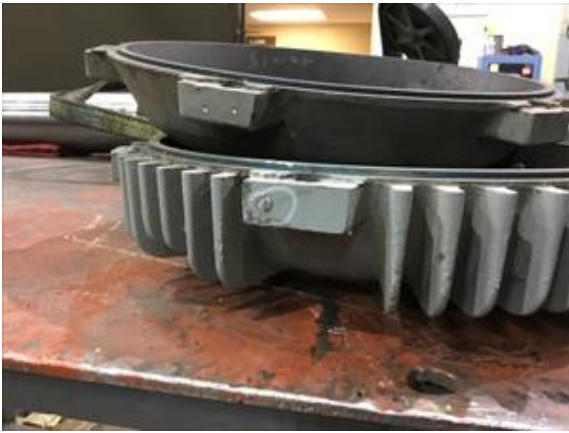
<div> <div></div> <div>102. ODE Endbell Fit</div> </div> <div> <div></div> <div>3 broken fan cover bolts</div> </div>	(F) Fail	P143
---	----------	------
